# Massive alumina red sludge release after the failure of a containment dam

4 October 2010

**Kolontár**  
**Hungary**

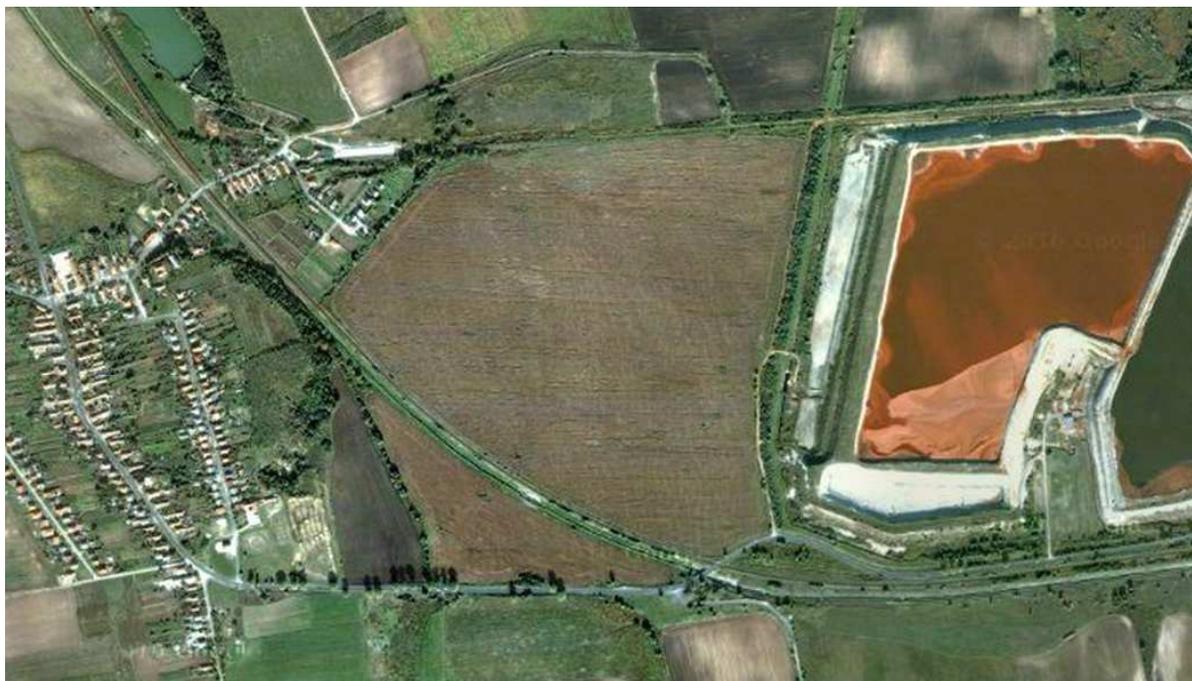
2. Satellite view of the Reservoir 10 and Kolontár before the accident

The MAL Inc. and its predecessors placed the red sludge into tailing ponds in the Torna Creek's valley between Ajka and Kolontár. Between 1943 and 1968 the red sludge was brought to Reservoirs 1-4 inside the premises of the factory. After 1967 six new reservoirs (5<sup>th</sup> -10<sup>th</sup>) were built west from the factory. The Reservoir 10, where the accident occurred has been in use since 1998.

The factory is located on a 49,11 hectare land, and the reservoirs cover a further 207 hectares. Reservoir 10's volume is 4.500.000 m<sup>3</sup> and its base is on 19 hectares. The height of the dam walls is between 21-25 metres, and the width is 10 metres at crest.
