Explosion of a formulation reactor at a chemical plant

January 11th, 2011

Bourgoin-Jallieu (Isère)

Chemical plant
Reactor
Explosion
Inerting
Toluene
Sodium methoxide
Glass equipment
Human factor

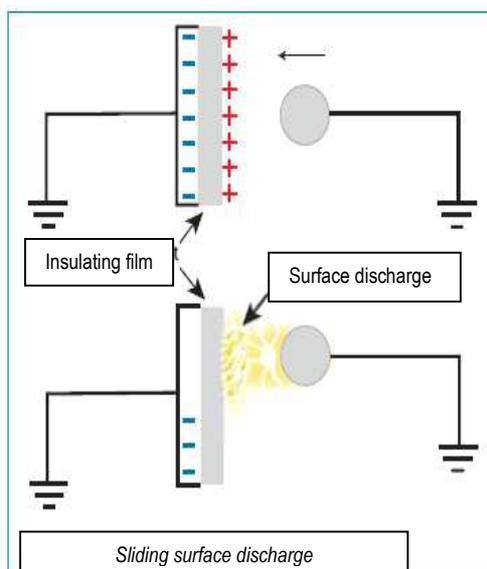
Definition of a sliding surface discharge:

A sliding surface discharge occurs along the surface of a thin insulating layer and is generated on both sides; moreover, it features very strong charges of equal magnitude and opposite signs. This insulating layer may either be a thin, yet plated, independent layer on a conductor or else a metal surface lining.
