Hydrocarbon spill during a transfer operation

17 July 2010

Speyer

Refinery
Hydrocarbons
Unloading
Pipe
Leak
Site clean-up
Procedures

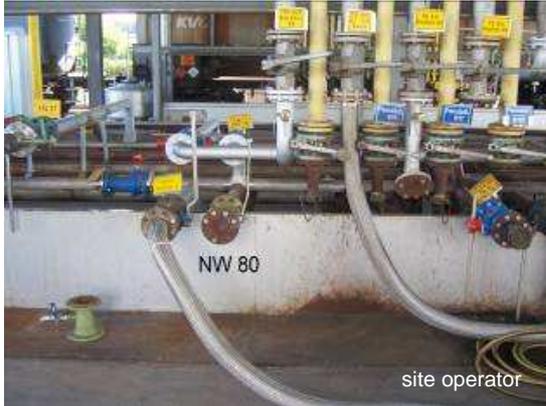
Flexible hose for tank connection

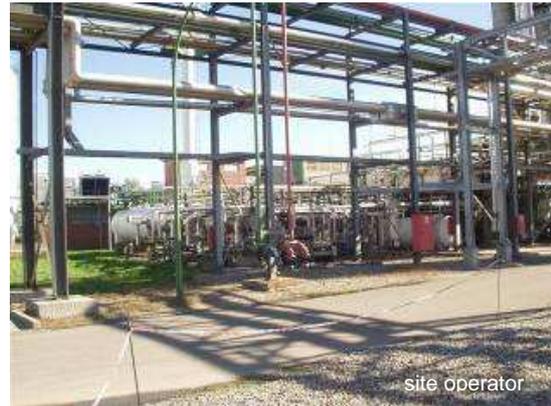
- The 450 m long pipe could not be positioned along a constant incline due to both geographic constraints and the site layout.
- Repeated pump malfunctions led to its cavitation, triggering the formation of cavitation bubbles.
- Pump start-up under more strenuous operating conditions led to a pressure surge that exceeded the pipe design pressure (16 bar).
- The narrowing cross-section (a nominal diameter drop of 150 to 80), combined with improperly placed support systems and the expansion compensator design, was responsible for leading to the breaking point.

Pipes rack

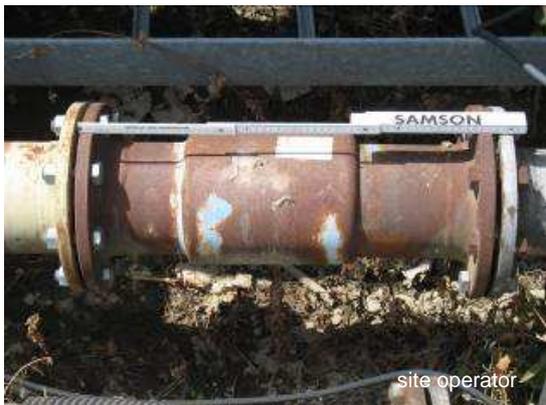
The pipe's expansion compensator burst due to the pump's repeated malfunctions and restarting under high pressure. Post-accident investigations revealed that a water hammer phenomenon occurred and was then accentuated by the following technical aspects:

Expansion compensator before the accident
