Explosion of a VOC recovery pipeline at a petrochemical plant

October 21st, 2011

**Loon-Plage (Nord-Pas-de-Calais)
France**

Explosion
Hydrocarbons
VOC
Management of change
Design
Risk analysis

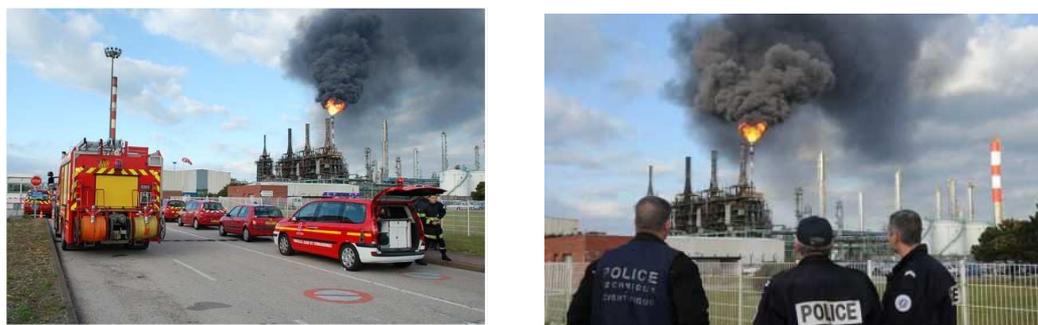
Both the in-house fire-fighting crew and Second Responders were at the scene by 3:44 pm to contain and control the blaze using onsite resources, which proved to be sufficient, i.e.: sprinkler ring placed on the equipment, 4 refinery vehicles (using water, foam, powder), and high-pressure mobile rotary nozzles. Emergency workers installed a water curtain in order to dilute the oxygen leak. Fire-fighters with local Rescue Services arrived to offer backup protection with a 40-man crew and several vehicles; their intervention however would not be required (Fig. 5).

Figure 5: Intervention of the public agency's rescue services (Source: C. FREMIN & DELTA FM / J.C. BAYON)
