Overflow of a gasoline tank inside a refinery

22 October 2011

Reichstett (Bas-Rhin)

Oil depot
Hydrocarbons
Automatism
Sensor
Test periodicity
Material failure

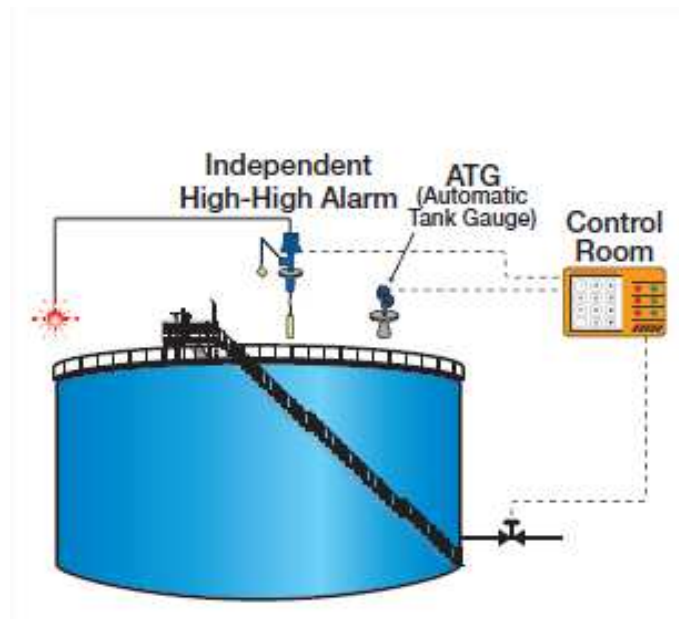
Figure 7: The American API 2350 Standard classes as Category III any storage tanks managed remotely; moreover, it recommends use of a high-high level safety sensor that is independent of the operating level (ATG) sensor and, preferably, offers self-diagnostic capacities relative to its malfunctions and defects.

- improve the quality of information available on the control operator's console, including a more refined representation of ongoing transfer processes capable of alerting the technician of a deteriorating situation. Given the change in tank use patterns, operating conditions needed to be modified: no more tank-to-tank pouring and regularly scheduled purges due to the use of vapour (as was the case when the depot had been jointly run within the refinery complex);
- replace the 7 distinct MIP mechanical systems using a plunger to control operating levels by MIP systems based on a floaters or mechanical scale device, deemed more reliable and easier to test. Moreover, the plunger
