Rupture of a crude oil pipeline

26 May 2014

St-Vigor-d'Ymonville (Seine-Maritime)

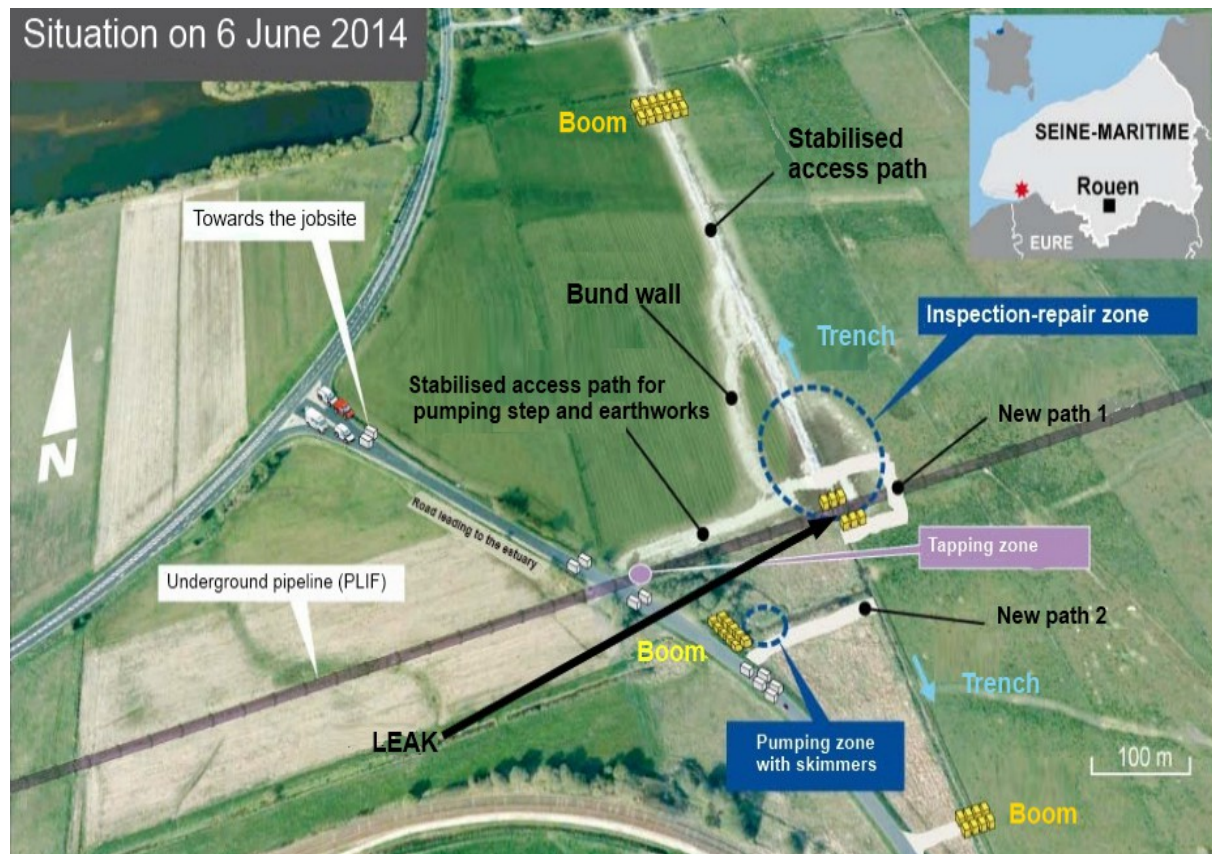
3:00 pm: Beginning of pumping operations at the most easily accessible point.

3:30 pm: Preparation of access routes leading to the northern, southern and western pumping zones, and initiation of pumping operations.

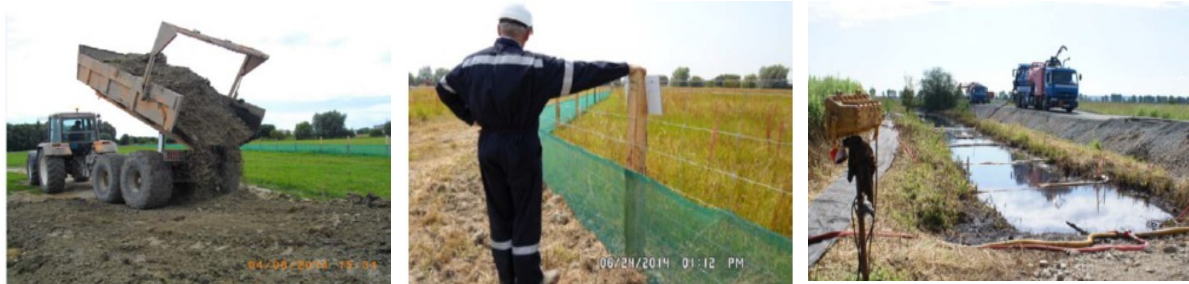
The pollution was completely confined using earthen dams reinforced by an impermeable membrane. Fences and anti-amphibian screens were installed to prevent local fauna from entering the polluted zone.

The 4500 m³ of crude oil, water and sediments pumped from the zone were discharged at the Normandy Refinery site (located a few kilometres away), where a settlement protocol had been implemented specifically to manage this accident. These 4500 m³ included the 2100 m³ of crude oil resulting from the pipeline drainage step prior to its repair.
