Fire in a fertiliser warehouse

October 29th 1987

Nantes – [Loire-Atlantique]

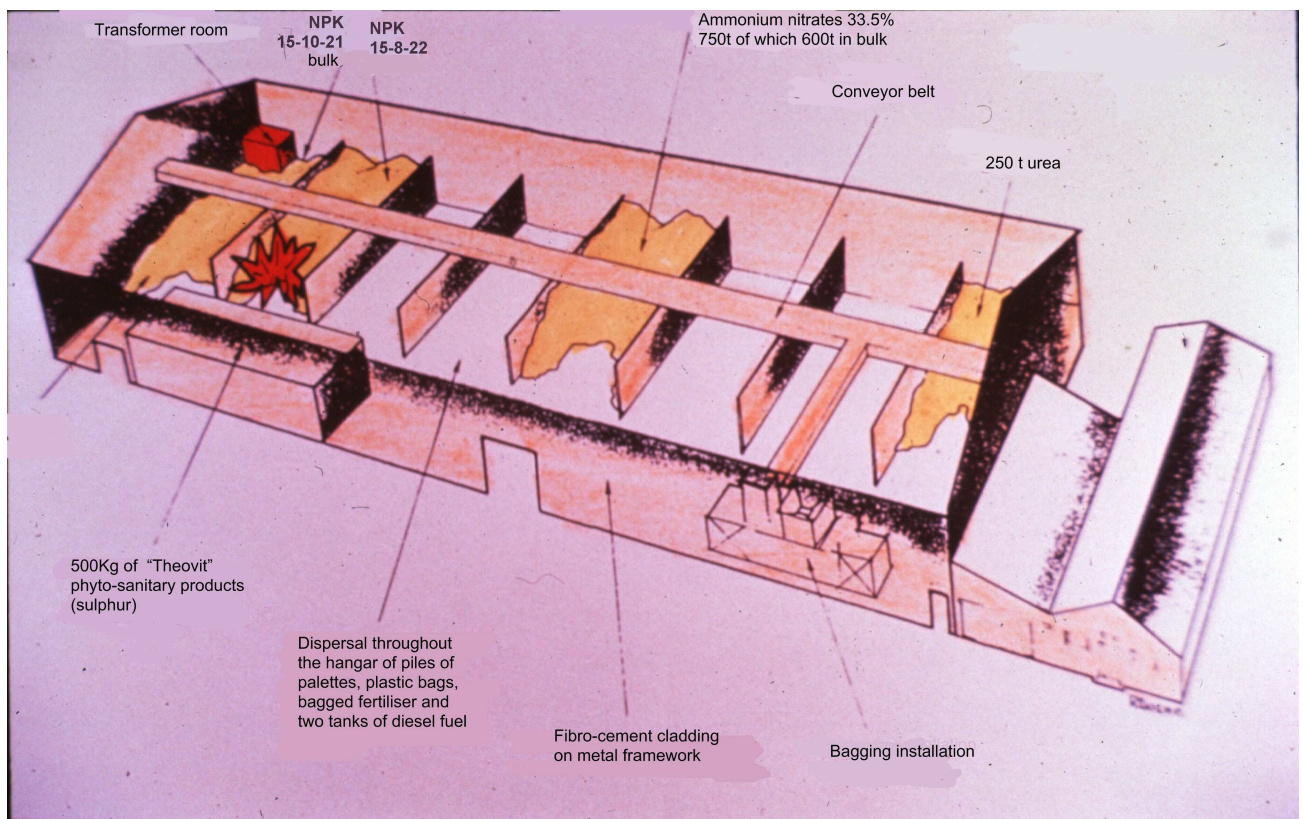
The storage installations consisted of a rectangular metal framed building with curtain walls and roofing in fibro-cement of 107.5 m by 32 m and a height of 10 m, or 7 m useable and a total volume of 24 000 m³. The ground surface area is divided into 8 boxes by mobile concrete partitions 3.5 m high.

A system of conveyor belts is used for the moving of bulk products from a trench communicating with the unloading quay to an airborne machine known as the "aeroplane" which spreads the products between the different sections. This device also supplies the products to a bagging installation.
