Large-scale fire in a wood chip storage facility

21 August 2017

Gasville-Oisème (Eure-et-Loir County) France

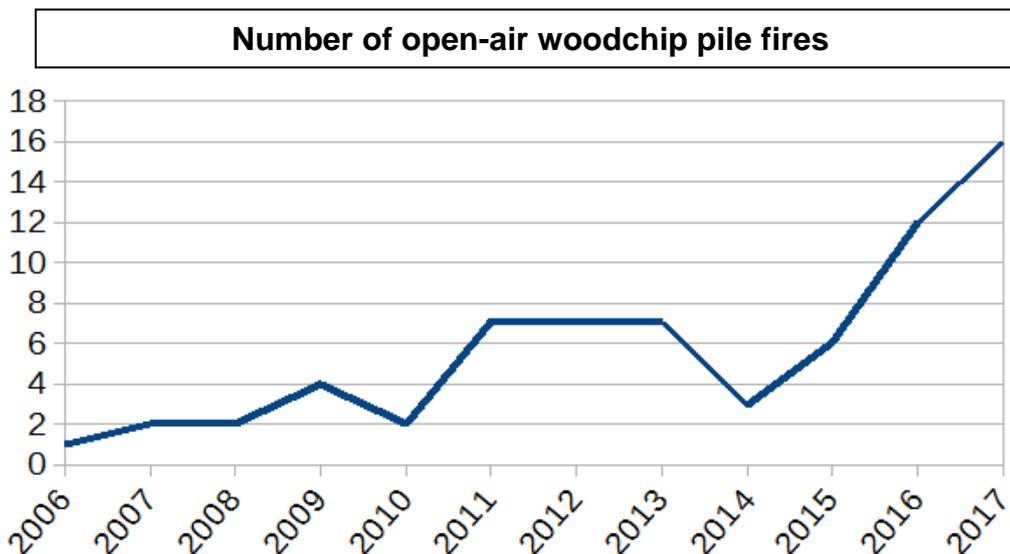
The accident is all the more interesting in terms of feedback as it took place amid a significant increase in fires in open-air wood waste storage facilities. The year 2017 was thus marked by 16 such accidents (ARIA 49357, 49541, 49614, 49591, 49892, 49863, 49868, 49940, 50309, 50082, 50141, 50270, 50268, 50359, 50580, 50696, 50856), which is a notable increase over previous years, as shown in the graph below.
