# Dust explosion in a port-based silo

## 23 February 2018

### Grande Synthe (59)

Silos  
Explosions  
Dust  
Wood  
Cereals

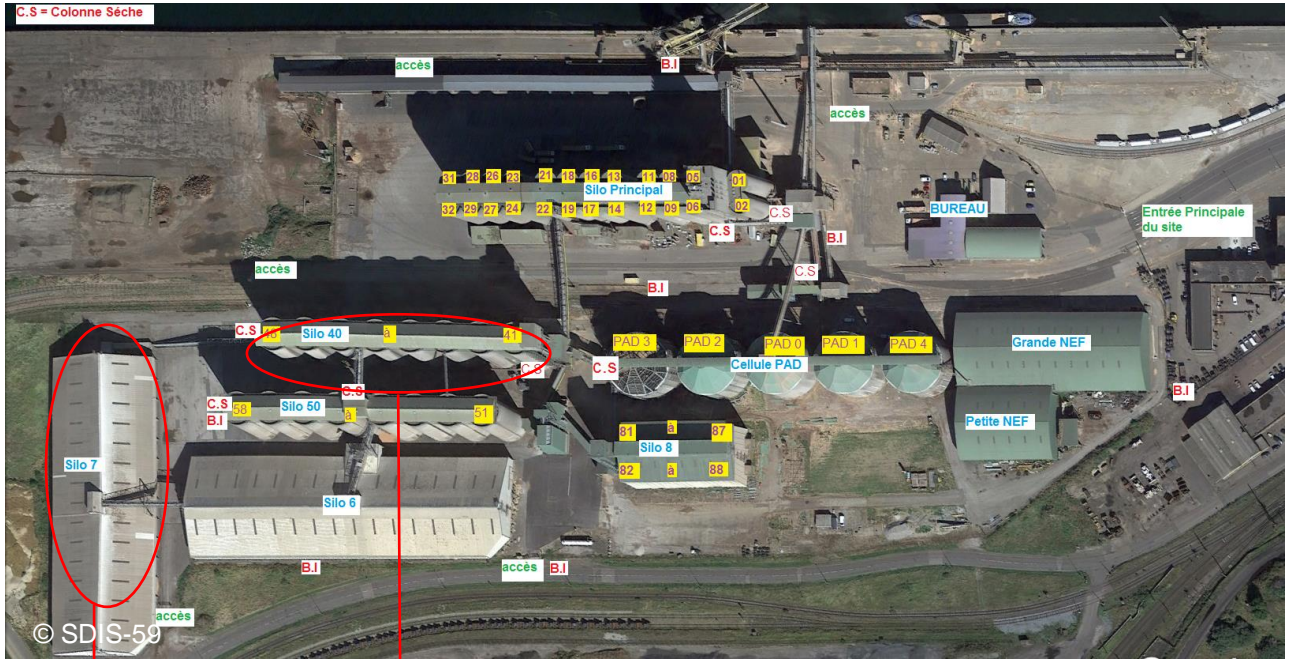
Flat silo

Vertical silo

Railcar loading facility

Covered overhead conveyor

Handling tower

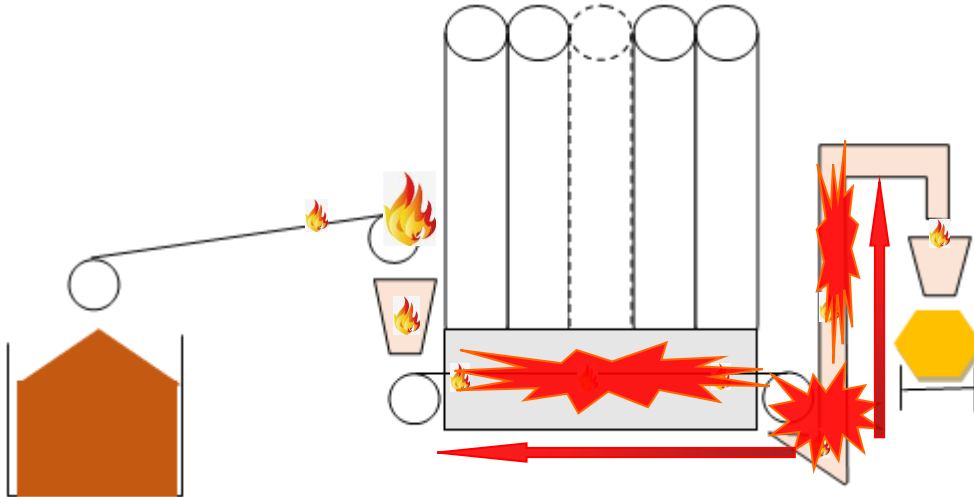
The explosion generated a flame front and a pressure wave that travelled to the handling tower and to the sub-cell gallery. The dust dispersed by the shock wave and the flame front created the conditions for the secondary, more violent explosion.

After the explosion, flames may have been projected by the open handling tower on its upper part affecting the inside of the vertical cells, which were also open on the upper part. Hot spots were detected in 2 empty cells, and surface fires were discovered in a cell containing 1,000 t of wheat and a cell containing 2,500 t of wood pellets. It took the fire department 3 days to finish emptying these cells.

*The analysis of the accident conducted by the INERIS estimates an explosion overpressure of between 100 and 350 mbar. This value is lower than the bursting pressure of the external reinforced concrete walls of the cells (430 mbar), which is consistent with the observed lack of damage to the concrete walls. The overpressure distances in the elevator shaft are 3 m for 50 mbar and 7 m for 20 mbar.*

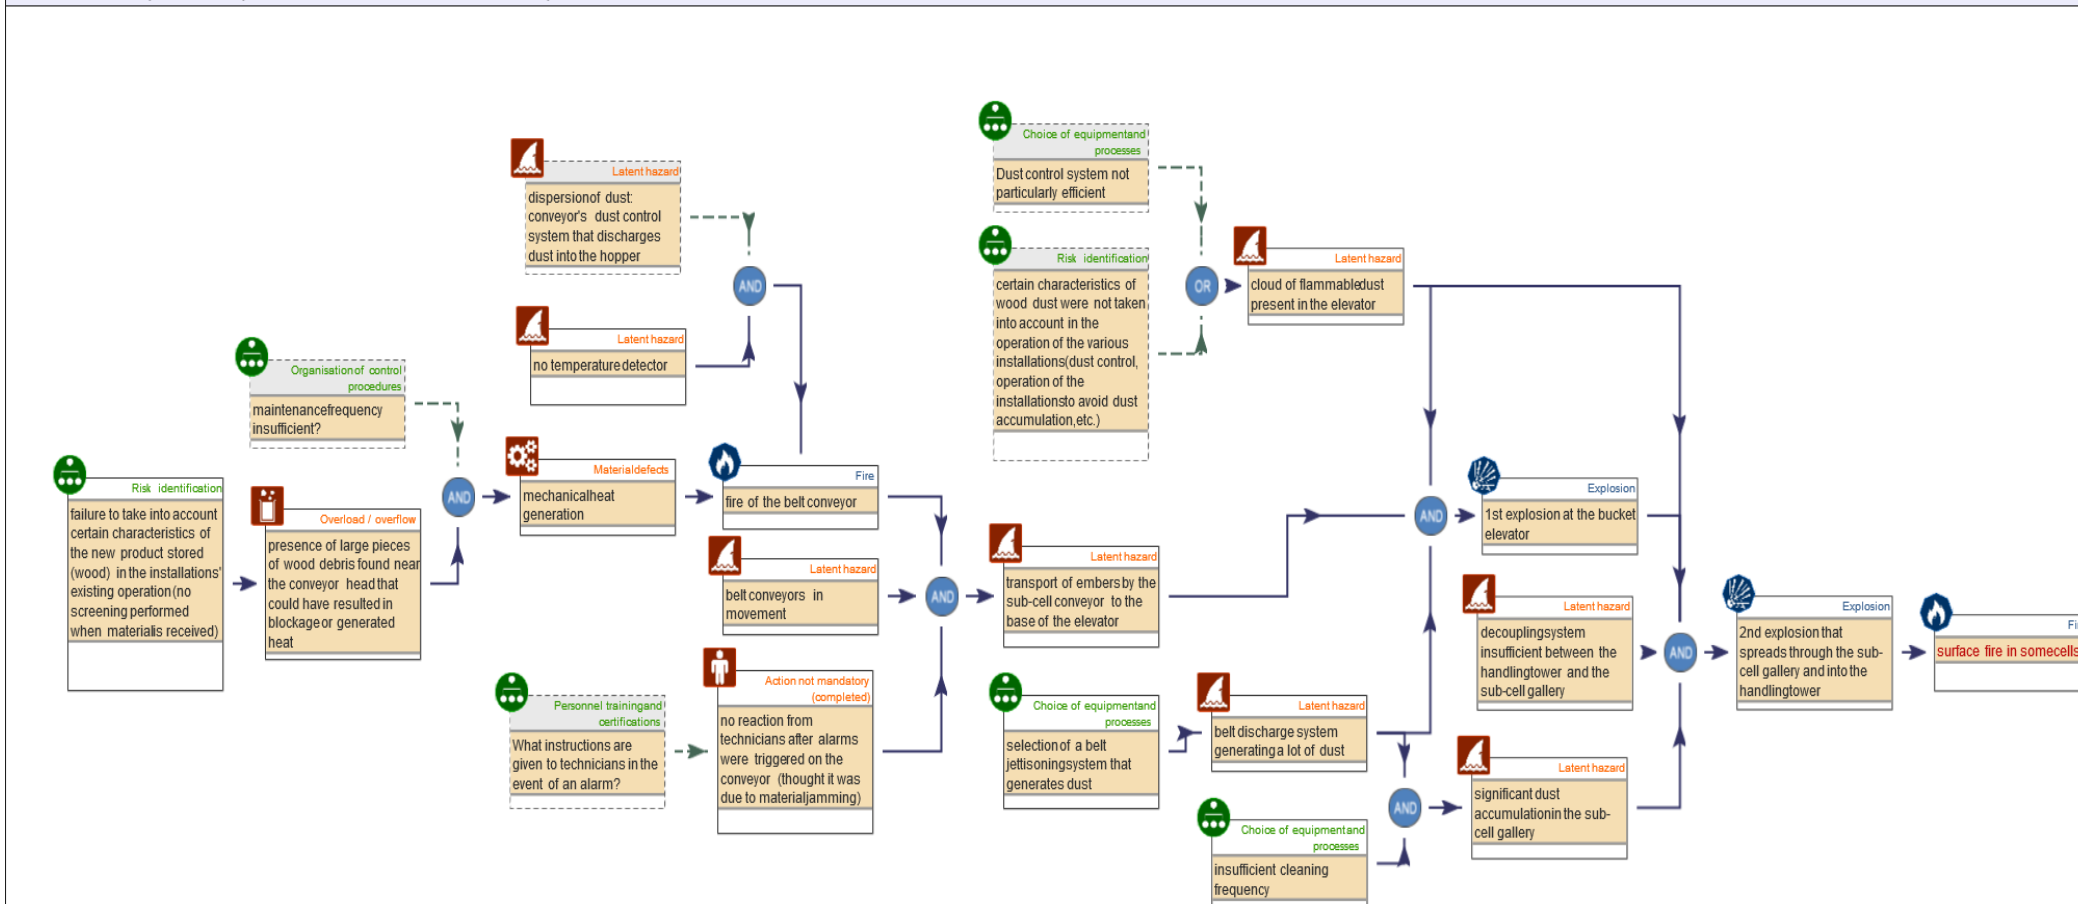
ARIA 51118 - Explosion de poussières et incendie dans un silo portuaire

Graphical modelling of the accident makes it possible to highlight proven and supposed organisational causes (dotted line):

Accident modelling makes it possible to highlight certain organisational causes:

- no **risk analysis** was undertaken following storage of a new product (wood pellets). However, wood and cereals have different physical and flammability characteristics. Such a risk analysis would have made it possible to identify any process and equipment changes to be carried out;

- the collapse of the bearing at the head of the belt raises questions **regarding the conditions under which maintenance was carried out**. Is the maintenance frequency sufficient? Are the criteria defined for this maintenance adapted to the changes in products stored at the site?;
