# Leak of sulphur containing gases in a refinery

## 1 march 2018

### Grandpuits (Seine-et-Marne)

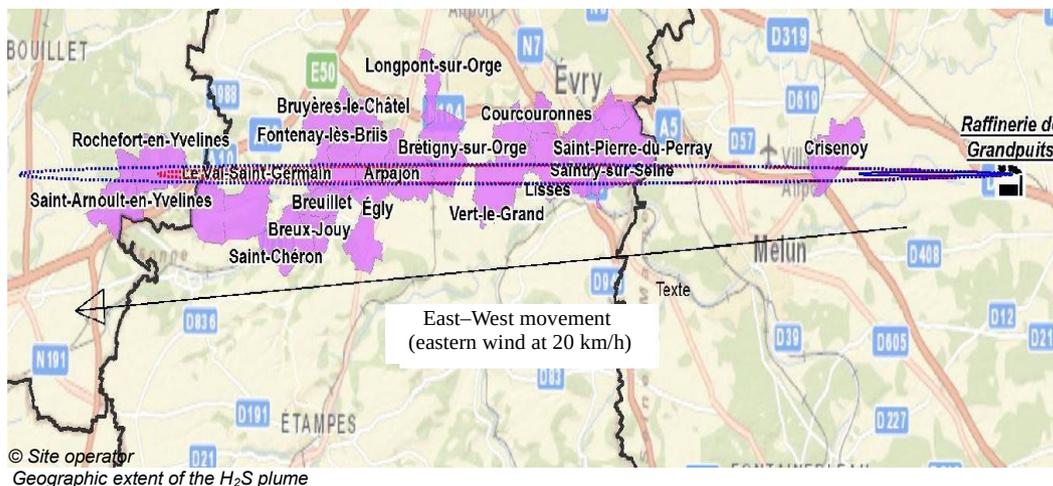
An analysis of the event showed that the leak occurred on a valve on the gas line between the purification column and the gas-flaring system. It was found that the valve's cap had been distorted by ice (outdoor temperatures below -5° C). During normal operation, the gas contained in the line does not flow. Heat tracing is used to prevent the formation of condensation, but the operator noted that it was not working. The expansion of the ice caused a crack to form in the valve. This crack then allowed the gas to leak out when the ice thawed. The lack of insulation and the fact that the valve was positioned at the bottom contributed to the build-up of water in the valve.

An estimated 187 kg of gas was released. The icy temperatures, strong wind, and atmospheric stability that remained very high throughout the event and the area explain why the odour was noticed in three counties. Computer models and air-quality measurements taken near the site show that the H<sub>2</sub>S concentrations were very low (less than 1 ppm) and thus there were no offsite toxic effects. However, the significant lethal effect thresholds<sup>1</sup> may have been exceeded in some areas near the leak inside the refinery.

In addition to the ice-induced damage to the valve, significant shortcomings on the operator’s part prevented on-time detection of the leak, placement of the refinery in a safe state, and implementation of its internal emergency plan. After the analysis of the event, the operator proposed technical and organisational safeguards to prevent a similar accident from recurring. More particularly, it checked and reinforced the refinery’s heat insulation and heat tracing systems. It also lowered the H<sub>2</sub>S detection thresholds to 5 and 10 ppm in order to speed up the localisation of leaks.
