## Damage to a CDG boat during locking

18/02/2020

Sablons (ISÈRE)

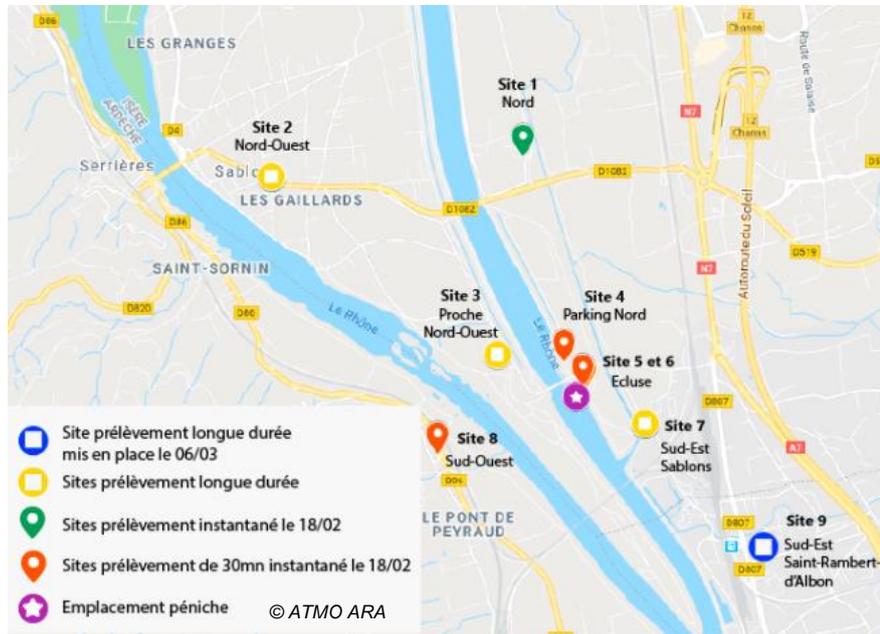
Though no members of the boat's crew were injured, they, like the staff on duty at the NMC, were shocked by the accident. 169 canisters<sup>6</sup> were used on 9 sites<sup>7</sup> to take air quality measurements continuously until the end of the safety operations (from 18 February to 23 March).

Though the VCM measurement results were variable over the entire period, they were all below the reference value taken into account for population exposure<sup>8</sup>. The highest VCM concentrations were recorded over the first 10 days following the accident, with a peak on 20 February of  $882\mu\text{g}/\text{m}^3$  on average over 24hr on site 3, which was also the site most affected with an average concentration of  $89\mu\text{g}/\text{m}^3$  over the 37 days of measurements. These measurements enabled assessment of the risk incurred and adjustment of the security measures for the surrounding population (prohibited access perimeter, temporary evacuation, or evacuation during unloading).

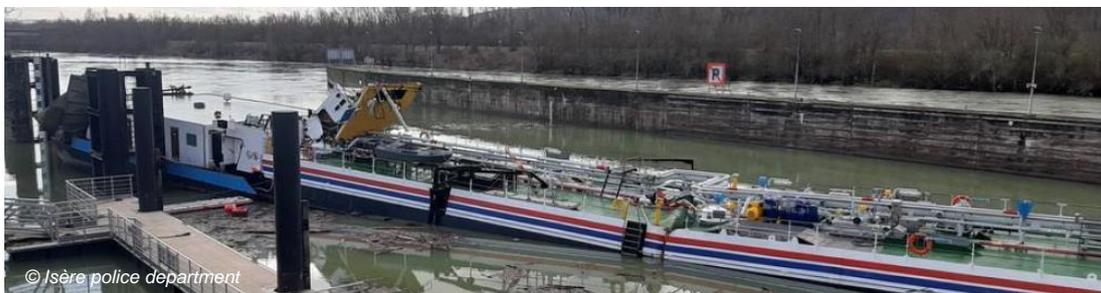
Major property damage was observed, both to the lock and boat: the downstream lock gate was destroyed, and the boat was deemed difficult to repair from a technical/economic point of view. It was towed 9 months after the accident.
