## Fire in a cement plant

07/09/2020

### Montalieu-Vercieu (ISERE)

Fire  
Scaling  
Maintenance  
Extinguishment

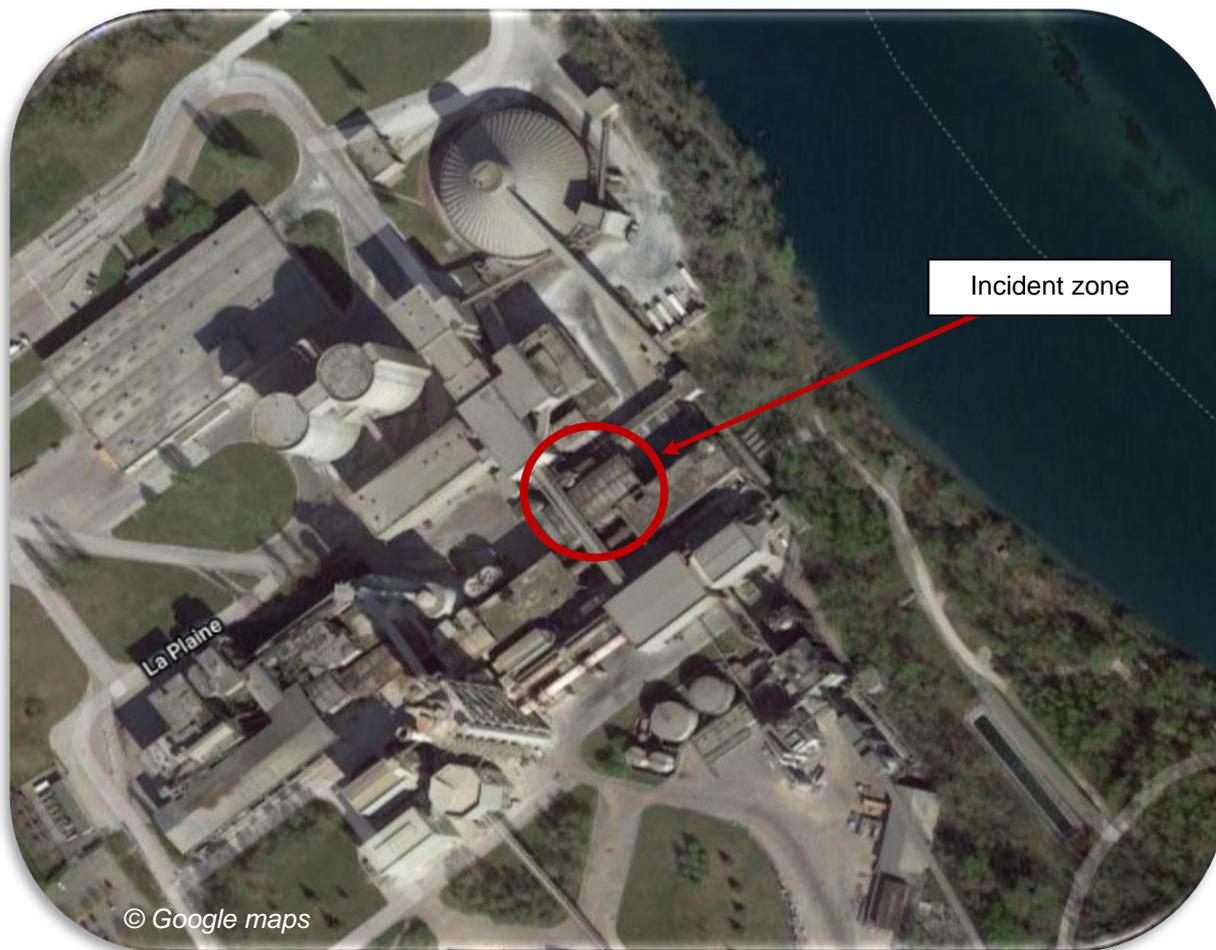
Adjoining this pit is an unused, inaccessible, and supposedly empty zone.

Near this storage zone is the animal meal silo. It is a metal, hermetically sealed, 400m<sup>3</sup> silo. It stores up to 230t of animal meal. This meal is prepared in knackery plants and is inactivated at 133°C at 3 bars for 20 minutes before being transported to the cement manufacturing plant. It is injected into the heart of the flame at 2,000°C and immediately destroyed.
