Catastrophic explosion of a cyclohexane cloud

June 1, 1974

**Flixborough
United Kingdom**

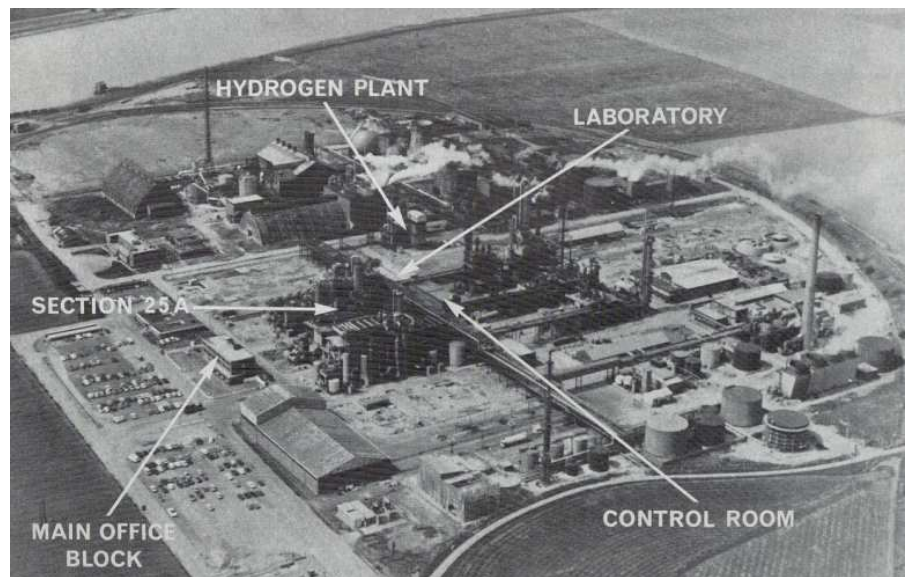
Aerial view of the site before the accident - Source: Secretary Of State For Employment (1975) *The Flixborough Disaster*. London: HSMO
