EXPLOSION AND FIRE IN THE TAR EXTRACTOR OF A COKING PLANT

20/11/2020

Dunkerque (Nord)

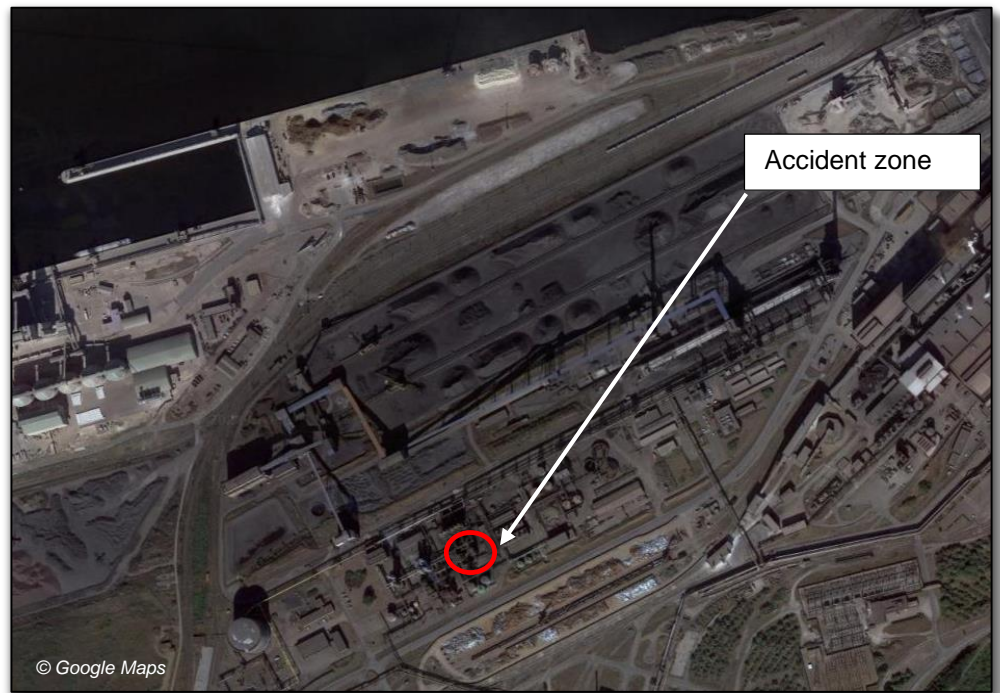
Figure 2: Aerial view of the unit involved

On 20 November 2020 at 4:13 p.m., one of the two tar extractors (DE3) in the coke oven gas treatment plant exploded. A fire broke out at the time of the explosion. The tar extractor had just been washed. It was in the dewatering phase and not in operation.

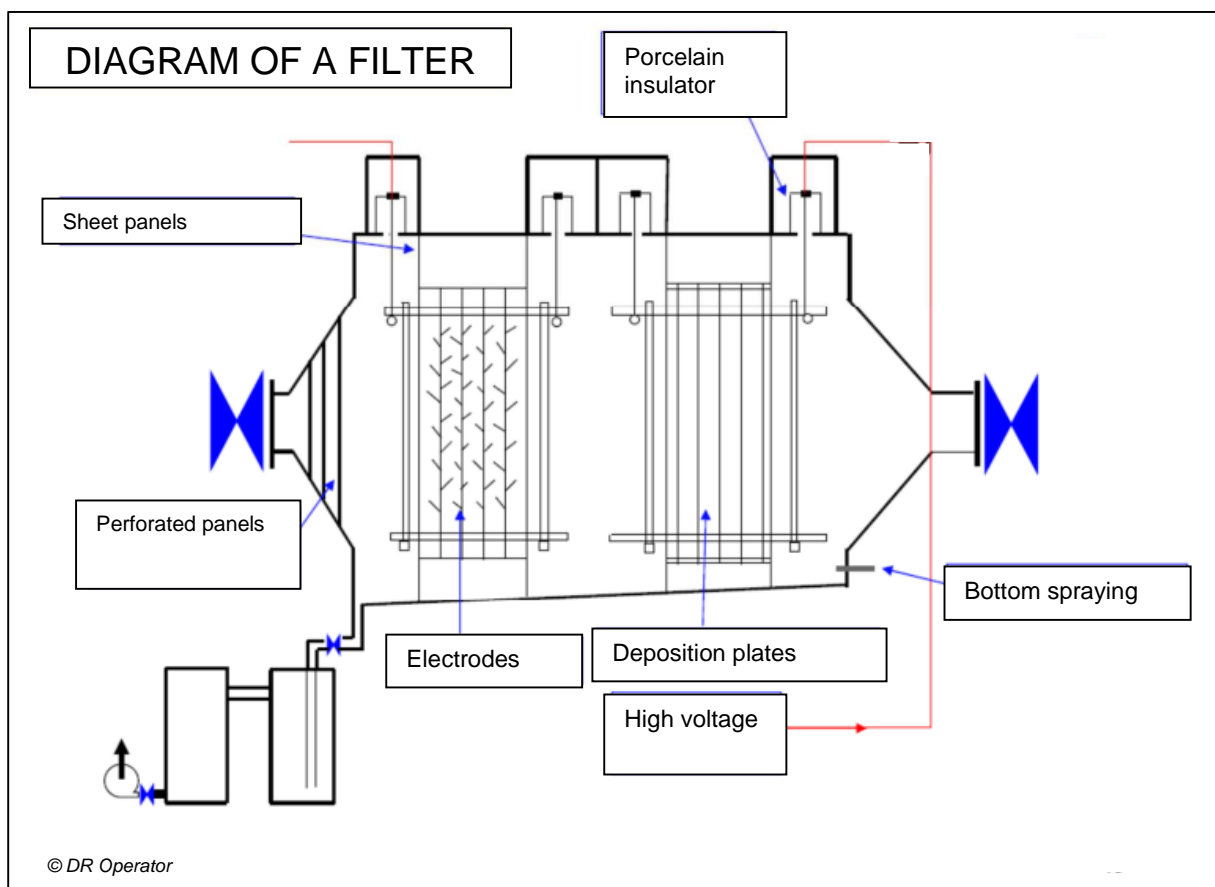
Figure 3: Inside a tar extractor chamber

Within the piping systems linking the various gas treatment equipment, **pyrophoric deposits** generated by the coke oven gas condensates may be present and give rise to slow **combustion**, releasing smoke (without flame) **in case of contact with air**. Interventions on these pipes must take this combustion risk into account. For example, phosphorus, cadmium, zinc/aluminium/magnesium powder or dust may be present.

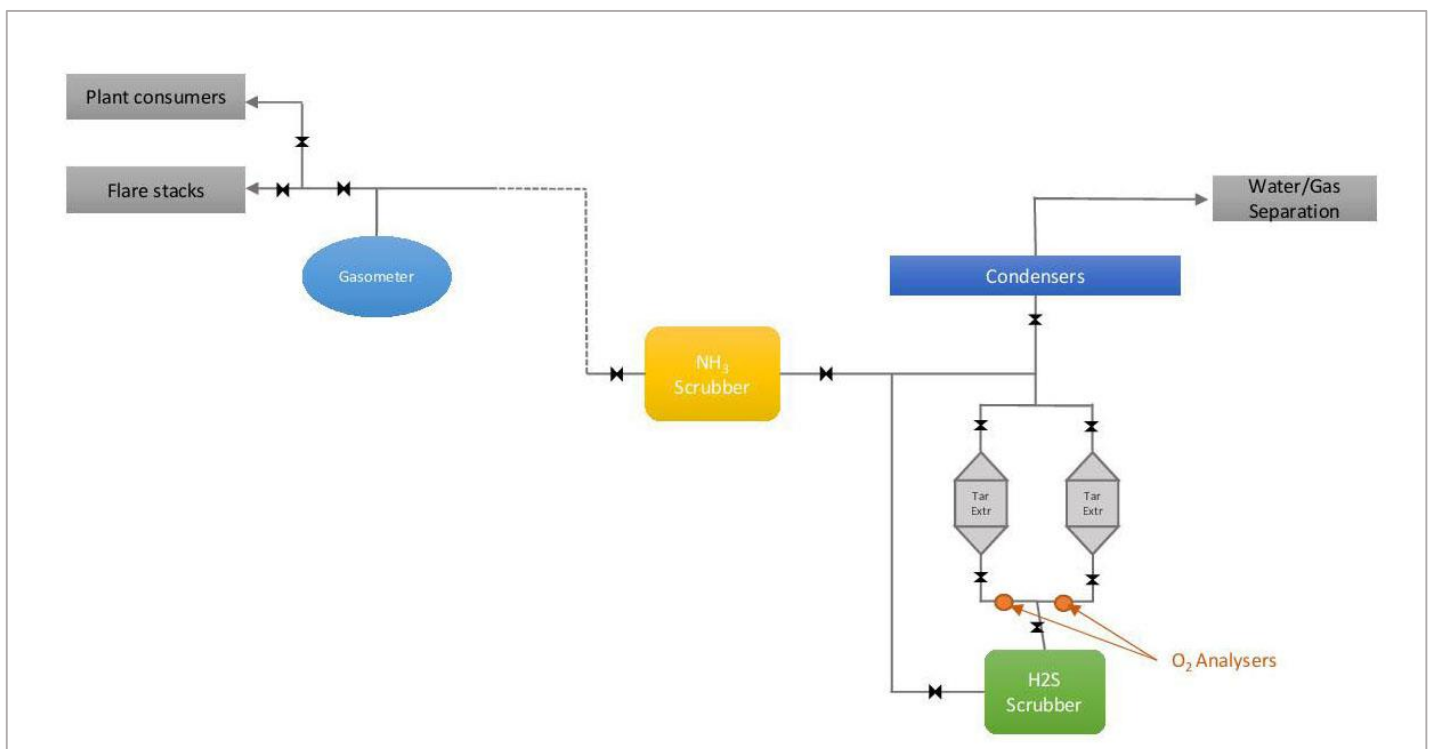
Figure 4: Layout of the gas treatment equipment

- return of the coke oven gas from the gasometer to the network, making sure that there was no return of the gas to the gas treatment system;
 - injection of nitrogen on the coke oven gas collector.

- around 11 p.m., the operator started injecting steam into the flare stacks to reduce the radiation.
