Watercourse pollution resulting from the release of liquid manure from a pig farm

02/04/2021

Taulé (FINISTÈRE)

Farming operation
Effluents
Piping
Disconnection
Overflow
Environmental impact

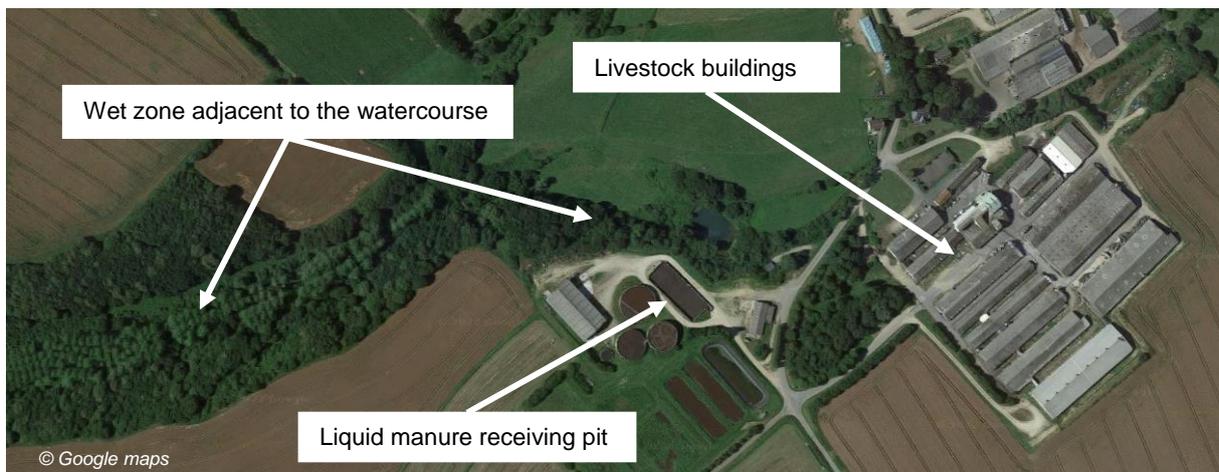
The livestock buildings are equipped with pre-tanks, located under the floor grates where the animals are housed. These pre-tanks are designed to collect the excrement. The pre-tanks are connected to the pits, then to a pit receiving all the effluents from both operating sites at the effluent treatment station. Transfers are mainly performed via a network of underground pipes. Depending on the configuration of the buildings, the transfer operation is performed by a pumping lorry equipped with a manual pump (manual connection to the fixed transfer network) or by gravity via removable piping.
