HAZARDOUS WASTE INCINERATOR FURNACE WALL FIRE

01/10/2021

Saint-Vulbas (Ain)

Fire
Scaling
Extinguishment
Training

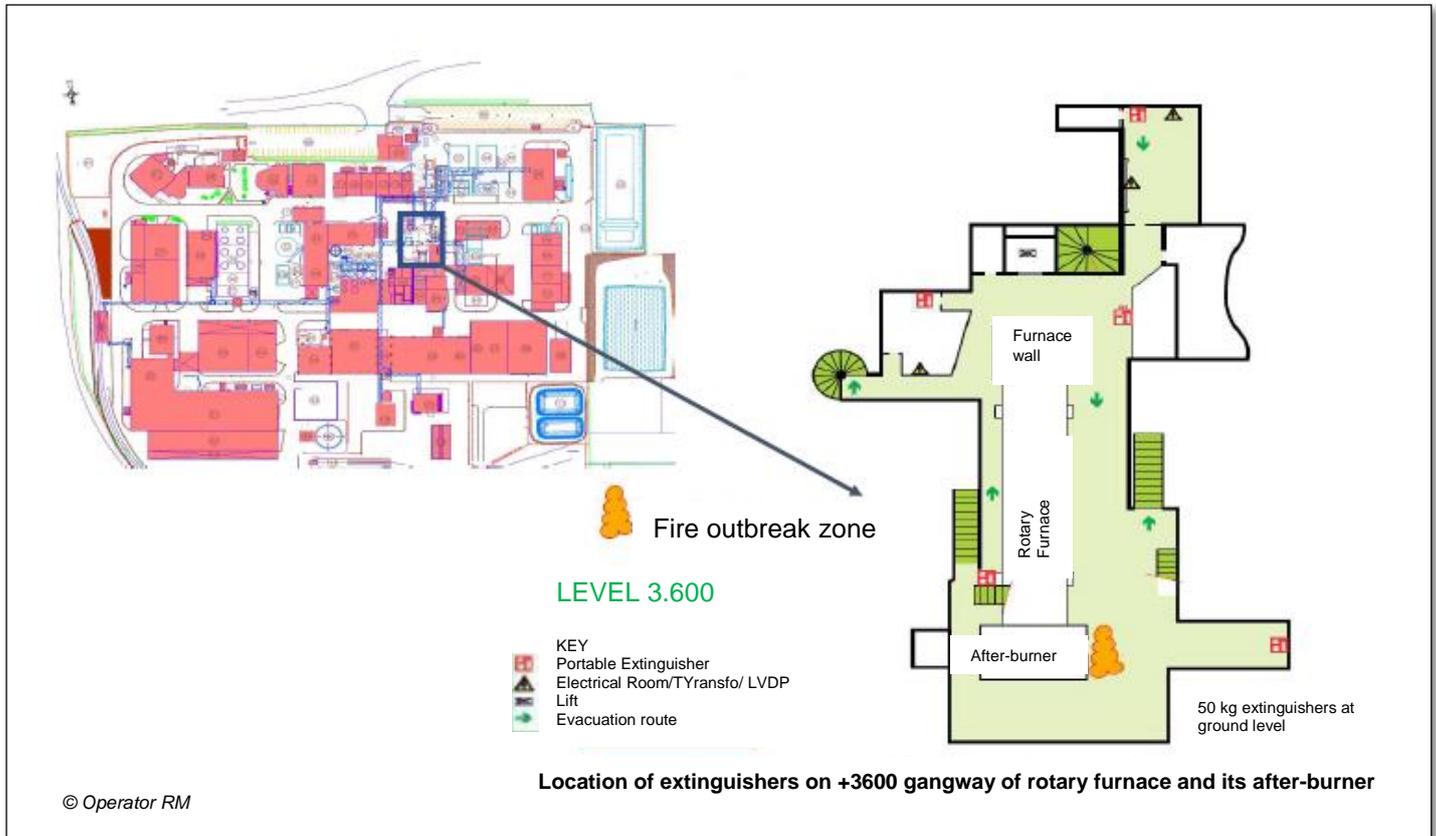
The teams on site, i.e., afternoon shift operators and night shift operators, used mobile extinguishers on the incipient fire. These six operators used four 50kg powder extinguishers and nine 9kg powder extinguishers. N.B.: the 50kg powder extinguishers were located on the ground floor and were carried by two operators up

to the first floor. Five 9kg powder extinguishers (out of the nine used) were located near the zone where the fire broke out on the first floor.
