Ammoniac leak during unloading of a railway wagon.

16th December 1994

Mazingarbe – [Pas-de-Calais] France

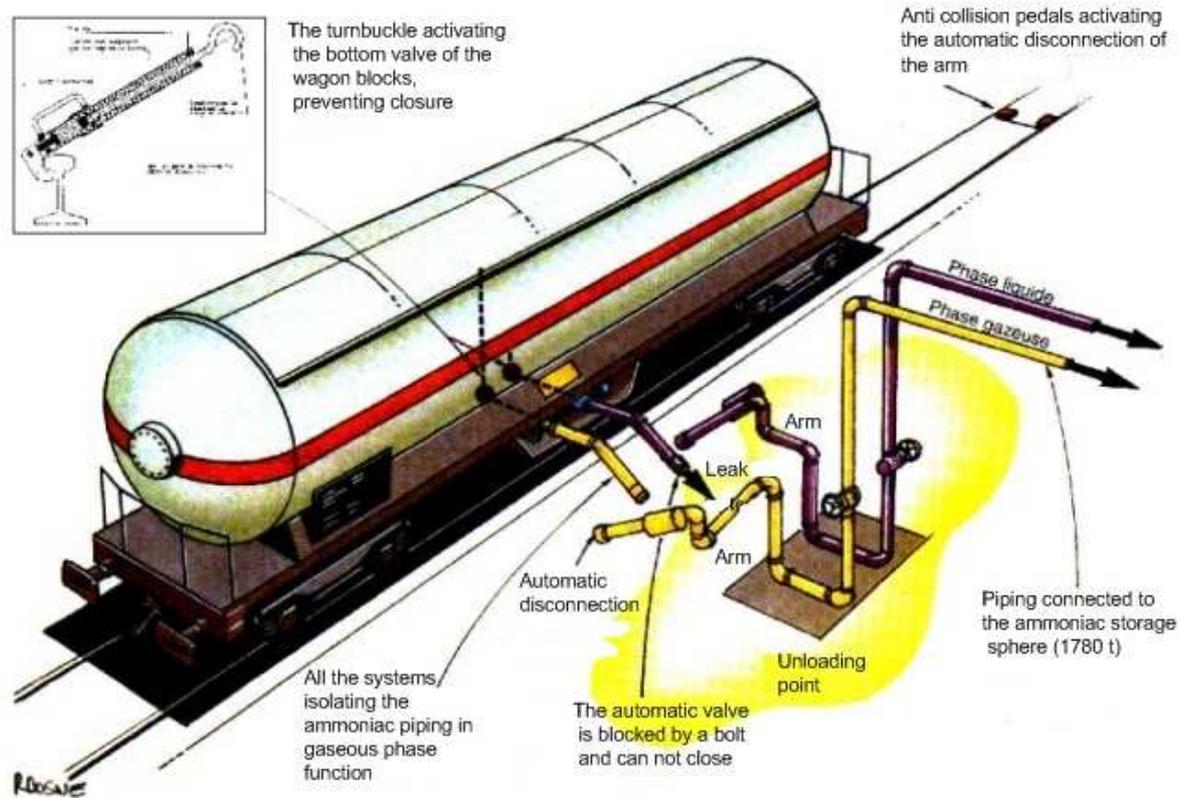
Furthermore, the second leak of ammoniac which occurred a few minutes after the sounding of the alert, at the level of the joint between the valve and the distribution pipe of the wagon, resulted from the progressive loosening of the straps induced by the jerky movements of the segment of the arm connected to the wagon under the pressure of the ammoniac escaping from the tank. Other leaks observed at the level of the joint above the valve (which had closed in the meantime) provide evidence of the lack of air tightness of the bottom valve.

Finally, it should be mentioned that the valve of the segment of the arm connected to the sphere functioned correctly, preventing the sphere from leaking.
