Pollution of the Rhone River by phenol

26th February, 1993

Roussillon (Isère)

Phenol
Sensors / Redundancy
Loading-unloading (station)
Maintenance / repairs
Training
Organisation / Procedures

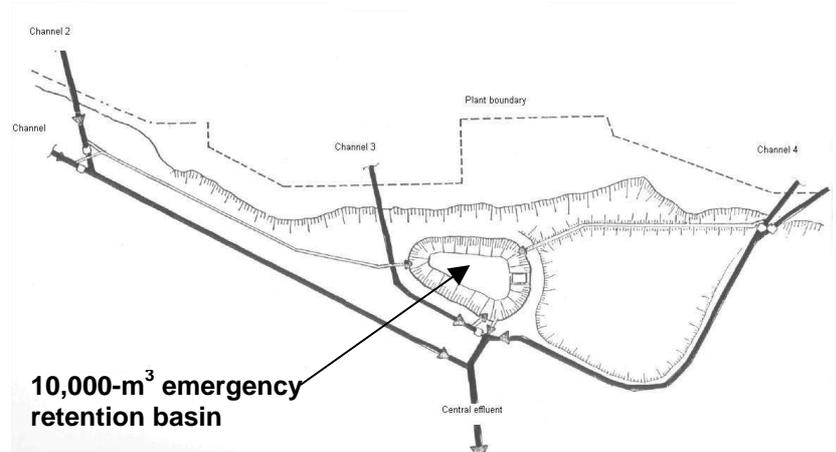
The Level 2 and 3 measurements were electronically transmitted to a centralized supervisor's office, adjoining the permanent control laboratory. Laboratory personnel, alerted by sound and light alarms, were required to relay information by phone to all potentially concerned workshops, requesting they conduct a search for the discharge source and proceed with all pertinent repairs. Given the fear of major impacts occurring to the natural environment, the entire discharge contents of the identified branch were rerouted and stored in an emergency, 10,000-m³ capacity retention basin (see summary diagram on the next page).

The unit responsible for the accident was synthesizing phenol; its installation included a lorry transfer station, with a retention facility present throughout. This retention basin however had already been filled with 10 m³ of water originating from application of the "defrost" procedures specific to the lorry transfer station.

Wastewater from the phenol workshop was being released into Channel no. 4.
