Explosion of a hydrogenation reactor

27th December, 1995
Le Pont-De-Claix (Isère)
France

Chemistry
Toluenediamine / Dinitrotoluene
Reactor explosion / Fire
Washing
Human error
Organisation / procedures / control
Victim

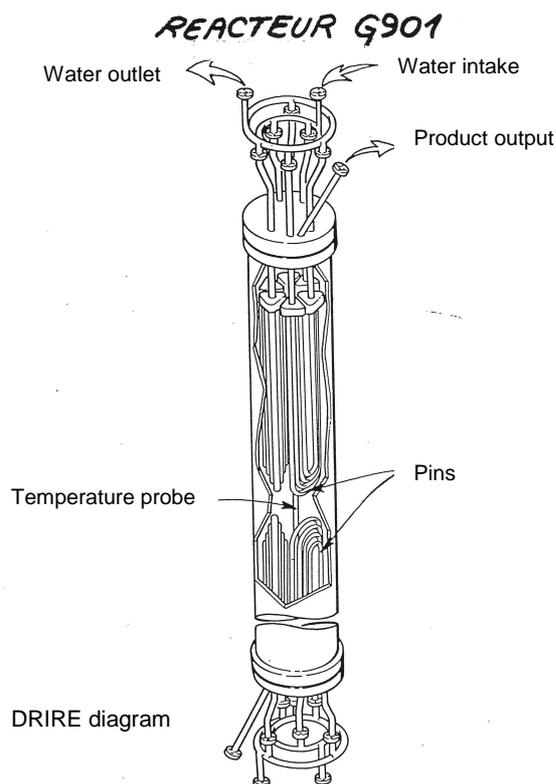
The damaged reactor:

Damage occurred to the first reactor (G901a), as a hollow vertical cylinder 6.80 m long with an external diameter of 0.414 m and thickness of 0.039 m. This reactor was fitted with piping (in the form of pins) that enabled heat transfer fluids to circulate. Hydrogen and the reactive mix were injected at the reactor base. A temperature probe was inserted in order to monitor reaction evolution.

The reactor was fed by the injection tank (R907b); the hydrogenated product was then channelled to reactor G901b.

Reactor G901a had been removed in January 1995 for washing and placed back online in March of the same year. This device had been classified under a special regulation dedicated to pressurised facilities.

The explosion of a pressurised device most often leads to a rupture of the capacity with little or no spraying of debris; in the present case however, this reactor fragmented into some 15 pieces. The clean breaks on this device suggested that it had been exposed to a pressure considerably above the 240 bar test pressure and undoubtedly in excess of 1,000 bar.
