**BLEVE in an LPG storage
Facility at a refinery
January 4, 1966
Feyzin (Rhône)
France**

- BLEVE
- Fire
- Domino effects
- Refinery
- LPG
- Purge valve
- Instructions
- Organisation of emergency
- Victims
- Material damages
- Projectiles

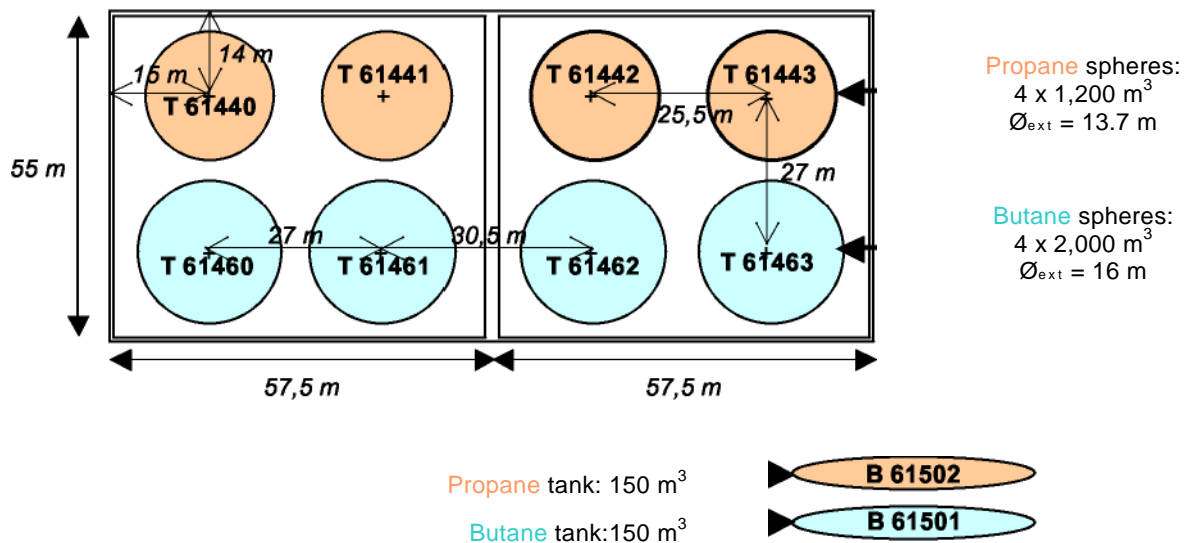
Figure 1 – Representation of the LPG storage zone

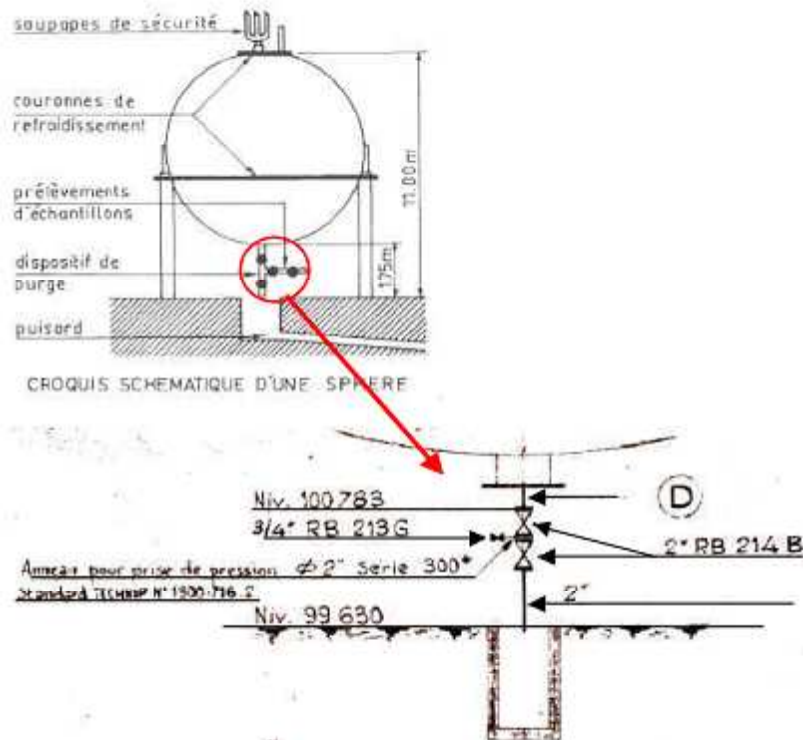
Figure 2 – Schematic representation of the purge device

The 2 purge valves are located about 260 mm apart. The pipes located between the 2 valves are equipped with a rudimentary steam heating device and lagging.

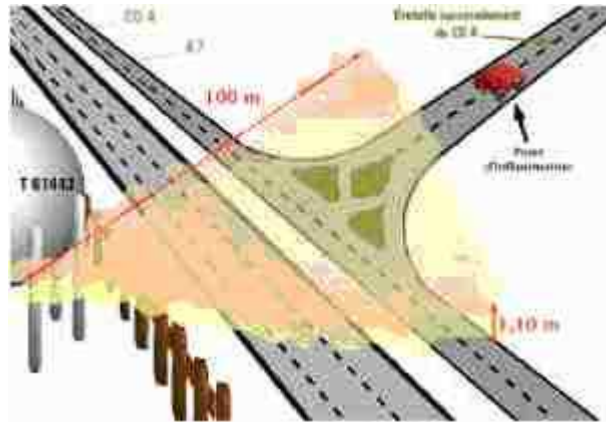
1- Leak calculation for the 2" branch connection:

$[0.82.S.(2gh)^{1/2}]$, i.e. 11.5 kg/sec. considering the flow was reduced: 8 kg/sec.

Figure 18 A highly schematised representation of the cloud according to witnesses
