Fire in an isomerisation unit and domino effects on a benzene saturation unit, in a refinery
December, 2002

Rome
Italy

Fire
 Refinery
 Paraffin
 Compressor
 Domino effect
 Material failure
 Material losses
 Benzene

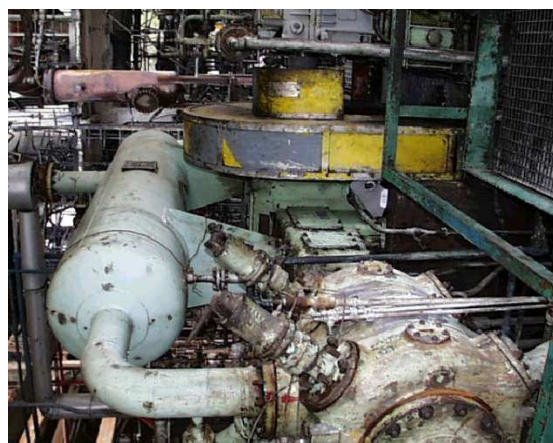
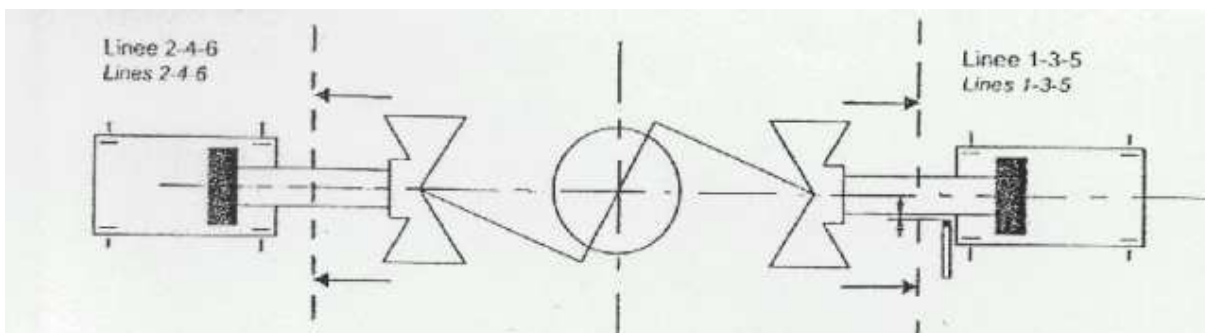
Reciprocating compressor K-2901B:

The accident was originated by one of compressor of the recycle gas compressors group (reciprocating compressor K-2901B), located in isomerisation unit, used to recycle a gas mixture to the isomerisation and Bensat units.

The compressor works in parallel with a twin compressor (K-2901A), at pressures from 15 to 21 bar and a thermal range from 40 to 60 Celsius degree. The gas mixture recycled consists mainly in hydrogen (70% vol), with the remaining part of methane, ethane, propane and butane.

The first phase of the accident consisted in the mechanical failure of the bottom of one of the cylinders of the compressor K2901B.

Nevertheless, the original causes of the event are not yet well identified. One of the hypothesis is the rupture of the crankshaft-rod mechanism in the compressor, with a consequent hitting action of the piston on the bottom of the cylinder 2. The combined effects of hitting-action with the internal pressure (20 bar) led to the failure of the nuts, which hold the bottom.

- ✗ Substitution of the current reciprocating compressors by a single centrifugal compressor in order to potentiate the TIP unit.
- ✗ Use of interception electro commanded valves in suction lines, to be inserted near the compressor in order to limit strongly possible gas release (currently these valves are hand-commanded).
