Explosion in a fireworks storage facility

3 November 2004

Kolding

Denmark

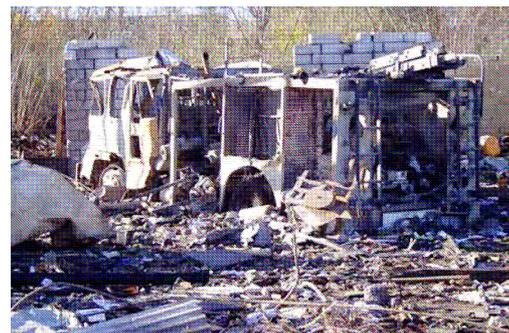
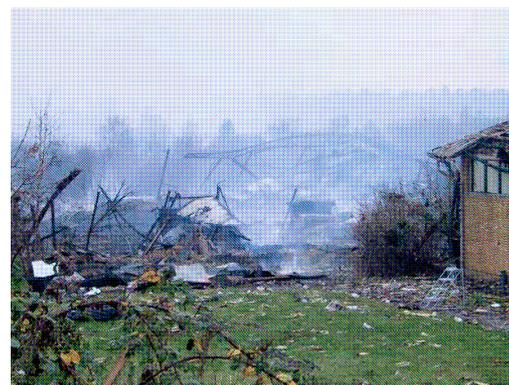
The company, most of the buildings in the industrial zone and a part of the residential buildings in the neighbourhood were destroyed or severely damaged: 450 houses were damaged and some were made unfit for living. Debris of the buildings were found over 1,000 meters away from the disaster.

A 2 m² and 15 cm thick fragment of the concrete wall, weighing a tonne, was found at 150 m from building 6 [3, 4]. The houses to the south of the site were damaged to a lesser extent. They were located on the other side of the 5 to 10 m high hill to the north of the facility and were thus partly protected. The damage caused to the buildings was assessed at 100 million euros [1, 3].
