Burst of a dam

2 December 1959

Malpasset (Var)

France

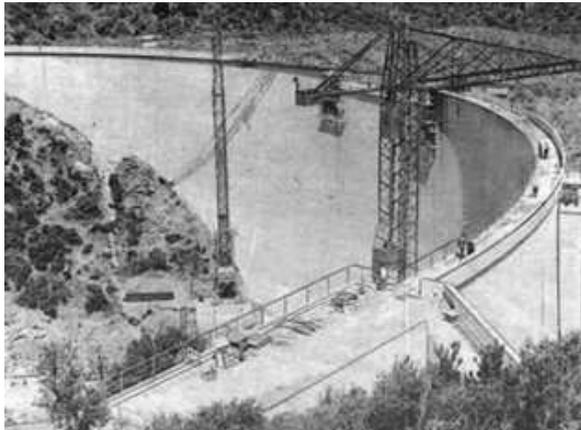
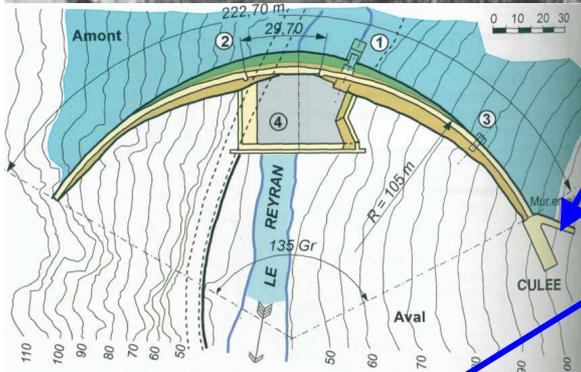
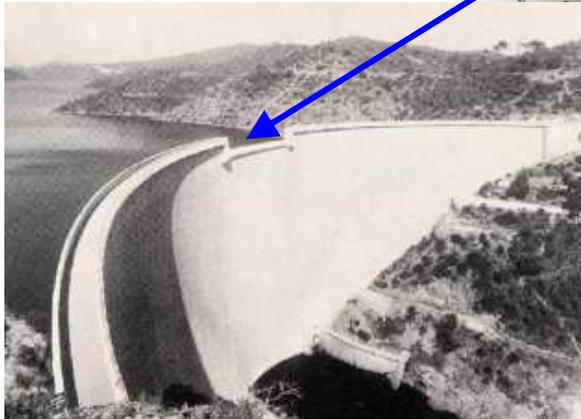
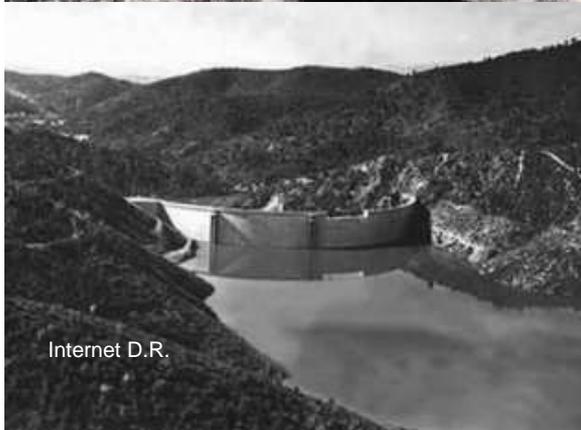
The Malpasset dam is a concrete arch dam with a base width of 6.90 m for a height of 60 m placing it in the thin-walled structures category.

Given the nature of the ground and the topography of the left bank, the dam support was reinforced by an 10 m high abutment as well as a wing wall at right angles with the contour lines.

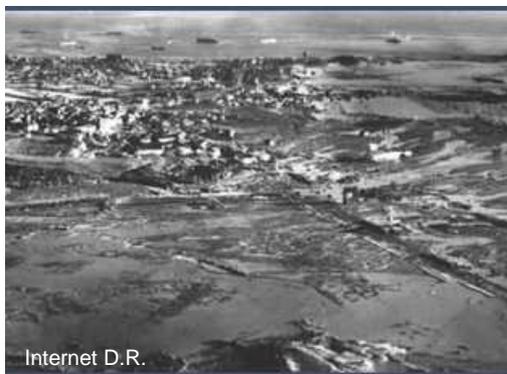
Railway track “twisted like a toy”
