Toxic release in a frozen food warehouse

23 April, 2005

Nemours – [Seine-et-Marne]

Toxic leak
Food industry
Refrigeration /
Ammonia tank
Organisation
Training
Work
Emptying

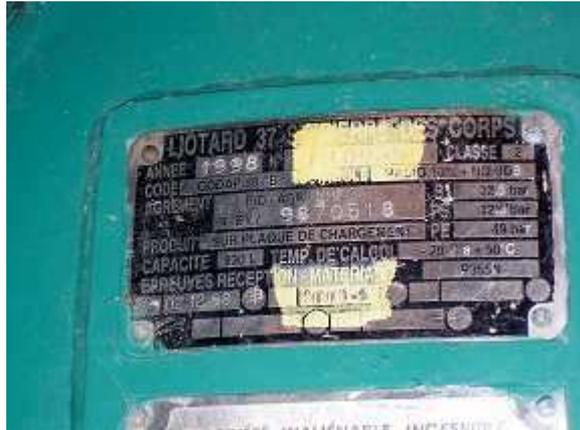
The tank was rented from a chemical product importer/distributor by the service provider in Nemours. This order did not require that a tank filling procedure be provided. The service provider was however required to attend certain internal training programs held on the distributor's premises.

According to the equipment log, the pressure tank had undergone hydraulic testing less than 5 years ago, in compliance with the provisions of article 13 c (bis) of the order of dated July 23, 1943.

One of the tanks burst Saturday, April 23, 2005 at 11.50 am, releasing 450 kg of NH_3 . None of the tanks had been handled during their storage period.

The rupture of the pressurised tank was the result of abnormally high pressure in the tank as a result of overfilling.

Considering the significant variation in temperature during the storage period of the NH₃ drained from the refrigeration installation, the dilation of the liquid contained in the tank increased the pressure and ruptured the tank.

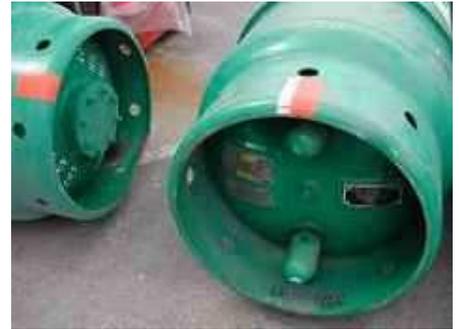
These "multipurpose" tanks and their filling method may be the cause. These tanks were actually designed to store liquefied gas or liquids. The filling rate is thus able to vary between 85 and nearly 100%.

It was noted that, due to the design, the end of this discharge tube is a variable distance from the cylinder wall: It cannot thus fulfil its role with precision.

Finally, the probability of error was increased by the multitude of various types of position marks (corresponding to various operating modes: filling, transfer, storage or drainage) without documents being provided explaining their meaning, and thus their use.

Furthermore, accidental mixing of incompatible substances cannot be fully excluded between 2 successive uses. In this case, just the presence of water after possible rinsing and insufficient drying is incompatible with the "refrigeration quality" (minimum purity 99.95%) of the anhydrous NH₃ or R 717.

- complete its danger study with a precise evaluation of the possible consequences of a similar release with a proposal of measures to reduce the consequences of a similar leak
- reinforce its internal contingency plan
- review its procedures concerning its filling operations

After having planned out several provisions to reduce the area of impact in the event of a similar accident, the operator changed its facility (tubular heat exchanger replaced with a plate heat exchanger, etc.) thereby reducing 600 kg of NH₃ load in the facility which no longer comes under a authorization procedure (only declaration procedure). The replacement of existing equipment freed up sufficient space in the machine room to store transfer containers. The construction of a dedicated loading dock makes it easy to handle containers.

In case of a similar maintenance operation, the NH₃ barrels will be stored in the machine room. In the event of a leak, the toxic fumes will automatically be directed towards the chimney of the room reducing the exposure of staff while channelling and diluting the toxic cloud.
