Spillage from a semi-buried jet fuel tank

30 December, 2005

Sainte-Marie – [Reunion Island]

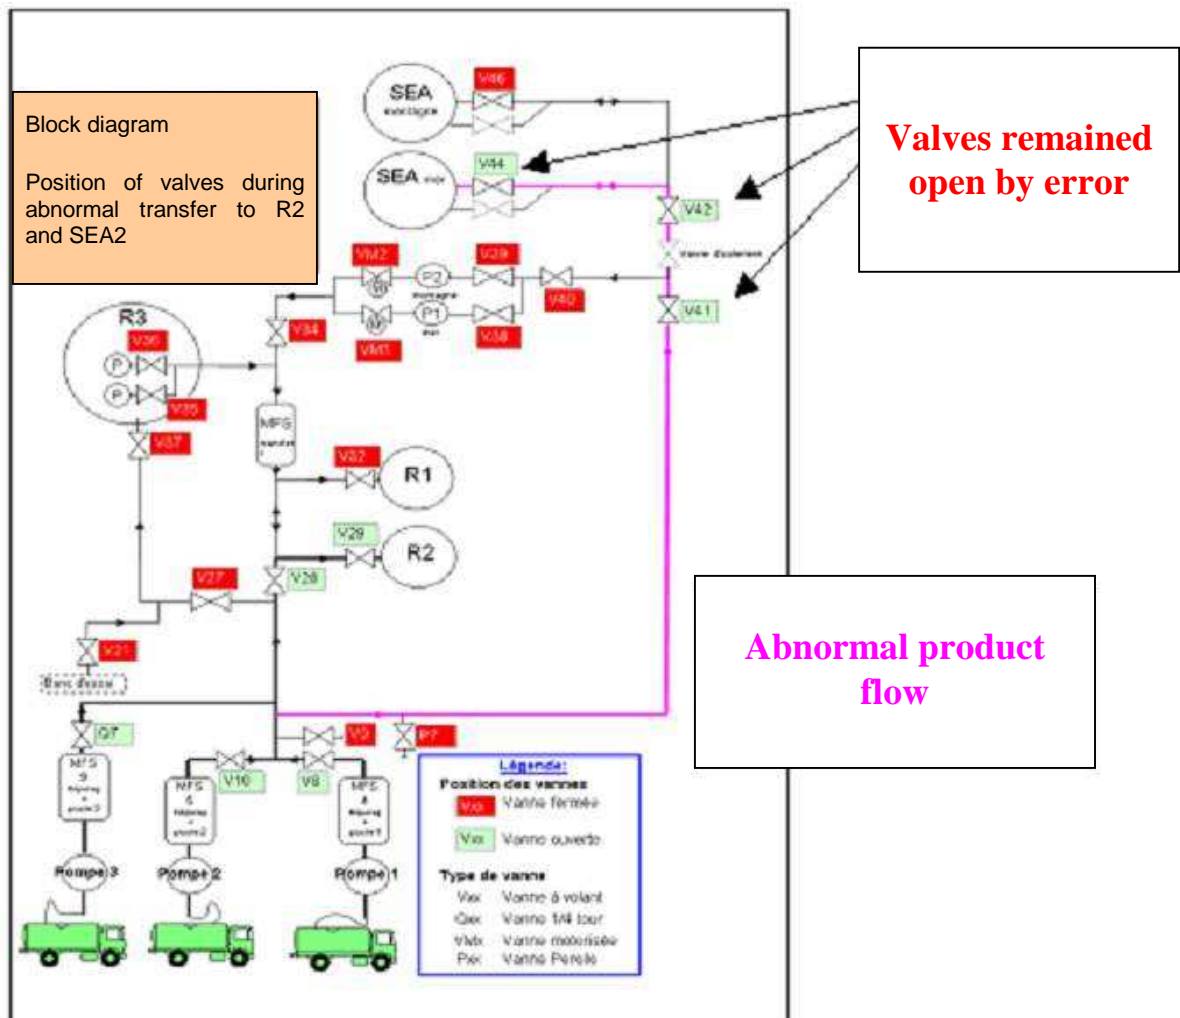
The high level detection safety alarm on the SEA2 tank did not function.

At around 8.30 am, a worker of the depot B noted jet fuel pouring from the two vents on the SEA2 tank: a phone call was made to the facility A to stop the transfer operation. The facility's emergency shutdown was activated which immediately stopped the transfer operation.

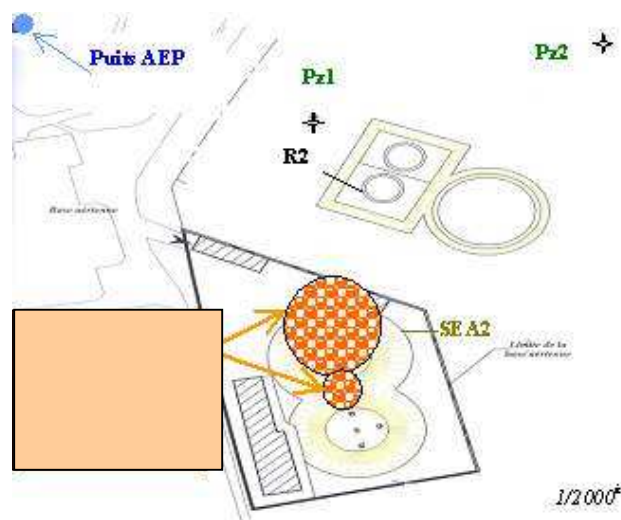
The quantity of jet fuel spilled was estimated at 33 m³. The product spilled onto the surface covering the underground tank and seeped into the ground, outside the bund and into the common parking lot in the zone B. The parking lot is connected to a hydrocarbon separator, which quickly became saturated. Roughly one hundred litres of hydrocarbons thus entered the rainwater drainage system that spills into the sea.

Between 8.40 and 9.15 am, the personnel from both depots blocked off the rainwater drainage system with sand and other oleophilic materials. However, after noting that jet fuel was present in the rainwater network, a worker of the depot B rinsed the drainage system with a large quantity of water at around 9.30 am to prevent the risk of fire, causing sand and jet fuel to be conveyed toward the sea.

▲ Product infiltration zones (photo DR)
