Fertiliser decomposition in a dryer

8 February 2010

Ribécourt-Dreslincourt (Oise) France

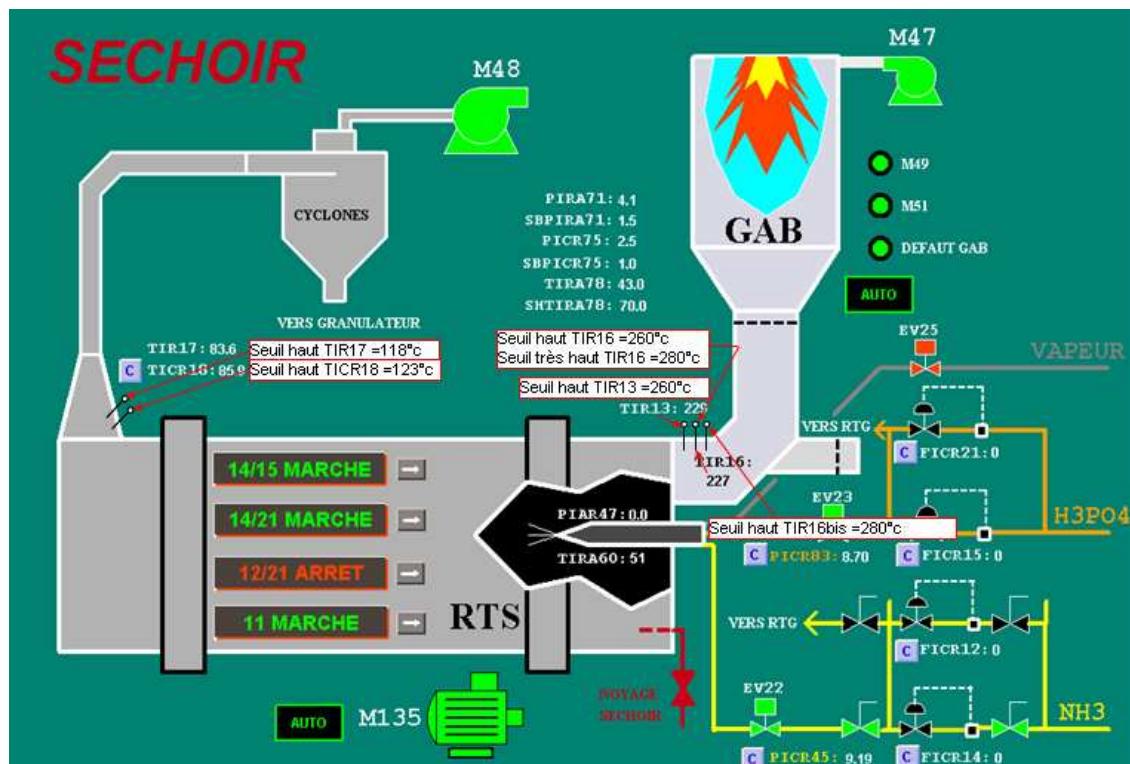
The accident occurred at the fertiliser drying unit.

Fertilisers exiting the granulator were being dried within a rotating tube. An ammonium phosphate slurry, obtained in a tubular reactor by means of reaction between phosphoric acid and ammonia, was sprayed onto aggregates at the dryer intake. The drying stage relied on hot air produced by a natural gas generator operating at a 7 MW heat release rate.
