# Rupture of an oxygen pipeline

13 June 2010

**Richemont (Moselle)**

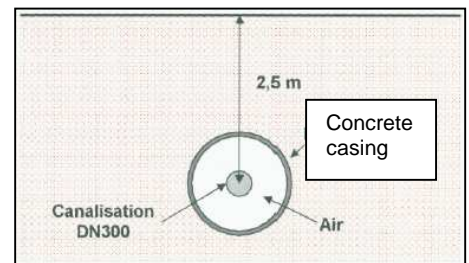
The accident involved the underground gaseous oxygen pipeline, labelled "O<sub>2</sub> Richemont-Gandrange", operating under 40 bar of pressure and buried for 36 years within the site boundary at a depth of 2.5 m.

The pipe, with a nominal diameter of 300 mm (DN 300), is made of E24-4 steel (nominal thickness 4.9 mm / minimum thickness of 4.3 mm / maximum service pressure of 44 bar), featuring a spiral weld, coal tar pitch lining and cathodic protection (-1.4 V).

- The oxygen pipeline, "rolled out" in a strip over 1 m, was immersed in water.
- A crater was formed (diameter: 7 m, depth: 3 m). The TNT equivalent was evaluated by the operator at 0.14 kg.
- Pieces of the railway, along with sludge and fragments of pavement and concrete, were projected some 50 m (1-kg debris found 60 m away and 15-kg pieces blasted 30 m).
- A concrete wall located a few metres from the pipeline was partially destroyed.
- The fence was twisted and damaged.
- No fire outbreak was detected on the tube structure, although the onset of combustion was observed on a 220/24 V transformer installed in an electrical utility room 3 or 4 m from the break.

Corrosion seems to be the most likely source of this pipeline break. The metallurgical appraisal found the presence of generalised corrosion over a section where a casing crossed the alignment at the point of the accident, making it plausible to conclude that several factors acting in unison were the underlying cause :

- presence of an electrolyte (water), which moreover had a high chloride content
- delamination of the pipeline's anticorrosion lining
- defective cathodic protection
- an over-oxygenated atmosphere.

The classified installations inspectorate, which received a comprehensive report on the accident (including the internal emergency plan) along with a technical file on the damaged pipeline, requested a number of follow-up measures, namely : introduction of a safety perimeter around the oxygen pipeline ; decrease in N<sub>2</sub> pressure ; and installation of a local monitoring camera.
