Explosion and fire on an acrylic acid tank at a chemical plant

29th September 2012

Himeji

Chemical industry
 Acrylic acid
 Thermal runaway
 BLEVE
 Management of change
 Instrumentation
 Internal emergency plan
 Organization

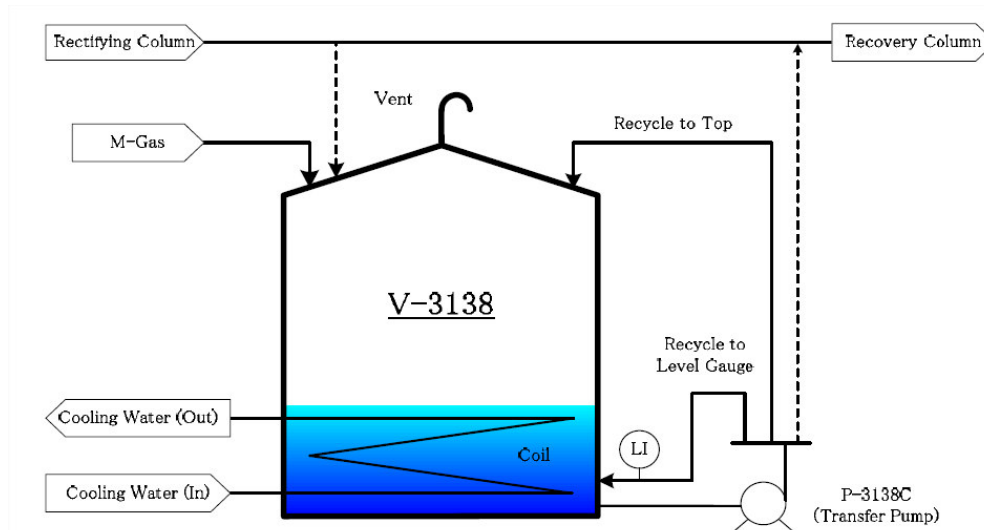
During column drainage for maintenance, the tank was full and a bottom-to-top tank recirculation system made it possible to cool the mix evenly (Fig. 4). The tank expansion space was depleted of its oxygen (7% oxygen, 93% nitrogen) in order to eliminate ignition risks. Moreover, the tank was heat insulated to prevent excessive cooling of the stored mix.

Fig. 4: Operating principle of the intermediate storage tank (Source: operator)

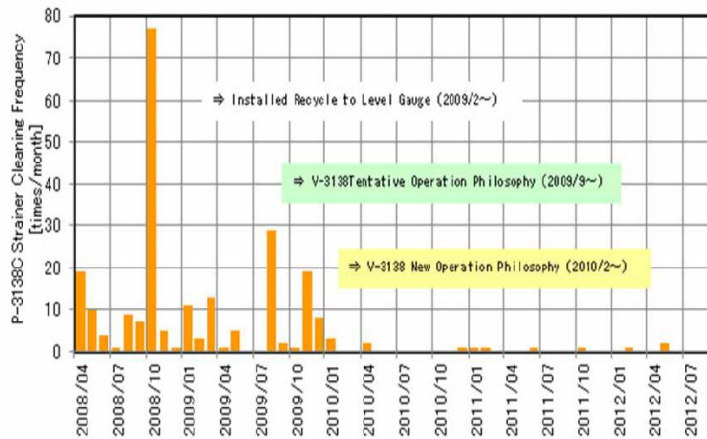
This mode of operations was modified in 2000: the mix at the column bottom was systematically routed via the intermediate tank in order to regulate supply of the recovery column. However, since the tank was being more frequently used, a precipitation phenomenon on the tank bottom appeared as the mix cooled, interfering with the level measurement and regularly clogging the racking pump strainer. To overcome this problem, a new recirculation line was installed between the tank bottom and the upper wall where the level probe had been placed. Since this step failed to resolve the problem, a new operating procedure was ultimately introduced in January 2010: during normal operations, the mix at the column bottom directly fed the recovery column, without being routed via the intermediate tank. This revised procedure proved to be efficient in significantly reducing cleaning frequency (Fig. 5), but at this point the tank was only being used when the rectification column was turned off. According to this configuration, upward recirculation could only be activated once the recovery column had been shut down, given that the accumulated mix volume then exceeded the 25 m³ corresponding to the cooling loop design criterion.

Fig. 5: Evolution in tank cleaning frequency vs. time and enforced operating procedures (Source: operator)

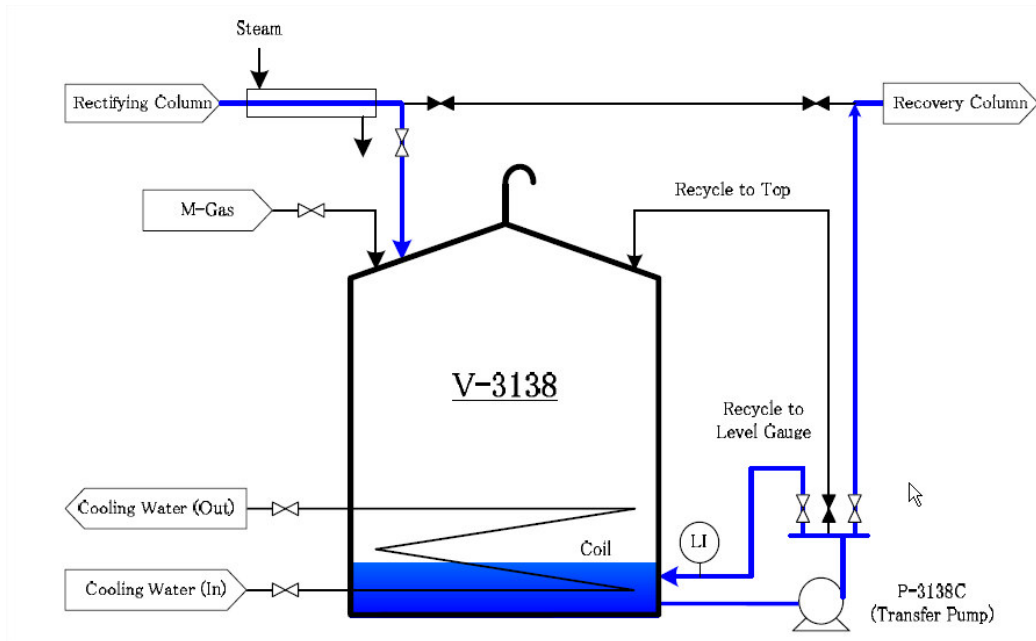
- 1st phase, start-up (21st through 25th September): Following a maintenance shutdown period, the unit was gradually brought back online. The tank's cooling loop was initiated; inerting of the expansion space got underway and the recirculation loop near the probe was activated. Beginning on the 24th, the recovery column received inflow of the mix from the column bottom via the tank, at a volume stabilising around 10 m³. The transfer pipe between the bottom of the rectification column and the tank was steam traced to prevent clogging due to product precipitation (Fig. 6).

Fig. 6: State of intermediate storage tank during unit start-up (Source: operator)

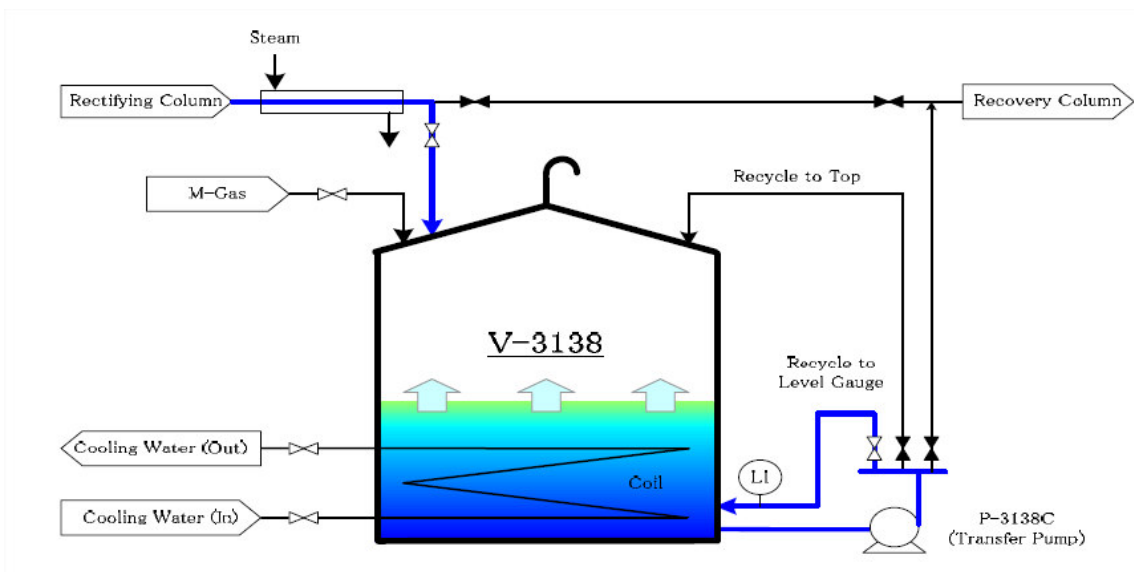
- 2nd phase, filling (25th through 28th September): At 9:30 am on the 25th, the recovery column supply from the tank was shut down in order to test that column's capacity, while the tank continued to be fed with mix from the rectification column bottom. The maximum tank operating volume (60 m³) was reached on the 28th at 2 pm, i.e. after 77 hours of filling. Since the upward recirculation loop had not been activated, the layer of mix above the cooling loop had not been cooled (Fig. 7). The exothermic dimerisation of AA was initiated, causing a sharp increase in average temperature of the stored mix (from 40°C to 60°C).

Fig. 7: State of the intermediate storage tank during filling (Source: operator)
