## Boilover of a crude oil tank

30 August 1983

Milford Haven [Wales]

Refinery

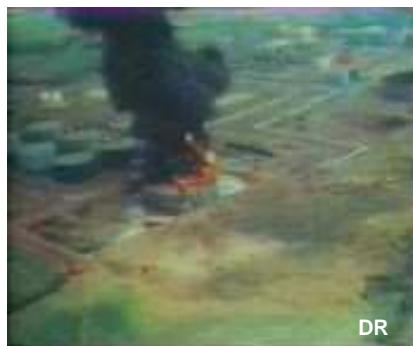
On 30 August 1983, at 10.45 am, a compressor of the catalytic cracker broke down. At 10.50 am, flames were seen on the roof of the tank TO11. At 10.55, due to the lack of fixed fire protection device, the fire department of the refinery sprayed the tank roof with foam liquid using a canon fixed onto an aerial platform. The firemen required up to 26 water canons to cool down the tank shell and protect the two adjacent distillate tanks with a water curtain. However at 11.05 am, the cracks on the floating roof opened and the accident worsened: flames as high as 12m covered half of the surface of the tank and by noon spread to the entire surface. The access ladder to the roof was exposed to the radiation from the furnace and could thus not be used for rescue purposes, preventing the firemen from pulling fire hoses till the roof. By virtue of a mutual assistance agreement signed between refineries, the foam compound stock is stored in Haven and could be dispatched wherever needed.

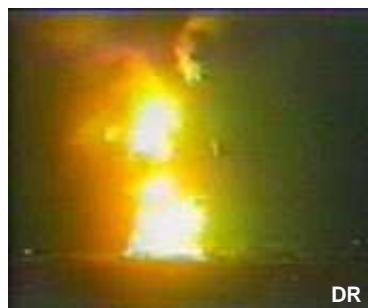
On 31 August at 2.10 am, a less intense second boilover occurred and the connection between the shell and the tank bottom gave in at four points releasing fiery crude oil into the dike. The bund wall over 5m high could however retain all the matter released. The thermal insulating material of the distillate tanks in the adjacent containment dikes caught fire and one of the tanks gave in, spreading the fire to the second containment dike. This fire was brought under control by the rescue team in 30 minutes.
