Sensor malfunction

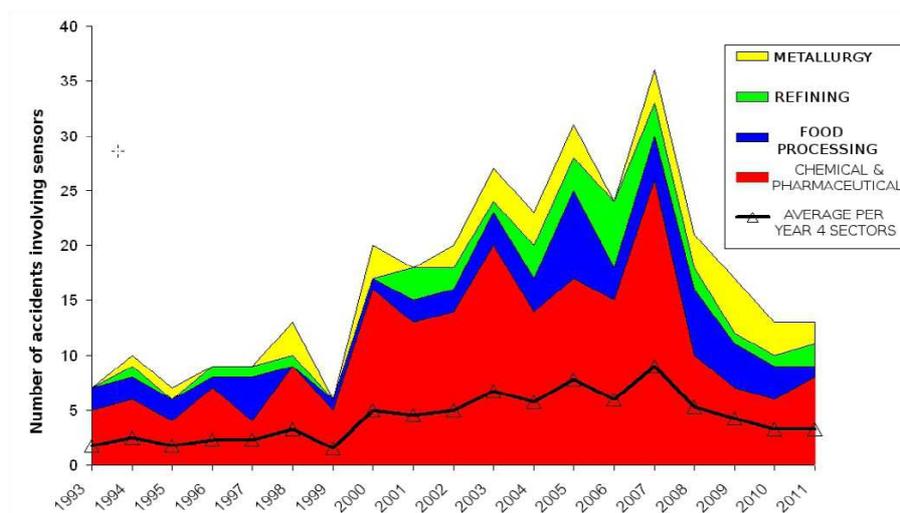
Fig. 1 : Annual number of accidents involving sensors for the most highly automated industrial sectors (ARIA base - 345 accidents)

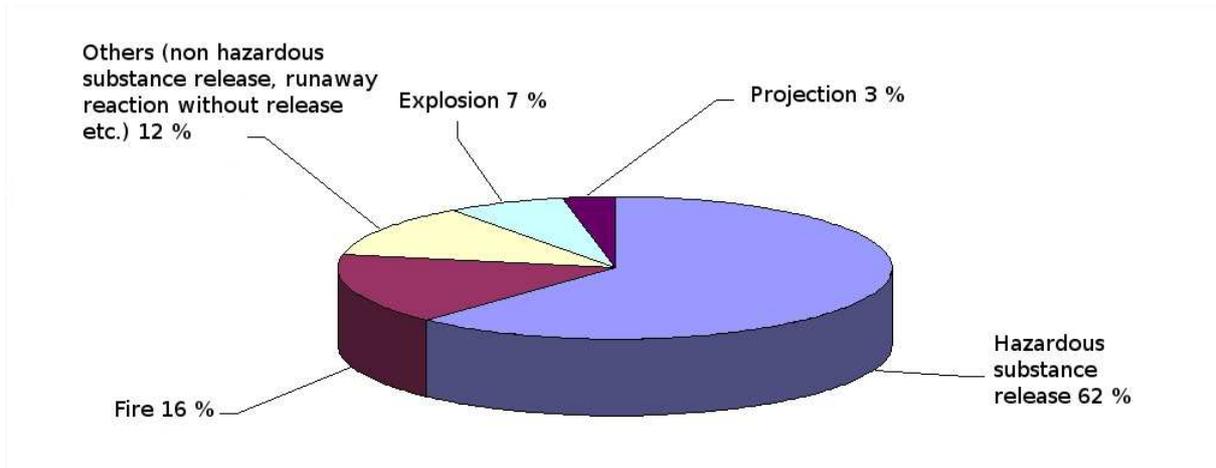
Fig. 2 : Breakdown of phenomena caused by accidents involving sensors (ARIA base)

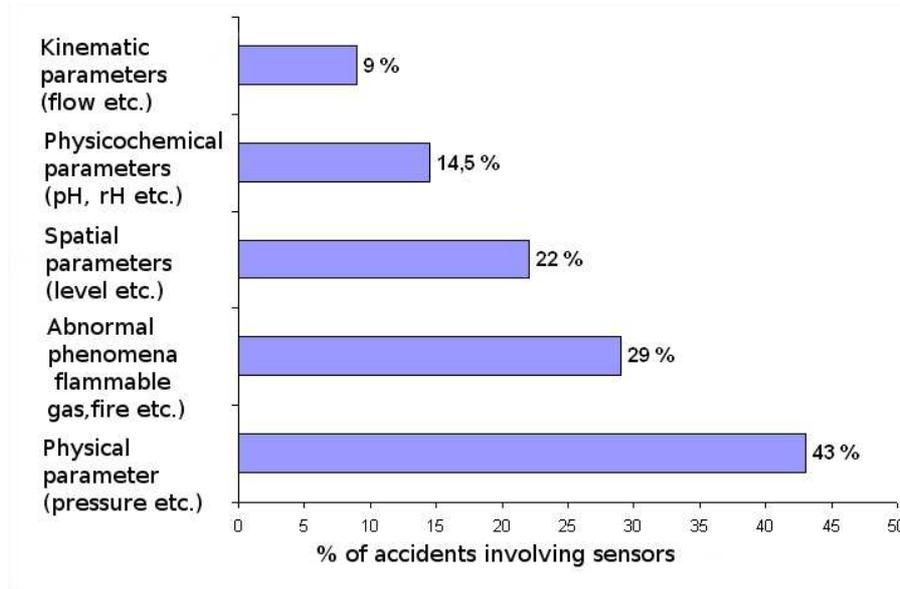
Some types of sensors involved in accidents stand out from the rest (Fig. 3). Depending on the extent of their use in industrial processes, especially chemical processes, temperature and pressure sensors are implicated in nearly half of all studied accidents. Sensors responsible for detecting an abnormal phenomenon (e.g. fire, toxic gas) were cited in the 2nd highest number of accidents, as a result of their role in exacerbating conditions in the event of malfunction. Lastly, level sensors are involved, on average, in over 20 % of all accidents inventoried and in up to 80 % of accidents recorded in the refining sector, where their operability is essential to ensuring process control.

Fig. 3 : Breakdown of the functions performed by sensors involved in the analysed sample of accidents (ARIA base)

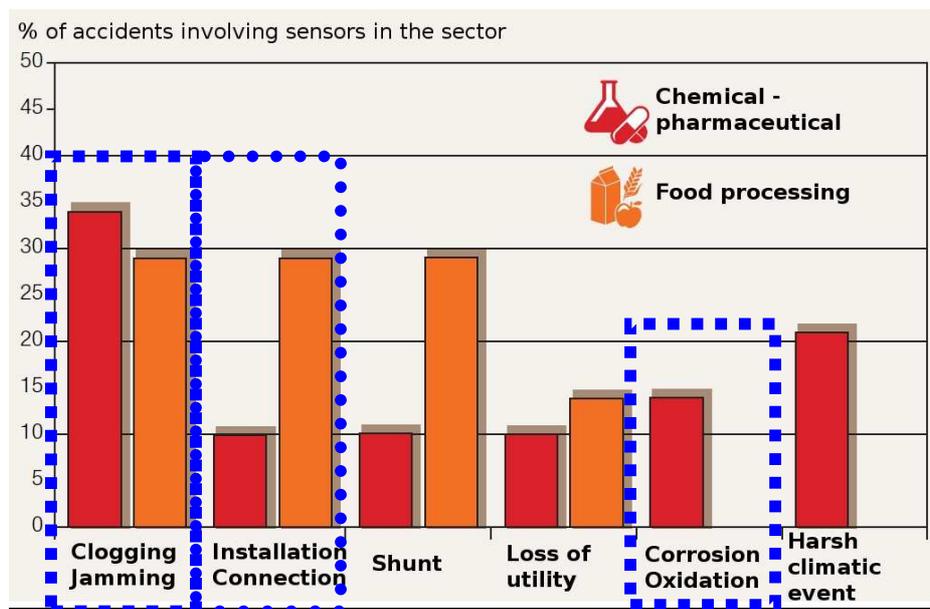
An analysis of accidents caused or exacerbated by sensor malfunction has revealed that the problems of fouling, seizing and corrosion account for nearly half of all sensor-related accidents in the chemical - pharmaceutical sector, with almost one-third of those occurring in the food processing sector. Food processing also stands out by the frequency of causes related to sensor installation and connection, no doubt reflecting less rigorous supervision of instruments here than in the chemicals sector (Fig. 5).

Fig. 5 : Primary causes of sensor malfunction for the chemical and food processing sector (ARIA base)
