LESSONS LEARNT
from industrial accidents

IMPEL Seminar
Lille, 2 and 3 June 2015

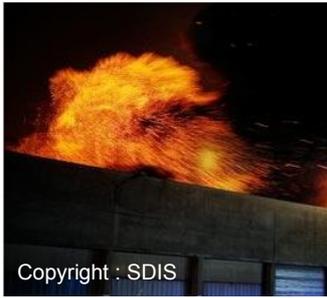
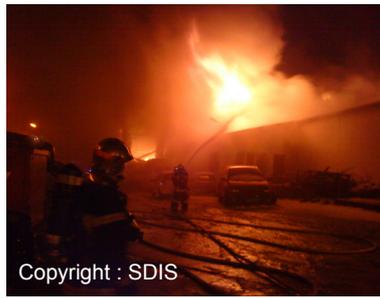
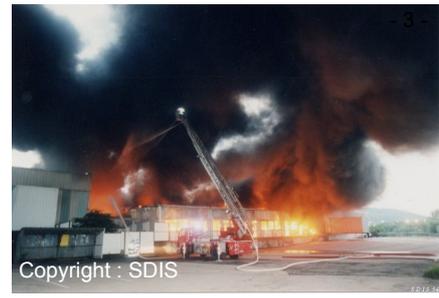
Wind is an aggravating factor regularly encountered in accident records. It stimulates the propagation of fire from one building or one facility to the next and fans flames. Wind also limits the efficiency of smoke exhaust outlets.

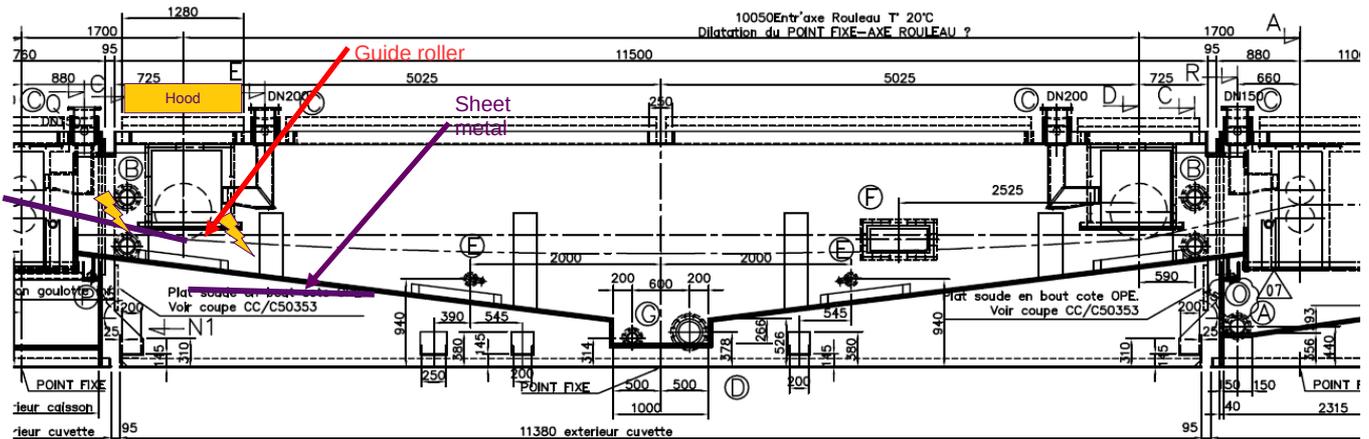
The 450 m long RD79 line is composed of several sheet metal treatment stations. This accident mainly affected the stripping installations. Investigations indicated that the most likely source of the ignition point was a welding operation taking place on a strip of sheet metal, which is typical in the process (occurring roughly once a month) and supervised by a specific procedure.

Less customary however was the fact that this operation had been carried out using a sheet metal strip guide roller, in a particularly narrow spot, which required the operator to wear both a head lamp and a mask.

The tests performed by the plant operator revealed that the material surrounding the roller, i.e. EPDM (ethylene propylene diene monomer) rubber, only required a small amount of energy to ignite. Placing a match in immediate proximity would cause it to slowly burn and be consumed entirely.

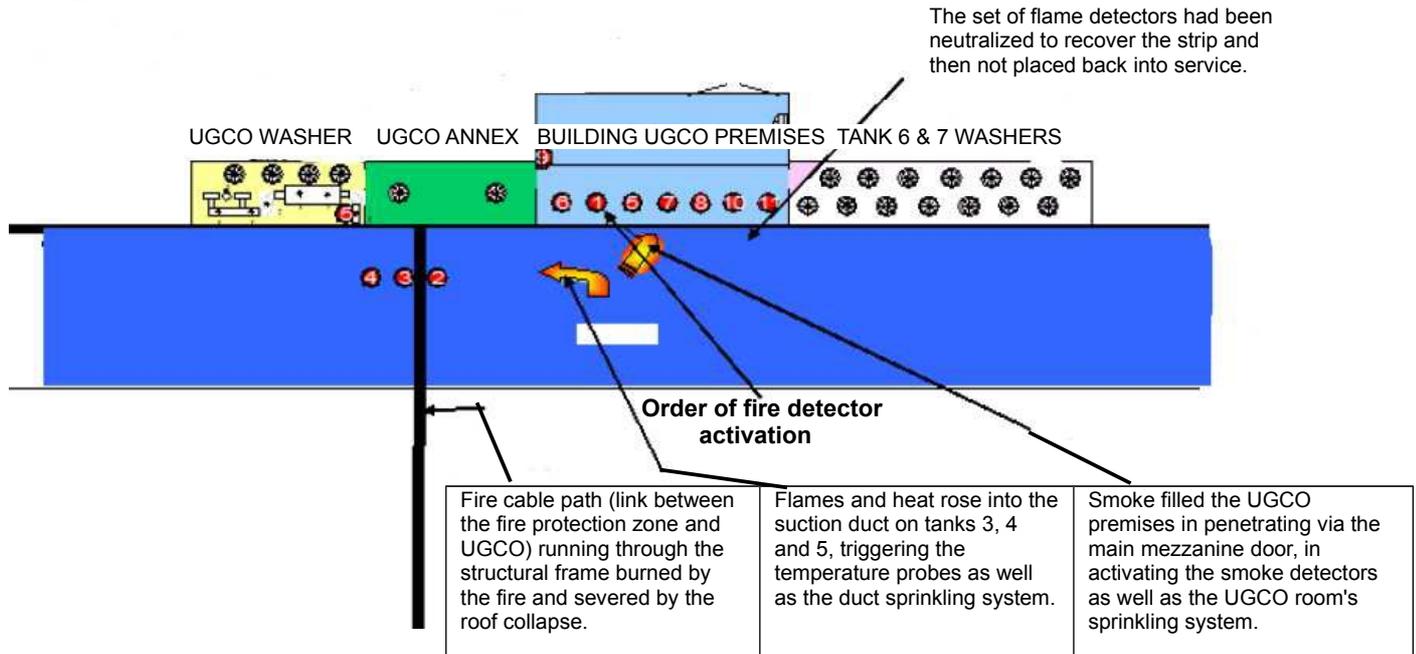
Diagram depicting the chronological order of fire detection activation (source: operator)

- 1 - P73 smoke detector on the mezzanine level of the UGCO premises - fire-fighter's beeper alarm.
- 2-3-4-5 - UGCO duct temperature probes - sprinkler activation in the ducts of tanks 3, 4 and 5.
- 6 through 11 - smoke detectors on the mezzanine level and on the UGCO premises - sprinkler activation after melting of the sprinkler head on the mezzanine level.
- Cut-off of the connection between the fire protection zone and the stripping detection after destruction of the cable path through the structural frame.
- Manual tripping of the sprinkler system in the structural frame of tanks 3, 4 and 5, followed by roof collapse, causing the sprinkler network to fall.

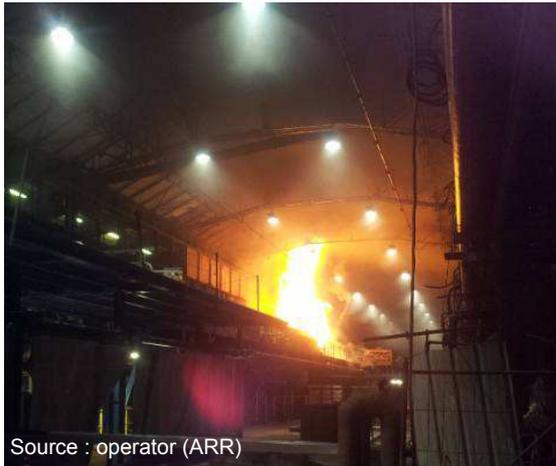
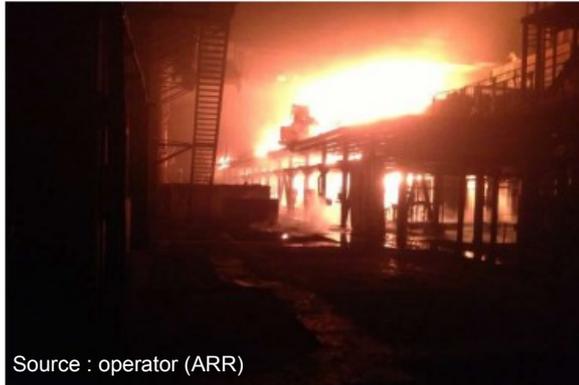
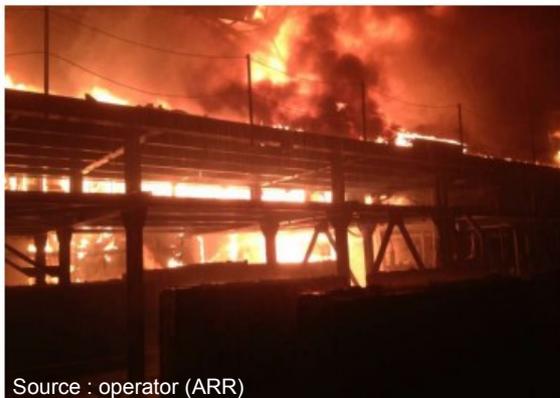
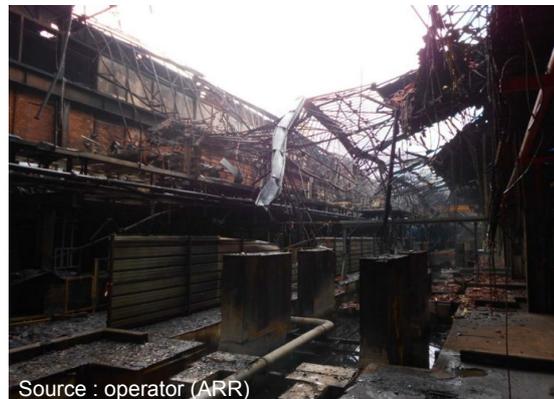
- complete destruction of tanks 3 through 7 and their supporting structures;
- complete destruction of the recycling basins on tanks 6 and 7;
- destruction of the vapour extraction systems on tanks 3, 4 and 5 (UGCO washer);
- destruction of the building over a 120 m length;
- partial damage of the asbestos cement roof located on the eastern lean-to of building 37;
- damage to overhead travelling crane 114.

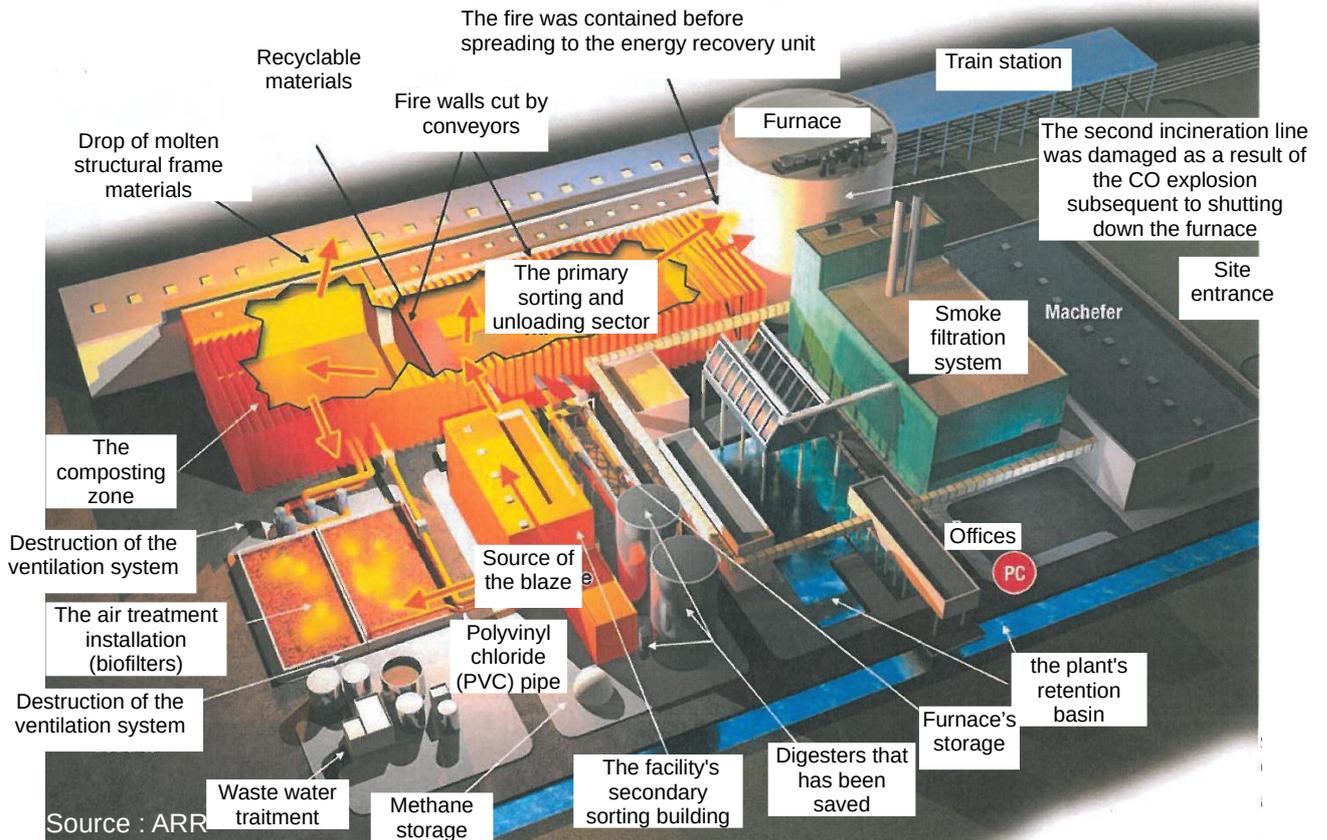
Diagram of how the fire spread inside the plant

On the night of 2 November 2013, fire broke out in the organic recovery unit located inside the facility's secondary sorting building. This unit was idle at the time. The blaze then quickly spread to the composting zone and ultimately to the primary sorting and unloading sector.

The energy recovery unit only sustained very slight damage.

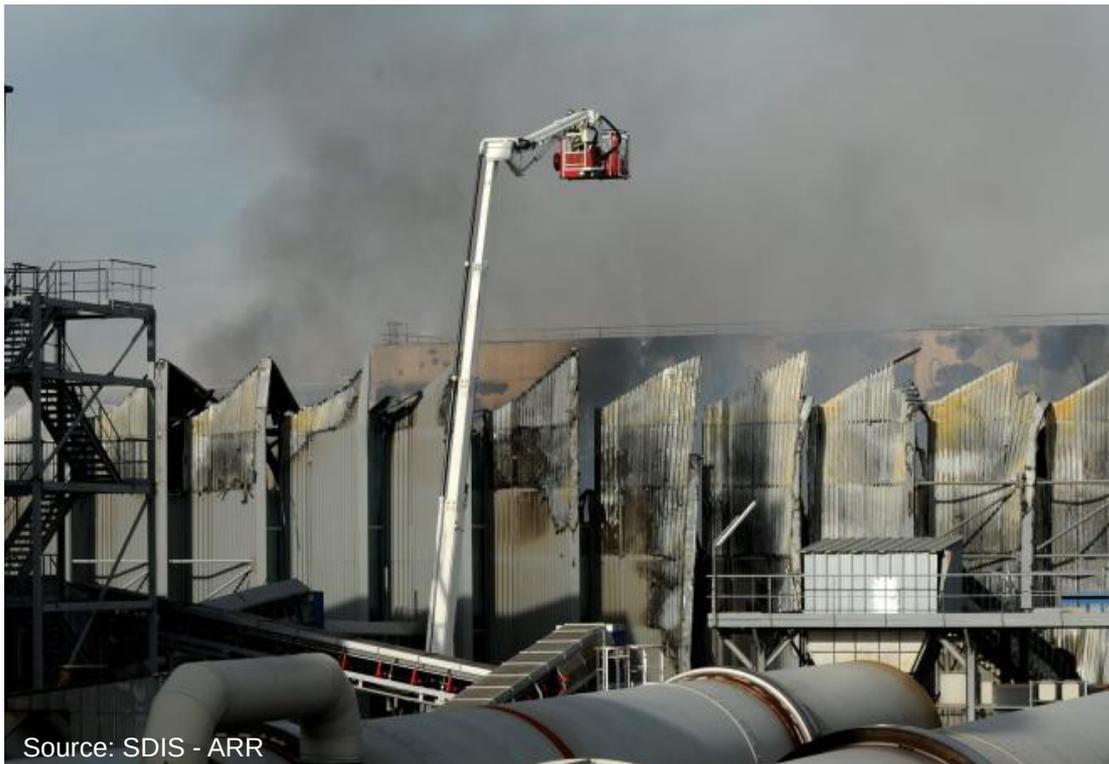
Primary sorting building ablaze

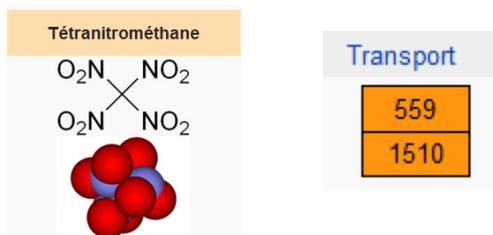
Among the numbers listed in the report, i.e. category no. 1510, the storage of combustible materials under the ICPE regulations was mistaken for the same UN number, which corresponded to Tetranitromethane, a toxic combusive product (see Fig. 4). Responders thus considered that, despite the absence of visible signs of ignition from the outside, a fire might have been smouldering within the foam and moreover fed by this combusive product. Accordingly, a physical investigation by a three-member team wearing self-breathing type masks was decided so as to remove this doubt.

Figure 4 : Tetranitromethane and its 4-digit UN code, identical to that under the heading entitled "Storage of combustible materials, products or substances in enclosed warehouses" listed in the French ICPE installation nomenclature

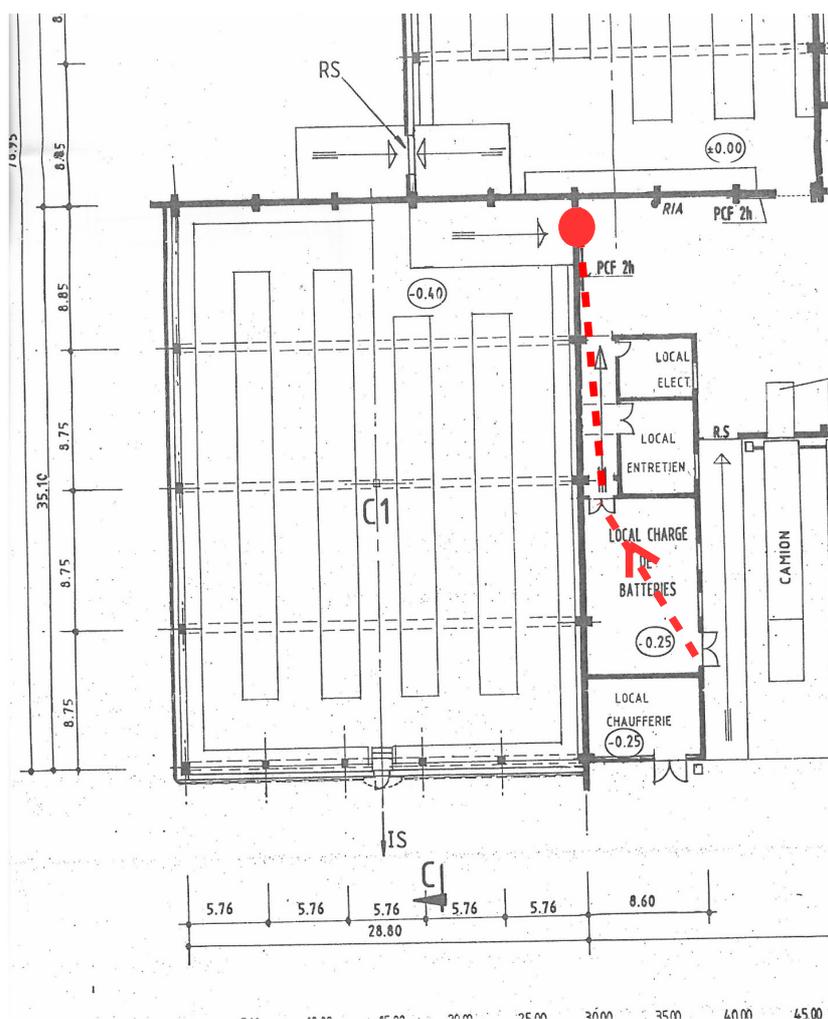
The two surviving fire-fighters of the three-man reconnaissance team, as well as the members of subsequent investigation parties, reported that the foam inside the buildings did not display the same consistency as that observed outside. They all complained of real difficulty in advancing into the foam, which entailed coping with a highly viscous substance that constrained any kind of movement. They also expressed that the foam had been an obstacle to vision, to such an extent that a hand placed in front of the eyes remained invisible. Similarly, the foam acted as sound insulation, thus preventing verbal exchanges (besides radio) with the other two fire-fighters in the trio. In addition, they mentioned that shortly before exiting the premises, the foam wound up penetrating inside their breathing masks. The team's progress had been slowed to a point that they were not even able to enter Cell 1 and had to turn around barely after reaching the door (red dot in Fig. 5).

Figure 5 : Path followed by the three fire-fighter investigation team (ARR)

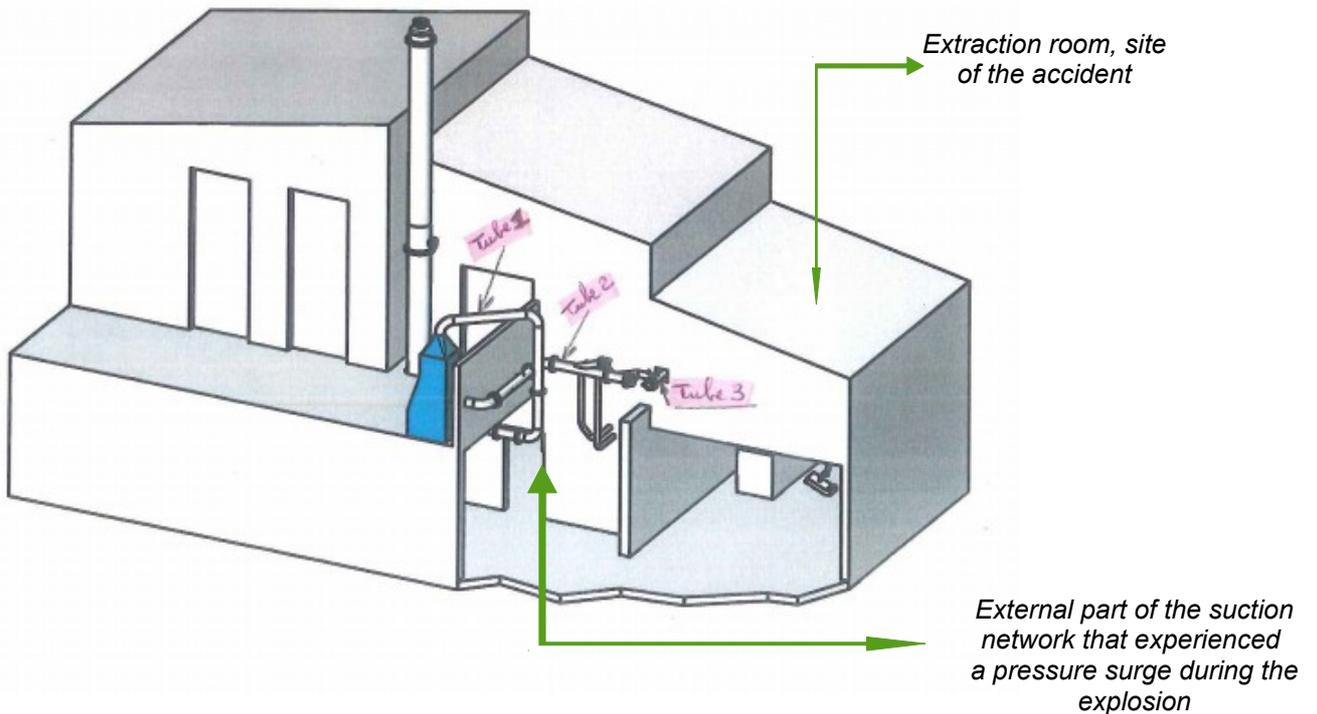
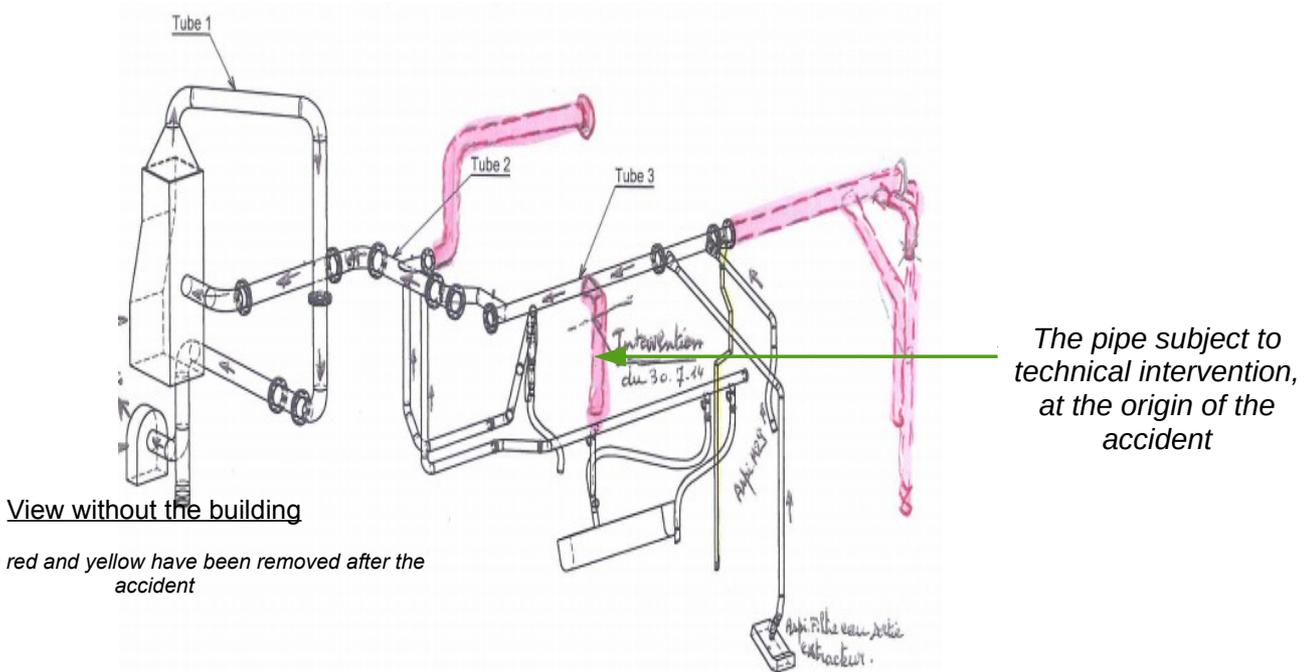
The accident occurred inside the "extractor" room located on the ground floor of the production workshop. This room was equipped with machinery for extracting the solvents contained in the powders output by the double-screw extruder operating on the floor above. This extraction entailed washing with hot water circulating upstream in a worm gear. The solvent-laden water recovered was then channelled to a distillation unit for solvent regeneration. In conjunction with this step, the air filled with volatile organic compounds (VOC) was also collected by a suction network for distillation treatment prior to discharge. This network wound up at the origin of the accident.

The pipes in red and yellow have been removed after the accident

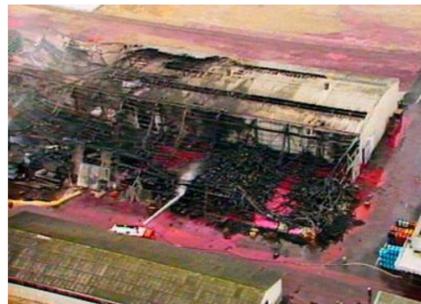
Fire broke out in a warehouse containing phytosanitary products south of Basel. 80-m high flames were visible 10 km away. Mercaptans in the smoke made the air unbreathable for kilometres around, and the RHINE River was polluted. The retention basin was insufficient: 15,000 m³ of extinction water flowed via the sewer network into the river, which turned a shade of pink (fuchsine); **30 tonnes of highly toxic products (e.g. insecticides, mercury) destroyed all aquatic life over a stretch of more than 250 km.**

The time interval between the fire outbreak and the alert sent to residents of Basel and neighbouring countries caused a major public outcry. The investigation assigned the origin of the fire to an accidental ignition of a pallet of Prussian Blue.

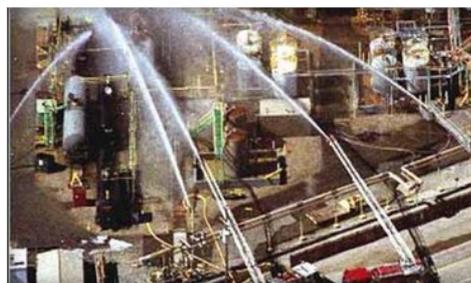
At 3:45 am inside a chemical plant, 2 employees were unloading a tanker car containing methyl mercaptan (MM) when a process pipe broke loose: approx. **70 tonnes of gaseous MM** were released into the atmosphere. Fire-fighters sprinkled the car where smoke was emanating. At 4:09 am, the toxic gas ignited, engulfing the car and producing a fireball 61 m high by 15 m wide. The car exploded (BLEVE-type explosion) emitting both MM and its decomposition products into the atmosphere. The unloading hose on a nearby car containing chlorine was destroyed: **12 tonnes of chlorine** out of the 81 contained in the car were released. The toxic cloud drifted towards the Canadian border marked by the river running alongside the site. At 12:47 pm, the leak was finally stopped.

This accident **took the lives of 3 plant employees** and **injured 49**. Some 2,000 people had to be evacuated. The river was closed to all forms of navigation. The investigation concluded that a corrosion-erosion phenomenon had caused the pipe to break and singled out safety rule compliance breaches. The State of Michigan negotiated a \$6.2 million settlement with the industrial group to compensate local residents, consisting of \$500,000 in fines and \$5.7 million to improve safety and training in addition to compensating the local population.

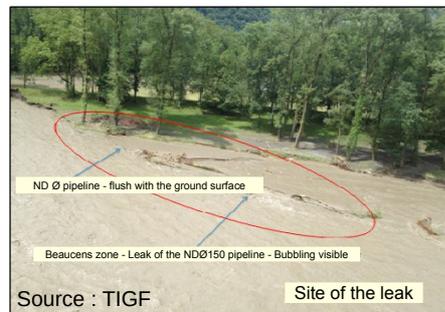
A discharge point was identified around 10 am upstream of the Beaucens switching station. The current flowing in this water course had caused a total break of the pipeline and was responsible for destroying the bank where the line had run. The pipe had been unearthed, carried, bent and broken, all due to the strength of this current. Helicopter flyovers of the flood zones were performed from 10 am to noon in order to detect other high-risk situations between the towns of Tarbes and Lacq.

Once the waters had receded and after creating a secure zone (through excavation), works to isolate the leaking pipe section began around 7:30 pm and were completed by 1:30 am on 20 June. A curved bottom was installed over the decompressed section.

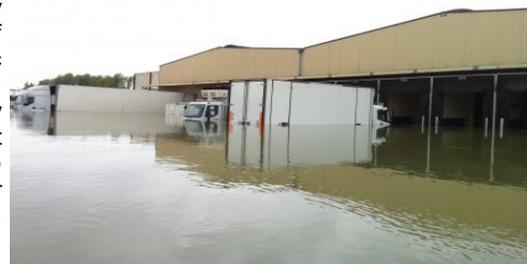
Loading platforms at the neighbouring firm (ARR)

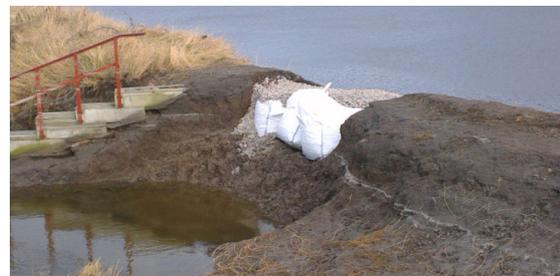
Figure 3 : Breach in flood defence with temporary staunching, source Inter Terminals

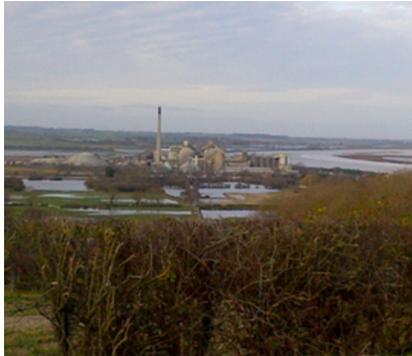
The flood water and silt caused catastrophic un-repairable damage to control systems, the power supply network, compressed air systems, buildings and the cement kiln which was currently operational due to insufficient cooling time. High and low voltage systems were wiped out by water tracking into the terminated ends of the cables. Production was not possible due to the flooding.

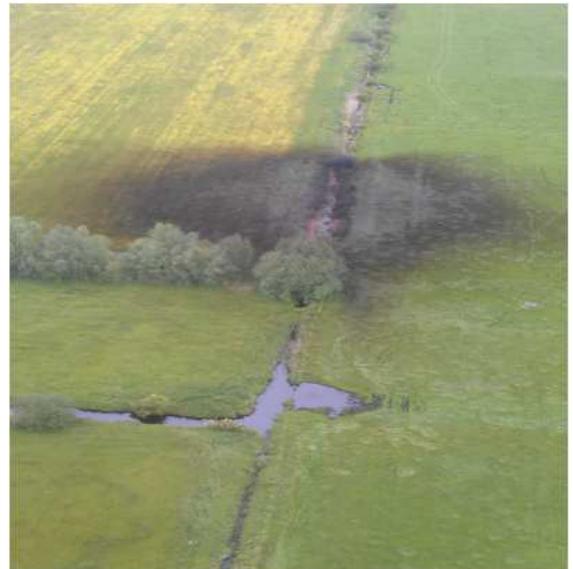
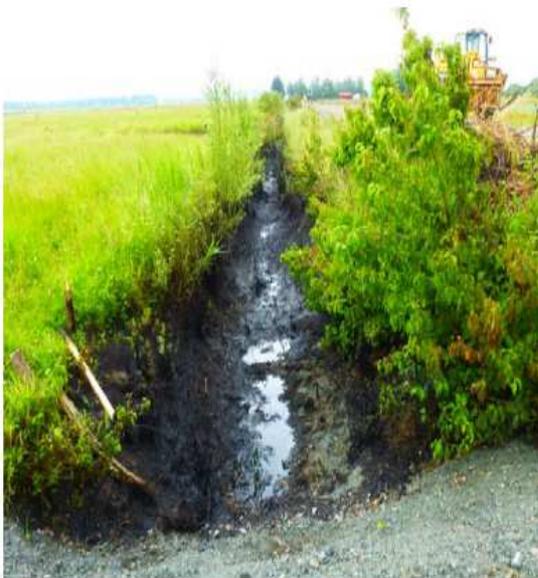
The oil spread and fouled 820 meters of trenches (submerged at the time), with the oil pooling at the bottom over 650 meters of this length. Both flora and fauna were immediately affected by oil at the surface.

The oil geyser resulted in a falling oil spray that stuck very tightly to parts of plants above ground. 14,000 m² of meadow, used mainly for the production of animal feed and beef cattle grazing, were adversely affected by the oil spill. Some 48,000 m² of surface were sprayed by oil (micro-droplets on the above-ground parts of plant life).

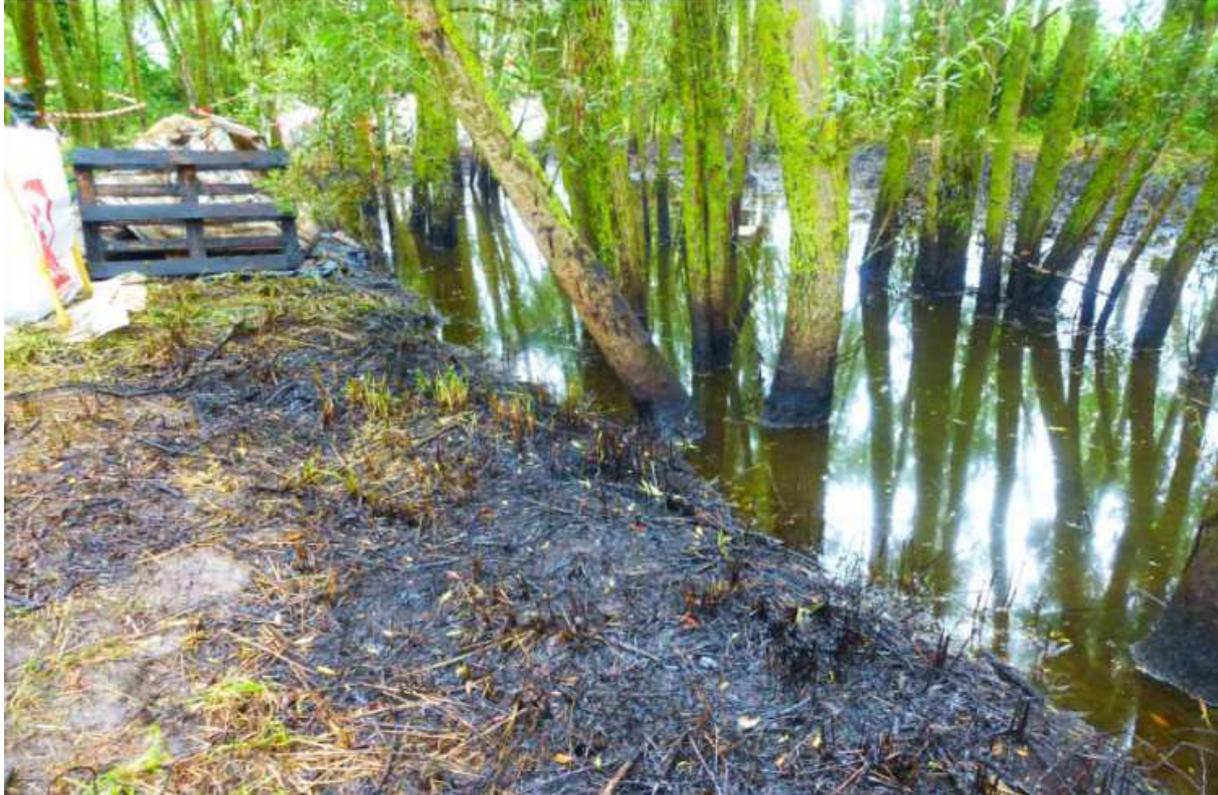
Via a trench, the oil also spilled into a willow plantation.

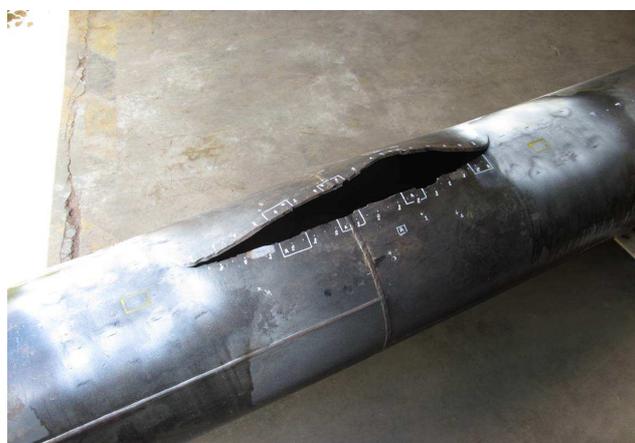
The oil leak occurred subsequent to the widening of an 87 cm long opening positioned along the upper generatrix of the pipeline on both sides of a circular coupling weld between two rolled-welded tubes. The longitudinal welds on this pair of tubes were located away from the rupture zone. An approx. 4 meter length of pipeline was removed and appraised by an expert. The section of burst pipeline displayed along its upper generatrix many signs of shock, dents and scratches as well as macroscopic deformation in the form of flattening and ripples. The outer surface of the circular coupling weld was also damaged, thus indicating that the damage occurred after installing and welding the tubes.

The morphology and location of this external damage reveal that it was probably caused by heavy equipment, subjected to a scraping effect from a power shovel and/or a track roller crossing over the ground.

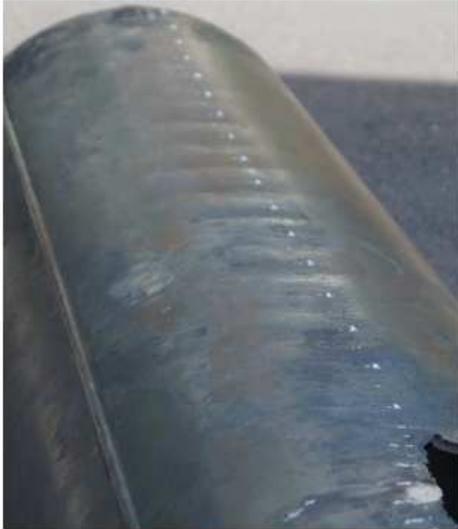
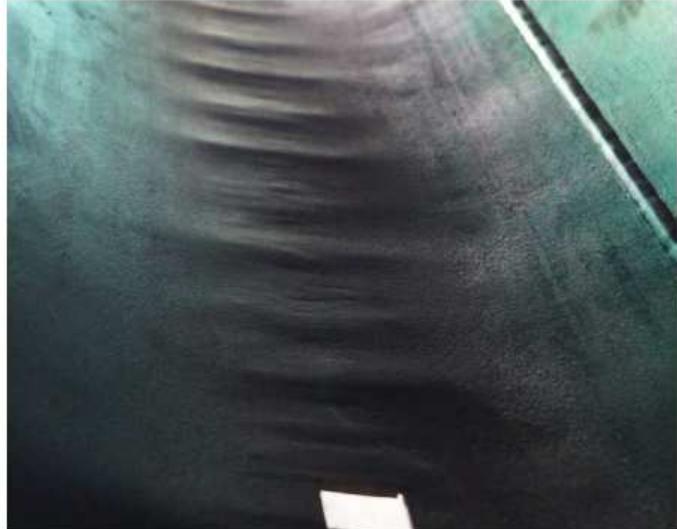
The tube appraisal conducted by an inspection body established that the sudden pipeline break, followed by gradual development of multiple longitudinal corrosion cracks due to stress, was initiated from the outer skin of the pipeline, in the strain-hardened zone with mechanical deformation.

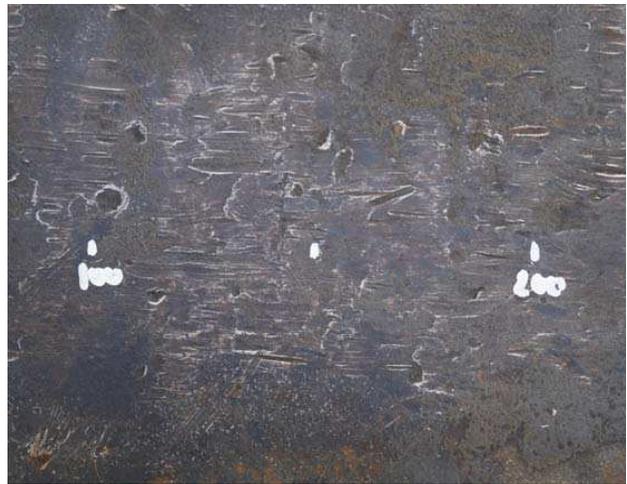
Inside the rupture zone, six lunula corresponding to pre-existing longitudinal cracks representing some 35% to 50% of the wall thickness could be identified. These lunula were characterised by an advanced state of oxidation, or even corrosion, that did not match the ultimate rupture zones and moreover proved that they predated the actual rupture. The presence of radiating bands from the external surface suggested crack onset from this surface. The remainder of the pipeline surface offered a clean appearance without any loss of thickness due to corrosion. Furthermore, no corrosion on the tube's internal surface could be detected.

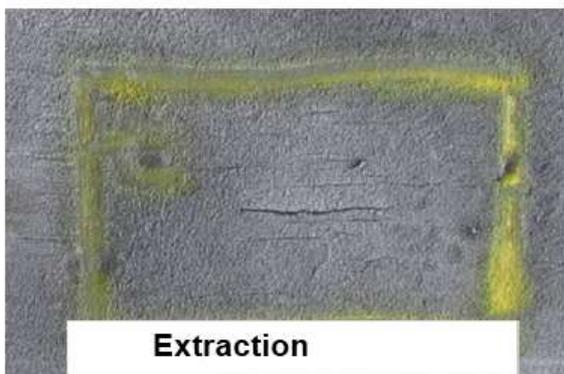
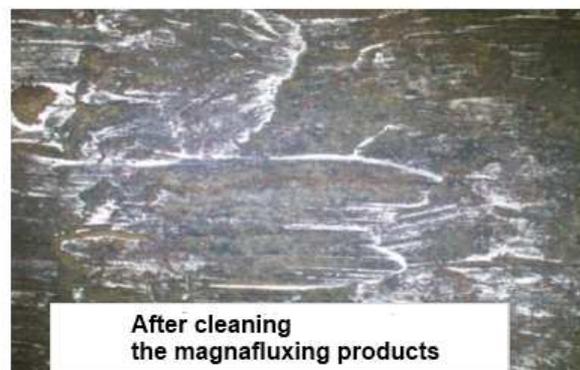
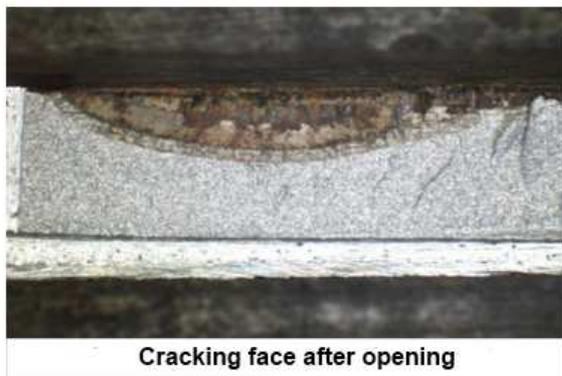
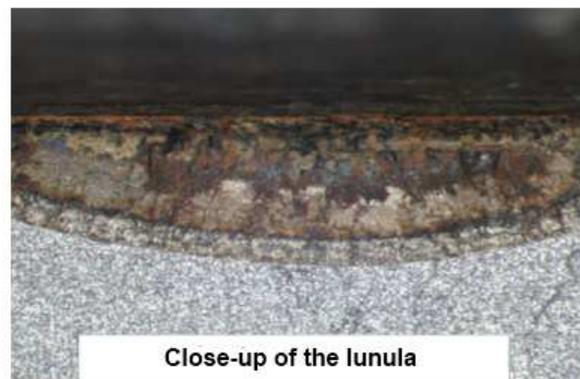
Outside the rupture zone, on the outer surface of the liner and along the upper generatrix, the magnetic particle inspection evaluation revealed the presence of crack-type anomalies associated with the identified mechanical damage that had strain-hardened the metal and caused the tube to flatten over its upper generatrix. Mechanical stresses at the level of the connection with the non-flattened zone had thus formed.

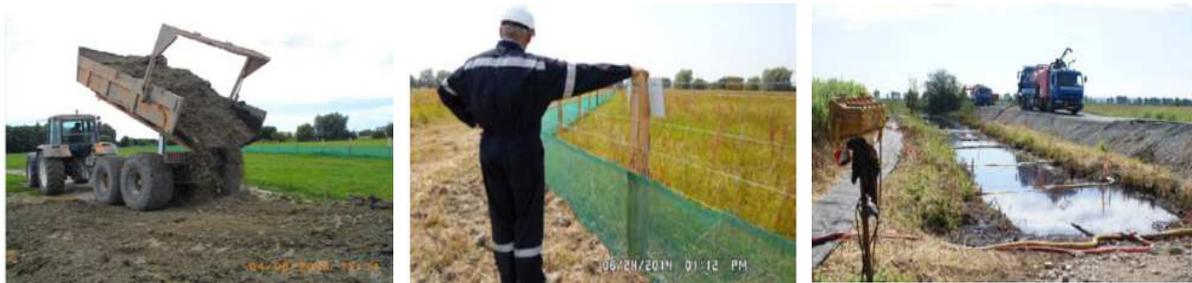
The pollution was completely confined using earthen dams reinforced by an impermeable membrane. Fences and anti-amphibian screens were installed to prevent local fauna from entering the polluted zone.

The 4500 m³ of crude oil, water and sediments pumped from the zone were discharged at the Normandy Refinery site (located a few kilometres away), where a settlement protocol had been implemented specifically to manage this accident. These 4500 m³ included the 2100 m³ of crude oil resulting from the pipeline drainage step prior to its repair.

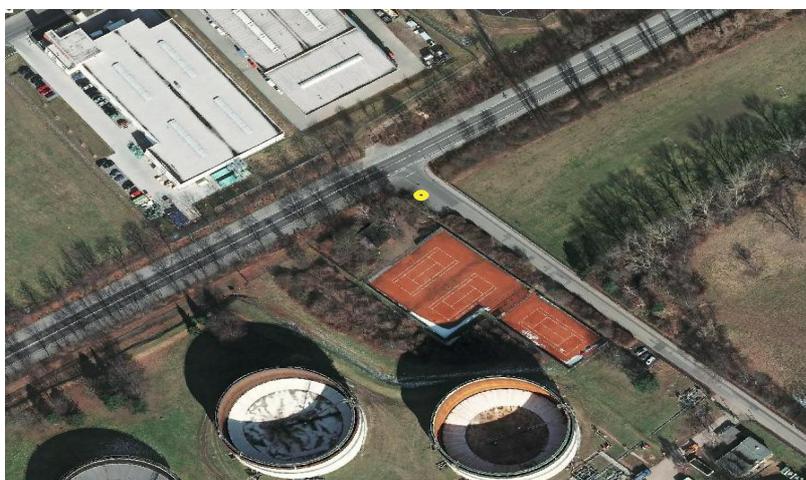
Figure 2: Location of the leakage (yellow dot)

On Saturday 25 February 2012, obvious changes of the filling level of two tanks at the Wesseling site of the refinery were observed. As cause a leakage of the connecting pipeline number 7 was assumed and verified by pressure and leakage checks. The pipeline was blocked on 26 February and discharged on 28 February. The location of the leakage outside of the tank field and the refinery was identified by noise emission analysis and verified by digging up (Figure 2). It was shown by later calculations that, over a time period of 28 days, 846 tons (or 1057 m³) of kerosene were emitted into the soil. The leakage rate was below 2 m³/h (0,5 l/s) and could not be detected by the installed leakage detection system because it was only able to detect a minimum flow rate of 5 m³/h (1,4 l/s).
