Overview of accident statistics on waste management facilities

- October 2016 -

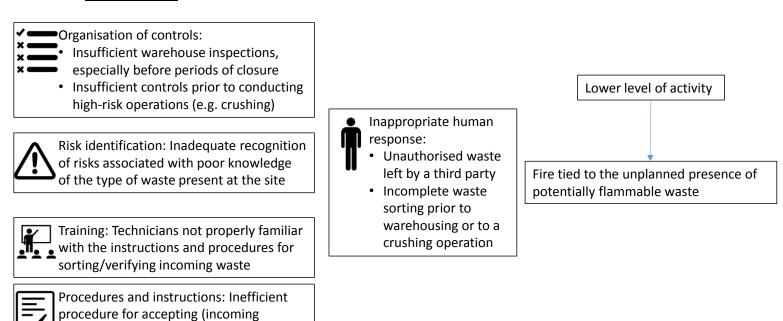
This residue, deposited in the cell around 8 pm, had been produced from the day's crushing activities. According to the facility operator, the fire may have been caused by the presence of a piece of incandescent rebar or a piece of incandescent foam in the pile of residue. The operator introduced a series of complementary measures to avoid the occurrence of

Causal analysis:

Recommendations:

controls) and sorting waste

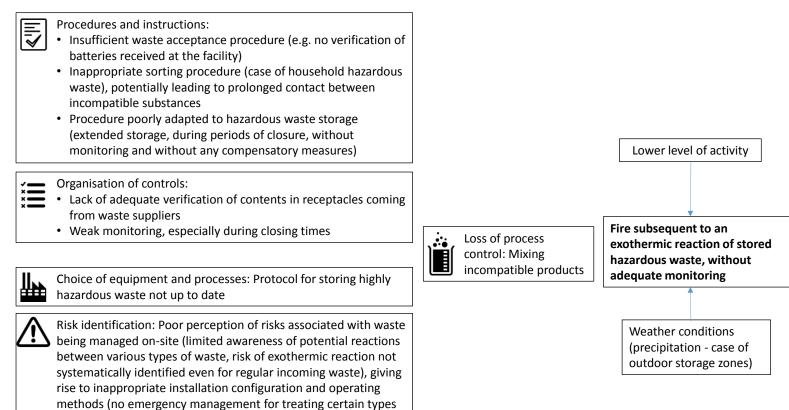
Chemical reaction during hazardous waste warehousing / storage

Causal analysis:

of waste so as to avoid their extended on-site presence)

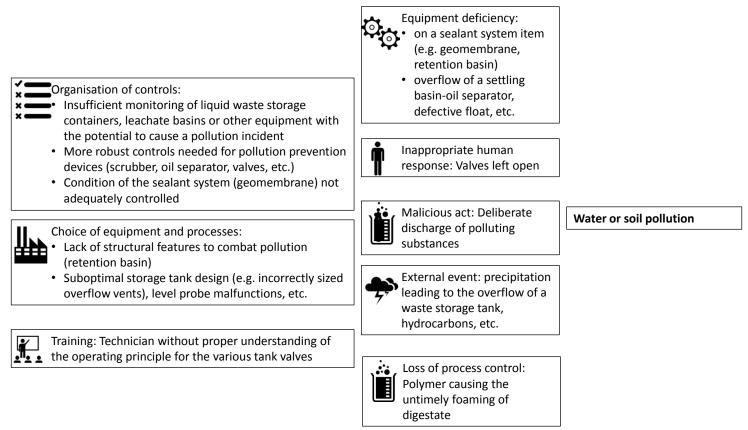
Causal analysis:

Recommendations:

- Stronger control and maintenance procedures applied to discharge treatment systems;
- More robust safety equipment associated with the storage facilities: larger vent diameter, high level alarm relay to the on-call technician;
- State-of-the-art control and maintenance of the relevant equipment: settlement tank, oil separator, float, etc.;
- Ongoing monitoring of the leachate basin level in order to avoid overflows during rain events (adaptation of treatment capacity to better match the flows);
- Installation of aquatic pollution protection systems, e.g. plugging of the stormwater basin overflow outlet via an inflatable system;
- Improved procedures for limiting adverse environmental impacts in the case of a loss of confinement: efforts required to ensure a more reactive response.

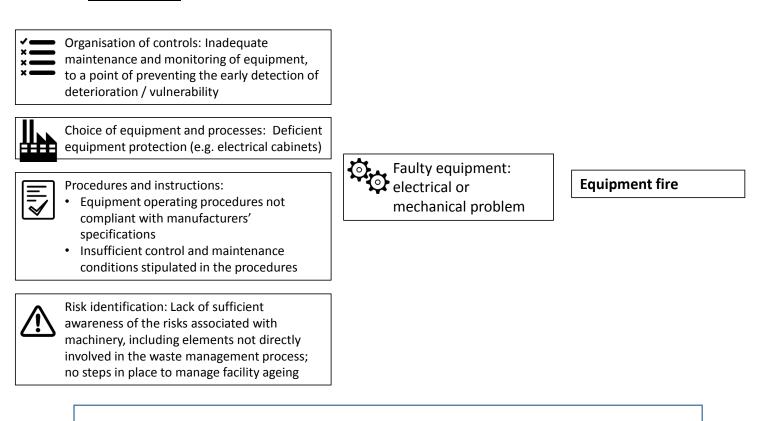
Causal analysis:

Recommendations:

- Improvement of the equipment verification and maintenance programmes to better manage their ageing, prevent their deterioration and spot defects as early as possible;
- Regular electrical inspections
- Compliance with the equipment operating protocols, manufacturers' instructions (avoidance of excessive loads, etc.) to avoid the occurrence of malfunctions or blockages capable of leading to heating.

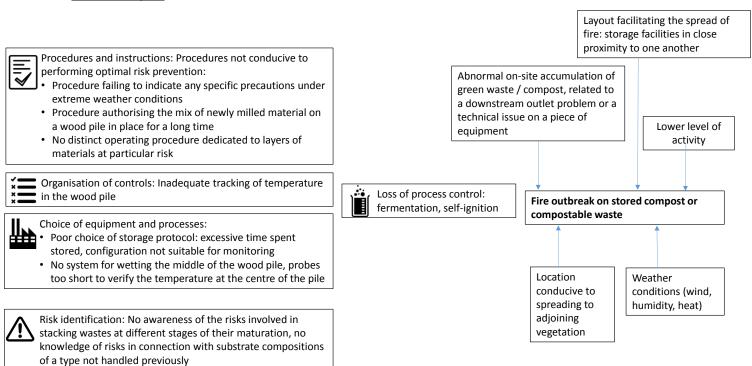
Causal analysis:

As regards the "weather conditions" type of exacerbating factors mentioned above, we note the example of rainfall: humidity accelerates the degradation of waste (methanisation) and makes it more flammable.

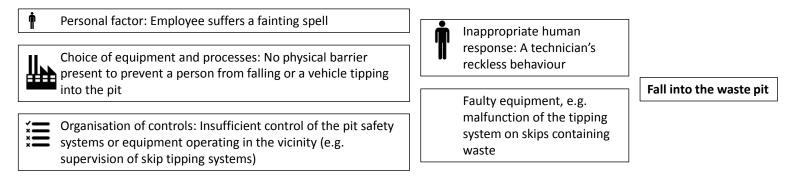
Causal analysis:

These events are often correlated with a combination of personal factors (lack of vigilance, fainting, etc.) as well as equipment factors (malfunction of the lorry tipping mechanism, absence of systems performing the role of physical barrier to prevent the risk of falling).

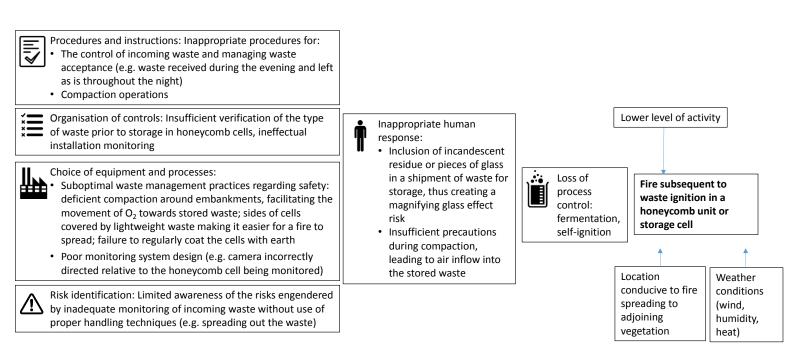
Causal analysis:

As regards the "weather conditions" type of exacerbating factors mentioned in the causal analysis, we note the example of rainfall: humidity accelerates the degradation of waste (methanisation) and makes it more flammable.
