Meteorological events of early 2018

Without trying to predict the weather for late 2018 and the seasonal storms in the Cévennes of south-central France, we note that the first half of the year was marked by a number of floods impacting factories in France. In addition to the economic consequences (water damage, production stoppage, a period of technical unemployment for the employees, etc.) often observed in such circumstances, environmental damage was also reported.

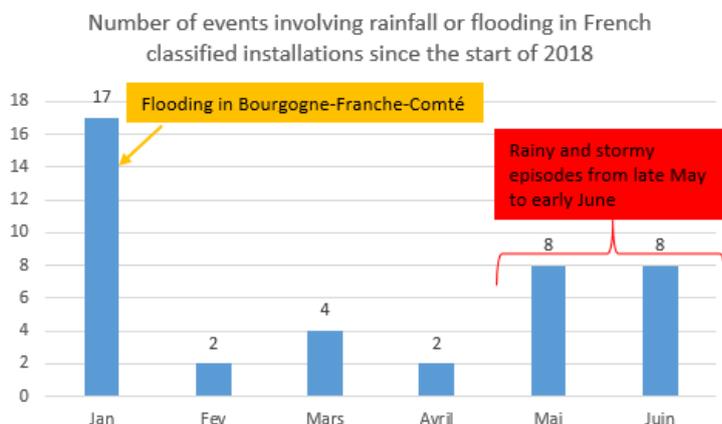
ARIA 51017 - 22/01/2018 - DOUBS

During the night, the Doubs River flooded a company specialised in the manufacture of steering columns for vehicles. The site's production facility was shut down while the water was drained off. Production was also paralysed at one of its customers which could not be supplied (ARIA 51009). The operator **had been monitoring the water level hourly via www.vigicrues.gouv.fr**. At the same time, a water level measurement was conducted every 2 hours on a manhole in the stormwater network inside a building.

When the level reached 10 cm below the level of the workshop, the operator triggered the **emergency flood plan**. This monitoring procedure made it possible to anticipate and conduct the necessary security actions:
