## Are visual diagnostics enough to anticipate concrete cell ruptures?

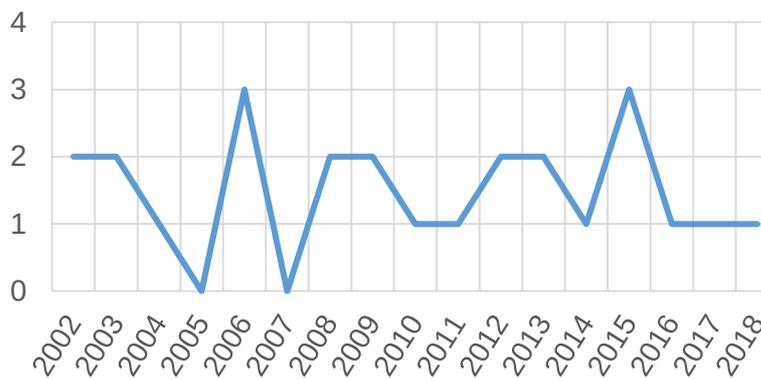
Evolution of the number of grain silo ruptures or collapses

In 30 years, the BARPI has recorded 30 ruptures or collapses of silo in France. These accidents mainly affect metal storage cells, although concrete cells were also involved in 9 accidents recorded in the ARIA database.

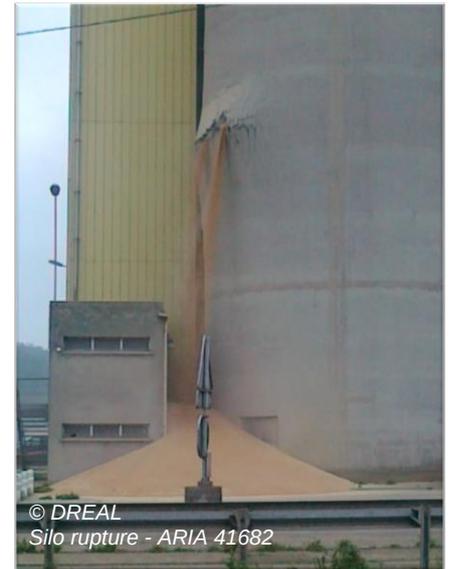
### ARIA 41682 – 30/01/2012 – SEINE-MARITIME

In a 45,000-tonne port-based grain silo, the cylindrical wall of a 60-m tall concrete cell (capacity: 3,500 t) ruptured transversely at a height of 15 m. The resulting breach allowed the stock of wheat to flow onto the quay through the damaged 4 m<sup>2</sup> zone. The silo, built in 1983, consisted of a 75-m tower and 18 cells grouped into blocks of 4 or 6 cells. In this case, the block consisted of 4 cells. The operator set up a 150 m safety perimeter and began emptying the damaged cell and the other 3 cells forming the block in order to limit the pressure on the walls.

In 2008, a specialised company had diagnosed steel corrosion problems and concrete defects of varying significance on the 4 silos located in the port area. A causal analysis of the accident highlighted a failure to comply with constructive data, particularly a lack of reinforcement, insufficient concrete cover and excessive spacing of the silo hoops.
