## Industrial accidents initiated or exacerbated by high temperatures

May 2020

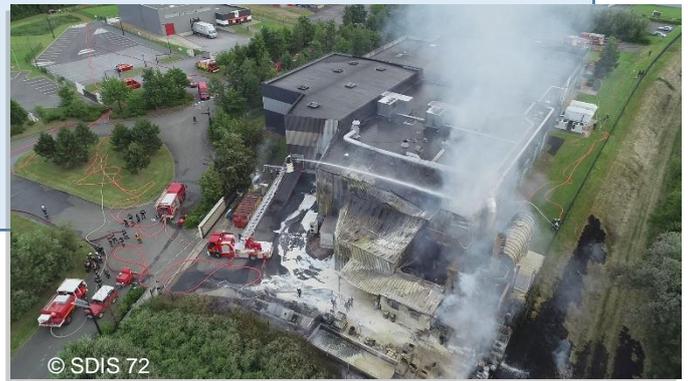
The operator took the following measures:

- earthing systems were doubled by means of overhead lines;
- insulation of the 1,250 kWh transformer along the property line;
- air conditioning of the premises;
- installation of a 6-hour fire wall rising above roof level;
- purchase of a water-based ink fountain cleaning machine.

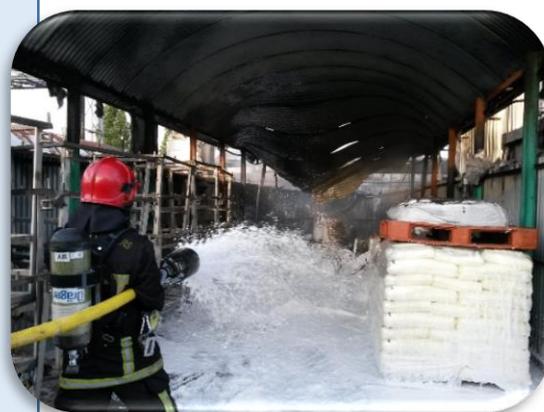
The site had been shut down for maintenance at the time of the accident. The building in question was typically used for storing toxic products. However, non-compliant finished products were also being stored there temporarily while maintenance work was underway in the usual storage building.

After examining the drums, the operator determined that a drum containing propargyl alcohol (having a flash point below 60 °C) had exploded due to the thermal polymerisation of the product following extended storage at ambient temperatures above 30 °C. The material safety data sheet did not specify this risk; it mentions that the product should be protected from the action of heat and to avoid exposure to temperatures above 80 °C.

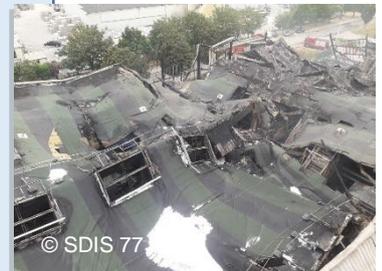
According to the operator, the presence of a combustion initiator in the stocker material, coupled with the high temperatures on the days preceding the fire, was responsible for the outbreak.

The operator identified the main vectors that allowed the fire to spread throughout the structure (ventilation ducts, conveyors, cladding, etc.) and has studied the modifications required during the reconstruction of the installations.
