Synthesis

Accidents involving fires at surface treatment facilities

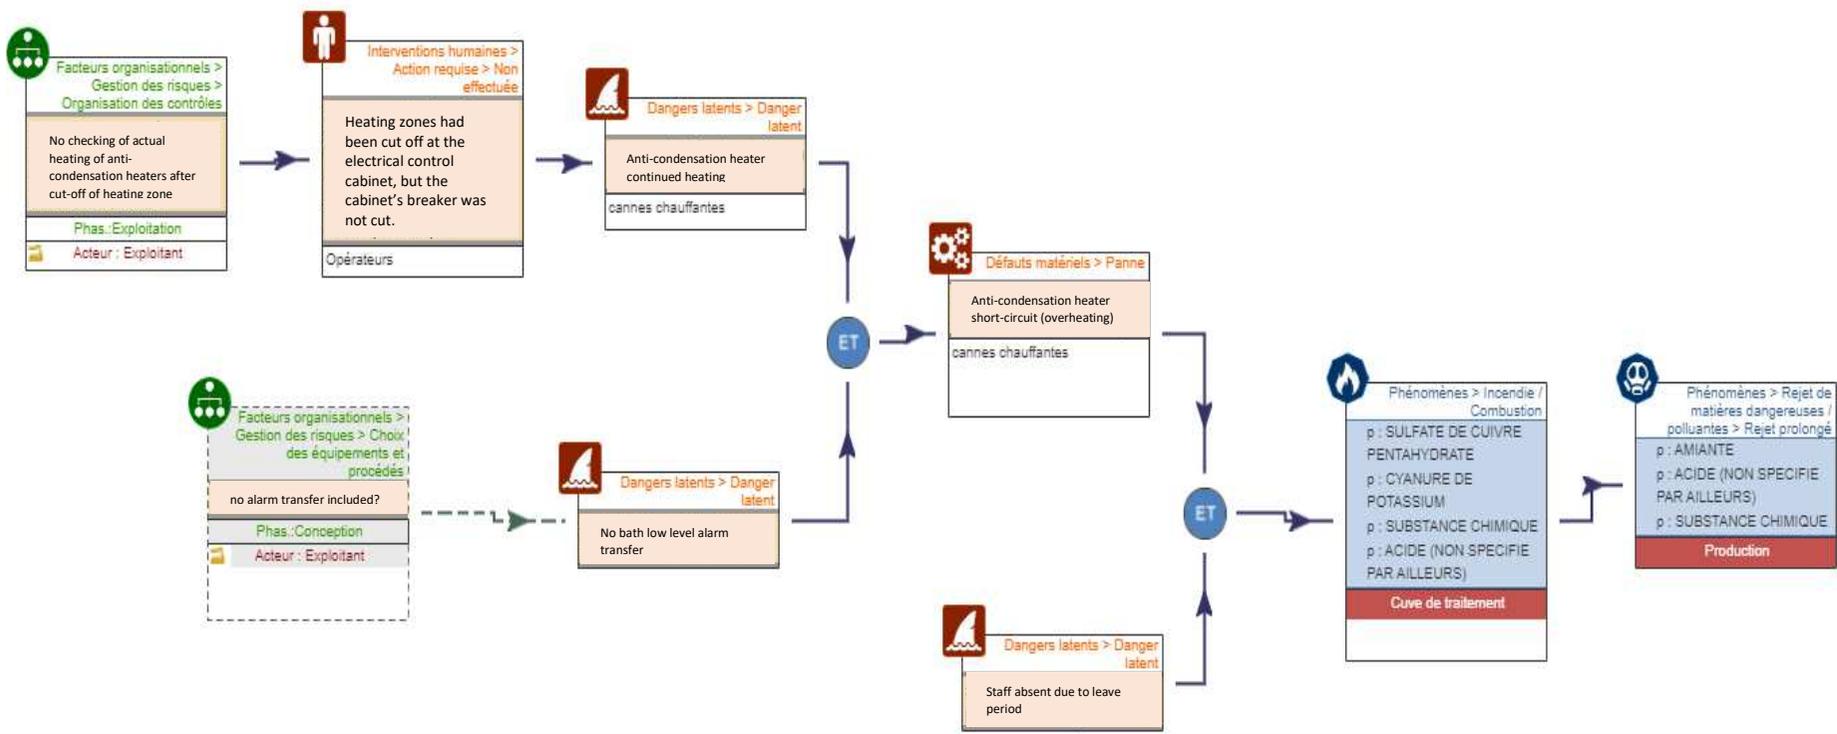
ARIA 52811 - Fire in a surface treatment workshop

Part of the ground floor, the mezzanine and all the upper floors burned. Outside, 1/8th of the building's metal cladding was burned. Products located in the affected zones, industrial equipment (plastic storage vats, tank and covering, ducts, pumps) and structural elements of the building were destroyed. The total volume of water used on the fire was estimated to be between 200 and 300m³. 2 months later, the soil analyses and samples were found to be well below the applicable references values to assess sanitary risks.

Initial investigations indicated that it would appear that the fire broke out in one of the tanks, which had been emptied, but in which the resistive heaters, which had continued to heat, would appear to have caused the polymer coating of the tank to catch fire. It would appear that the vapour catchment system caused the fire to spread to the sodium hydroxide washer. It would appear that the fire then spread to the upper floors.

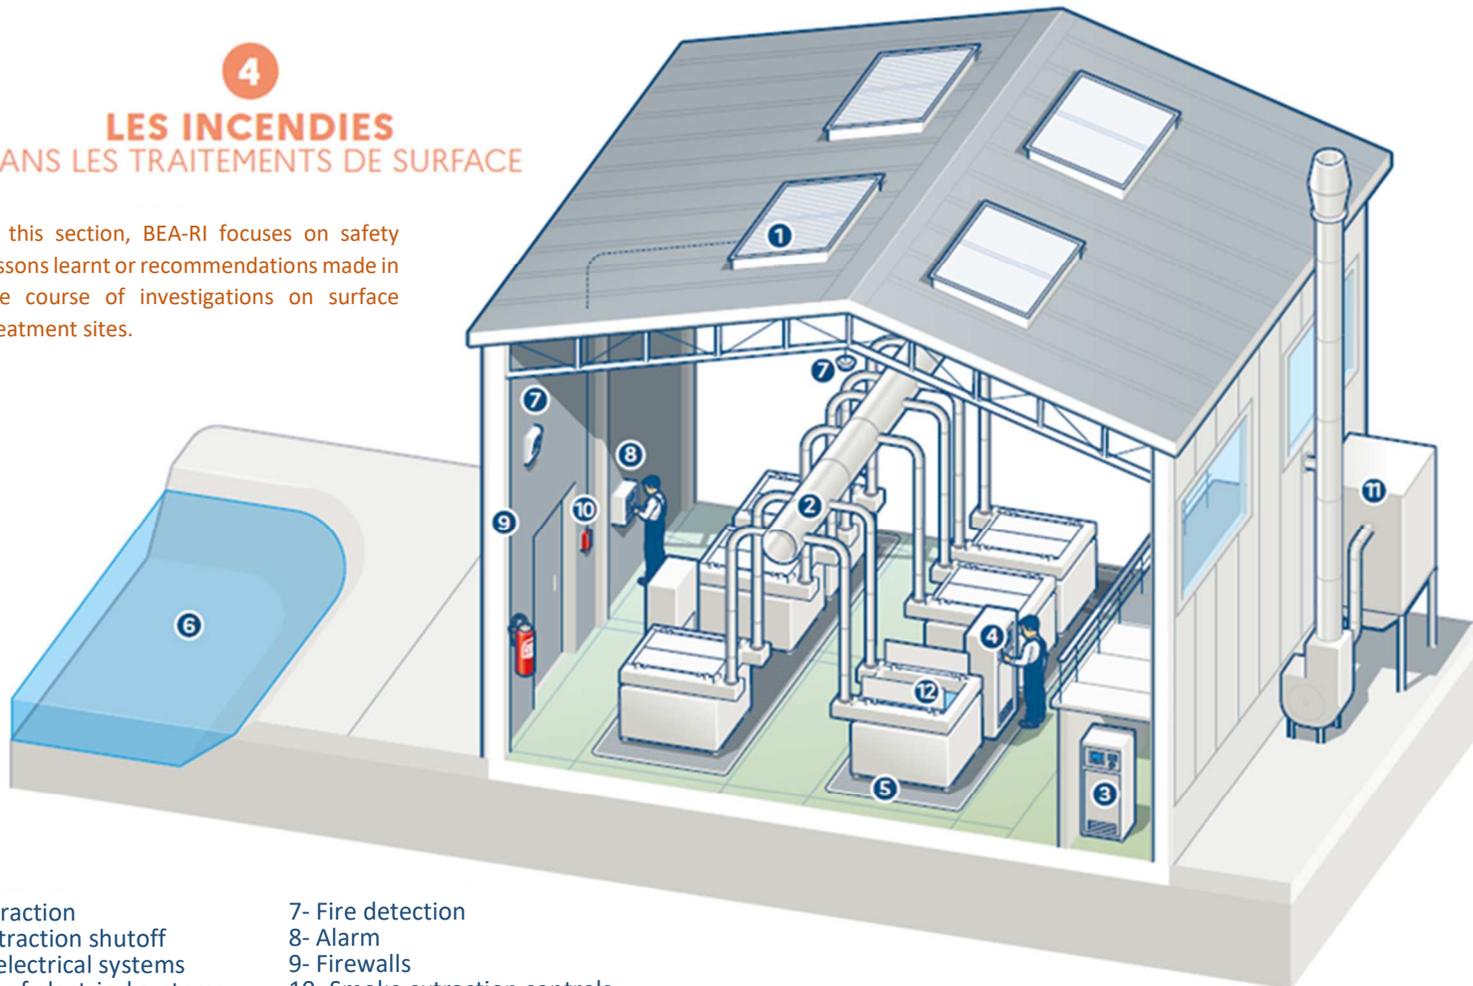
- 1- Smoke extraction
- 2- Vapour extraction shutoff
- 3- Design of electrical systems
- 4- Inspection of electrical systems
- 5- Retention systems
- 6- Firefighting water retention basin

- 7- Fire detection
- 8- Alarm
- 9- Firewalls
- 10- Smoke extraction controls
- 11 Vapour treatment system
- 12- Bath heating

In this section, BEA-RI focuses on safety lessons learnt or recommendations made in the course of investigations on surface treatment sites.
