LESSONS LEARNT from INDUSTRIAL ACCIDENTS

15th SEMINAR

23 - 24 May 2023 - Marseille

LESSONS LEARNT

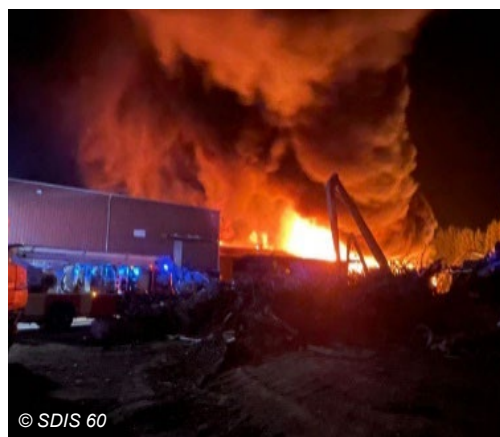
[ARIA 57876](#): Fire at an ELV centre

At about 5:00 p.m., a fire broke out in a car parked in an ELV centre. A large plume of black smoke was visible in the sky. The fire spread to other depolluted vehicles. The event involved 159 burned vehicles, and property damage was estimated to be €150,000. The fire outbreak was due to the intense heat and the mirror effect on the glazed parts of the vehicle. The wind quickly spread the fire to other vehicles.

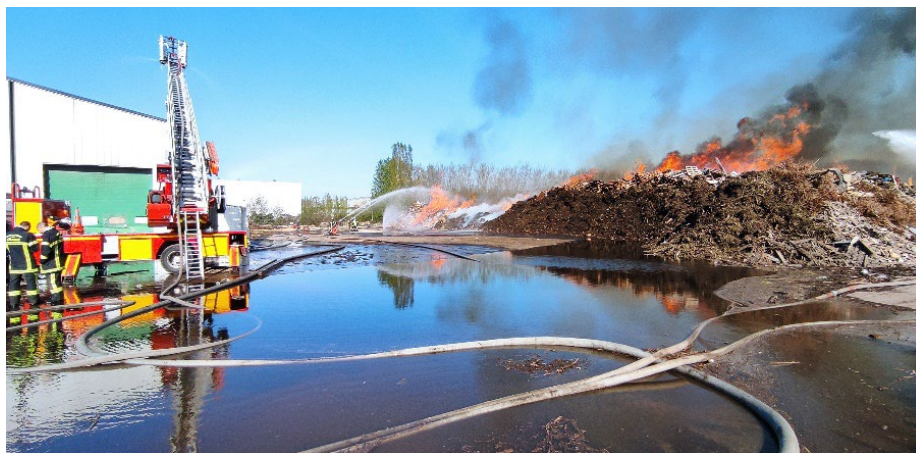
illustration photo

At 10:34 p.m., an alarm sent by the emergency telephone system alerted employees of a non-hazardous waste storage facilities that one of the thermal imaging cameras had detected a hot spot in a cell in use. Arriving at the site at 10:45 p.m., an employee began to smother the fire with the stock of soil near the locker. The site manager coordinated the management of the fire using a loader, compactor and shovel. The fire was brought under control at 11:30 p.m. In the absence of flames, layers of soil were spread with the compactor over the affected area. At midnight, the firefighters found that the fire was completely under control and that they did not need to intervene. The affected area was monitored overnight between 2:00 a.m. and 7:00 a.m.

The geomembrane was not damaged. Business activities resumed in the morning.

The alert system, with detection of hot spots by thermal imaging cameras and notification of alerts by an emergency telephone system, enabled good control of the fire and prevented its spread.
