## Rupture of observation windows in a brewery

### 17 and 18 January, 2002

### Champagneulles (54)

### France

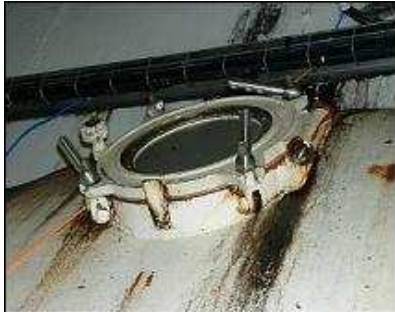
Photo DR

The fermentation tanks used on the site are made of coated steel. They measure 3 meters in diameter and 17 meters in length, for a volume of 120 m<sup>3</sup> used in the following manner:

- ✓ 80 m<sup>3</sup> of beer in fermentation;
- ✓ 40 m<sup>3</sup> of free space required for fermentation.
