## Reactor explosion

3<sup>rd</sup> January, 1996

**Sisteron**

Fine chemical manufacture

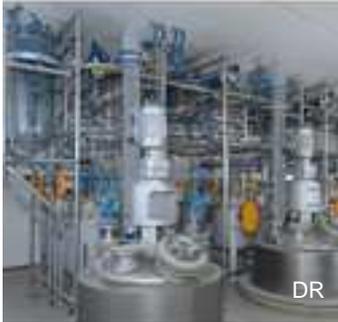
Example of an industrial reactor containing a glass column

The damaged building housed a multi-purpose, 6,000-litre capacity enamelled reactor used for the synthesis of various products. The reactor had been equipped with a glass superstructure that included a column, a Dean Stark distillation apparatus and a 200-litre loading tank. A valve calibrated at 2.5 bar was also installed on the reactor, and a rupture disc calibrated at 0.3 bar was placed on the glass column.
