Bringing gas-powered installations back online

Explosion of a superheater within a steam-cracking unit

ARIA 36496 - 15/07/2009 - 57 - Saint-Avoid

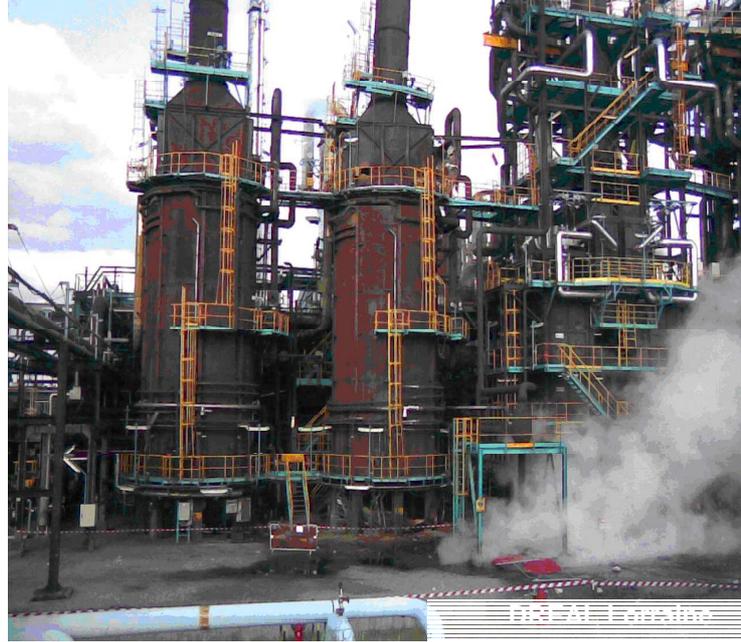
Cylindrical in shape, with a diameter of 5 m and some 20 m high, this water vapour superheater, connected to a chimney of the same height via a connecting cone, was holding no toxic products. The explosion was not followed by fire.

Superheater "A" on steam cracker no. 1 at a petrochemical platform exploded around 3 pm. Of the 8 staff present onsite, 2 were killed and the other 6 all injured. Projectiles, composed for the most part of refractory materials, were sent distances of some 100 metres, with some pieces nearly 50 cm in size landing immediately adjacent to the superheater; a dust cloud formed vertically above the site.

On July 15th, superheater "A" was reset around 3 pm with the intention of proceeding by a manual restart. A technician arrived carrying an adjustable pole in order to switch on the pilots when the superheater exploded. The bodies of both this technician and a second employee would be found amidst the rubble, due in large part to collapse of the superheater floor.
