# Accidents with CO<sub>2</sub> extinguishing systems

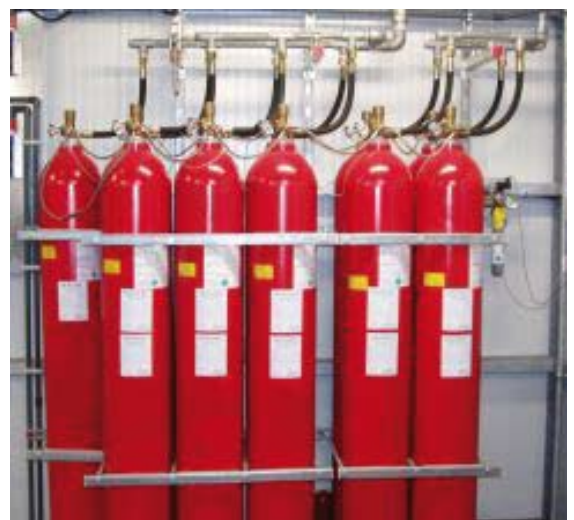
CO<sub>2</sub> itself actually constitutes a special kind of physiological risk: asphyxiating effect, respiratory disorders and an acid-basic reaction of the body. At high concentrations, it is capable of causing depression of the central nervous system, convulsive coma and death, with such effects arising even more quickly as the transition from a healthy to a «polluted» atmosphere is sudden.

*Note: A joint memorandum by MEDAT/DPPR/SEI, dated November 16, 2007, established the concentration levels corresponding to regulatory CO<sub>2</sub> thresholds for safety reports.*
