Results of an accident study covering the 2015 summer heat wave in France

- December 2015 -

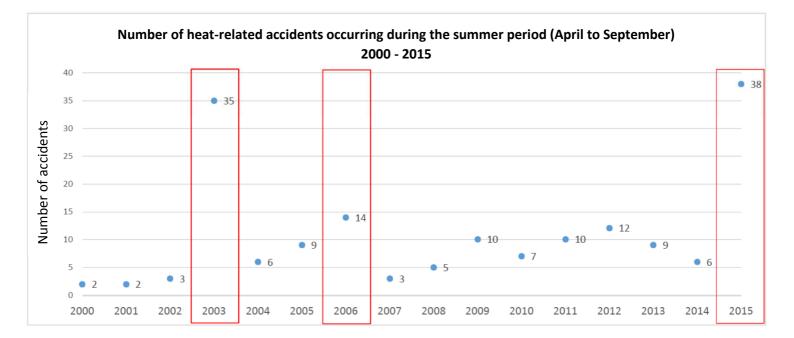
While the variations in number of accidents between "normal" years are all not necessarily easily explained, the impacts of the three hottest summers since the beginning of the 21st century can be distinguished quite clearly, i.e.:

- summer 2003 heat wave
- July 2006 heat wave
- summer 2015 heat wave

The number of accidents recorded in 2015 is of the same order of magnitude, even slightly higher, than the number attained during the 2003 heat wave. The smaller number of accidents registered in 2006 is related to the shorter duration of the heat wave (only during the month of July).
