# Accidents related to incorrect circuit positioning

## Understanding causation to prevent re-occurrence

- May 2018 -

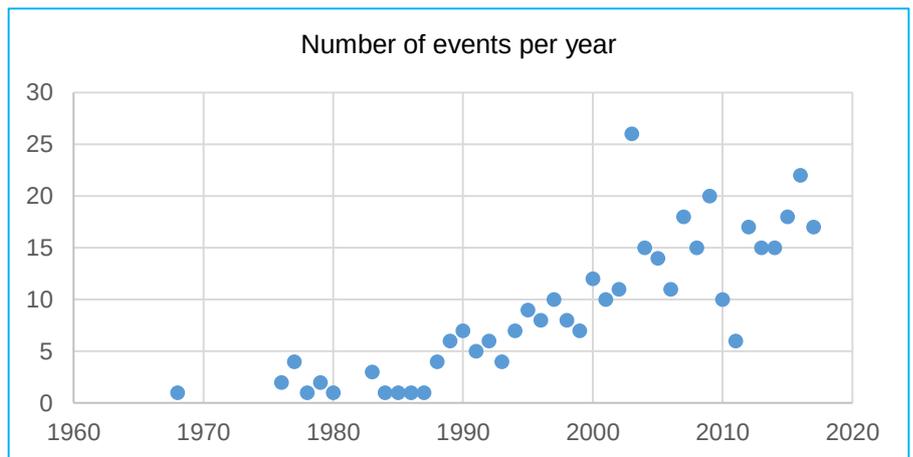
The graph below shows the number of accidents per year in the study sample. When the upward trend is clear, it is partly explained by greater accuracy of the information received by BARPI. This obviously makes it easier to identify accidents that are the result of poor alignment.

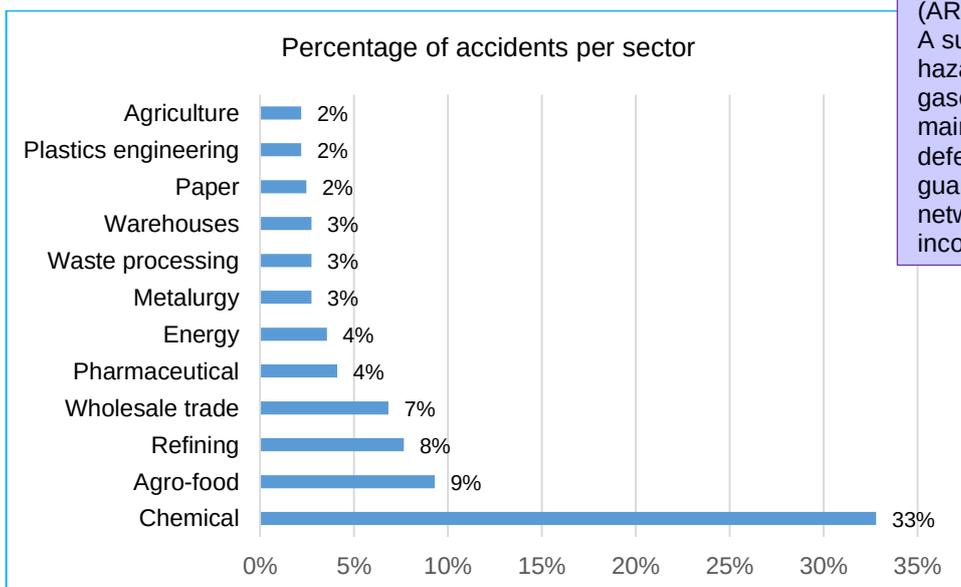
While the process industry sectors are the first concerned, alignment errors occur in nearly all the fields represented in the database. Twelve sectors make up 80% of the accidents. The percentage of accidents that occurred in each of these sectors is represented in the table below.

A third of alignment errors, therefore, occur in the chemical sector. By way of comparison, this sector's share of all accidents in the database is only 9.5%.

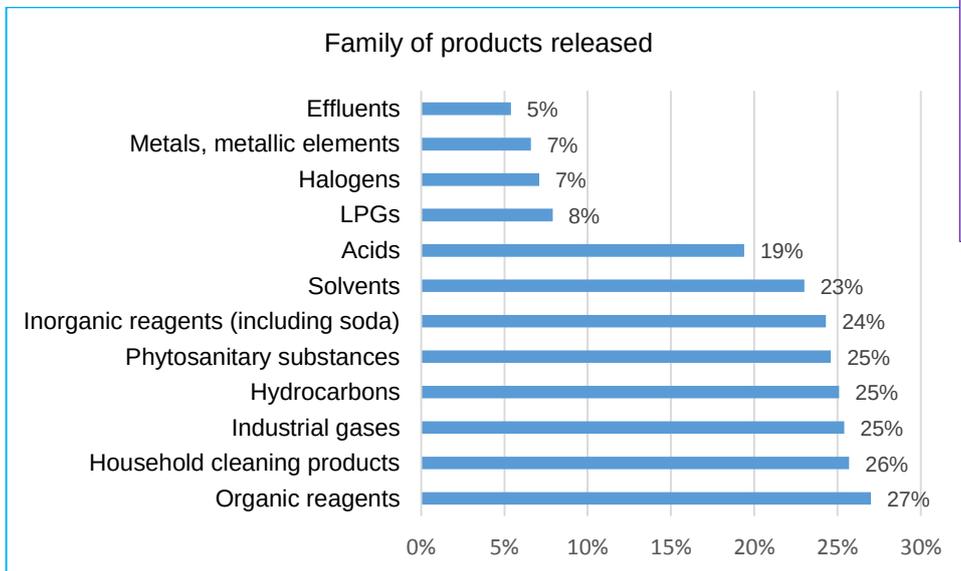
The hazardous materials involved are just as varied as the sectors of activity. The main families of materials are shown below, along with the percentage of accidents in which they are involved.

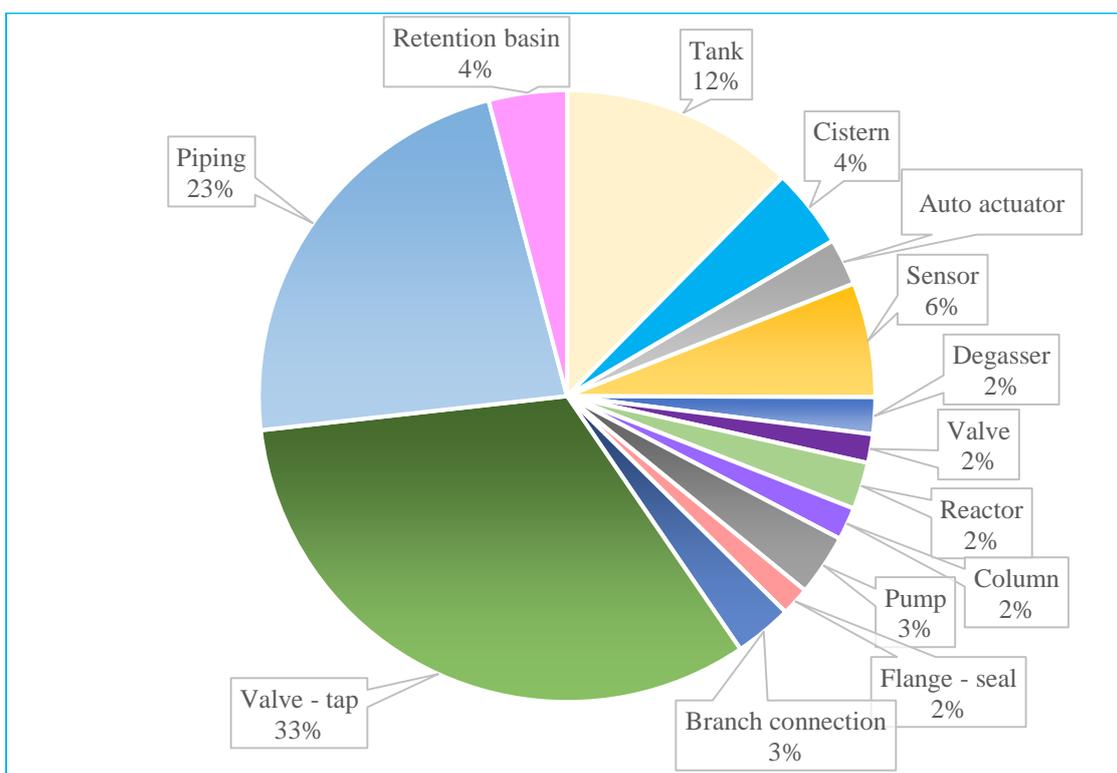
The components of the transfer systems, including piping and valves, naturally represent more than half of the equipment identified as being involved in accidents. Many other pieces of equipment are also involved, as shown in the graph below which details the proportion of events where the type of equipment is identified.
