Transboundary pollution accident River Daugava (Latvia) 23 March 2007 Latvia

Hazardous release Transboundary pollution Surface water pollution Pipeline Diesel fuel (hydrocarbons) Ageing Organization Response (difficulties of) Crisis communication

THE ACCIDENT, ITS CHRONOLOGY, EFFECTS AND CONSEQUENCES

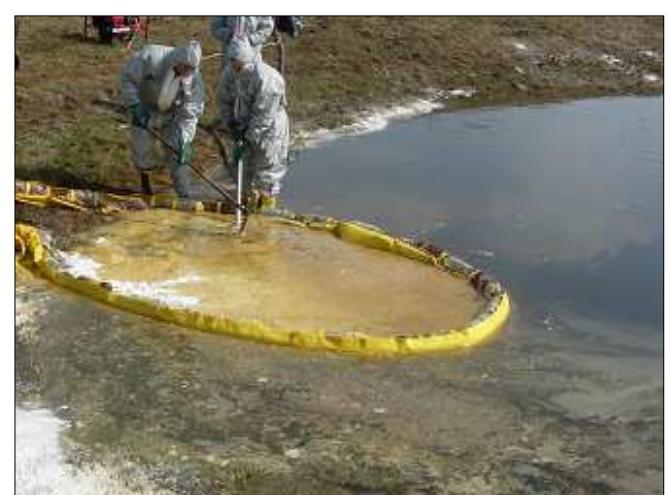
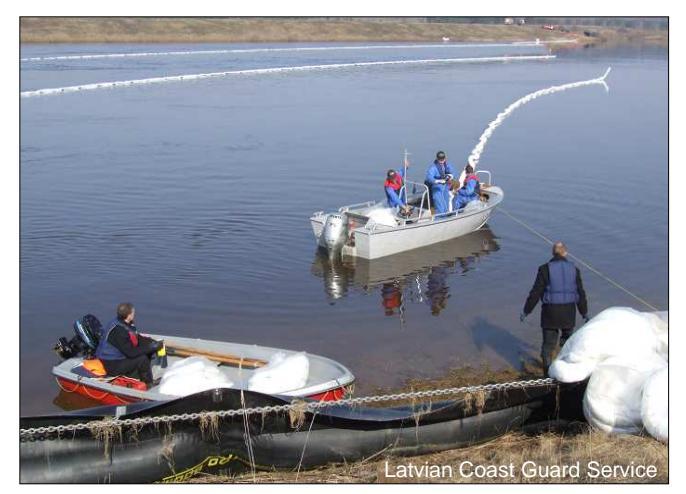
The second attempt of deployment of booms 50 kilometres downstream was successful. In total more than 4 tonnes of oil products pollution was collected. The size of the spill was constantly fluctuating and the main concern was that the leakage would continue longer than we predicted initially.

Observation of 40 sites in affected area was made during clean-up operation and during monitoring of affected area later on.
