Fire in a collecting chemical waste centre

May, 12th, 2000

Drachten

Industrial wastes

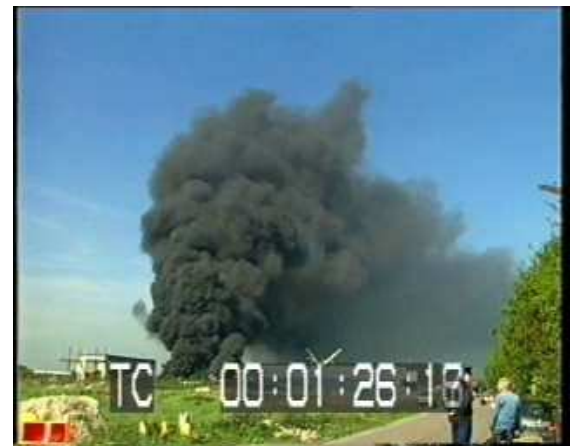
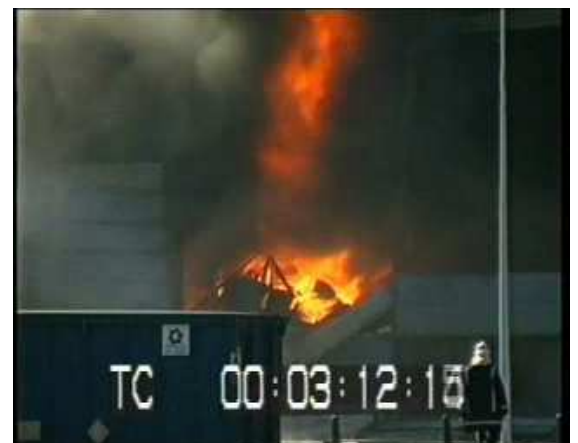
The waste-shed is destroyed, the fire-brigades did not succeed in extinguishing it but used a strategy consisting in preventing an eventual spread to other premises.

As so far as the substances stored were not well-known, it was difficult for fire-brigades to adapt themselves to the circumstances: violent fire, quick propagation, possibly hazardous substances stored, ...

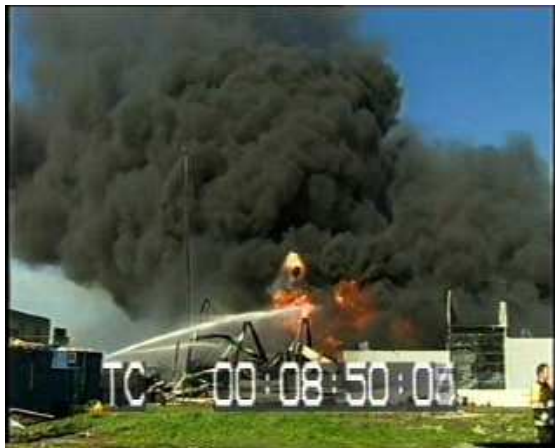
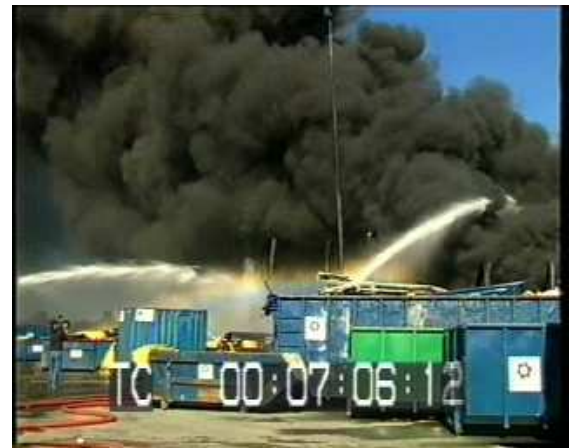
Chemical heating-brew and incompatible combination of "sorted" chemicals caused fire in the storage-shed.

When the accident occurred, the fire-extinguish installation failed :

- ✓ Hi-ex inside air installation seemed to be inappropriate for the kind of chemical stored
- ✓ Ventilation-grids did not close automatically
- ✓ Insufficient amount of foam
- ✓ Adding foam by the fire-brigade did not work out;

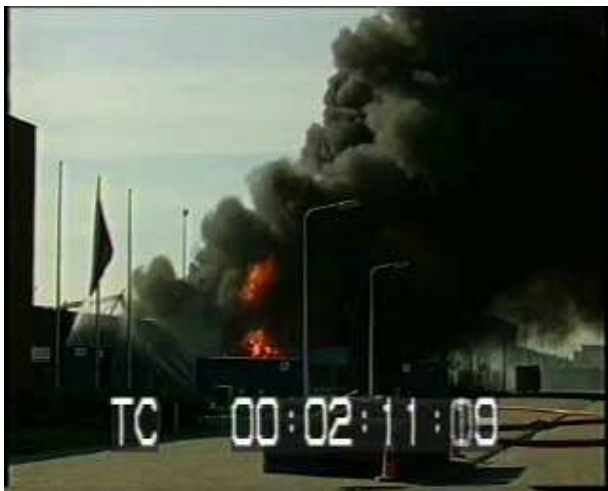
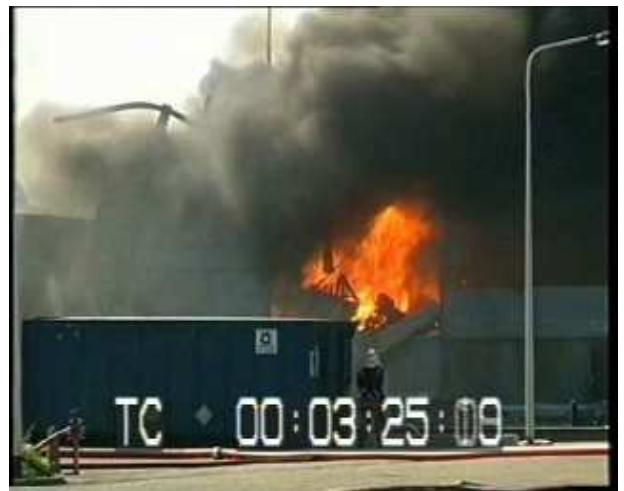
- ✓ The Mayor declared an emergency regulation for the immediate surroundings : emergency teams closed the area and evacuated the other industries located in the vicinity.

- ✓ The sewer was cut-off to collect extinguish-waters.
- ✓ Indicative measurements were carried out by fire-brigades with dräger-tubes : they indicated that there was no risk for public health and, as a consequence, they decided to take no measures toward civil population because surveillance showed that they were not exposed to the smoke.
- ✓ Air, grass and milk samples were supposed to have been contaminated by dioxines so :
 - ✗ Cattle were sheltered in,
 - ✗ Grass was cut and destroyed
 - ✗ Milk was treated separated
