Sudden fracture of a pipeline immediately upstream of an oil terminal 13 December, 2004 Nanterre – [Hauts de Seine] FRANCE

Soil contamination
Pipeline
Gas oil
Dismantling
Safety management
systems Mapping
Successive operators

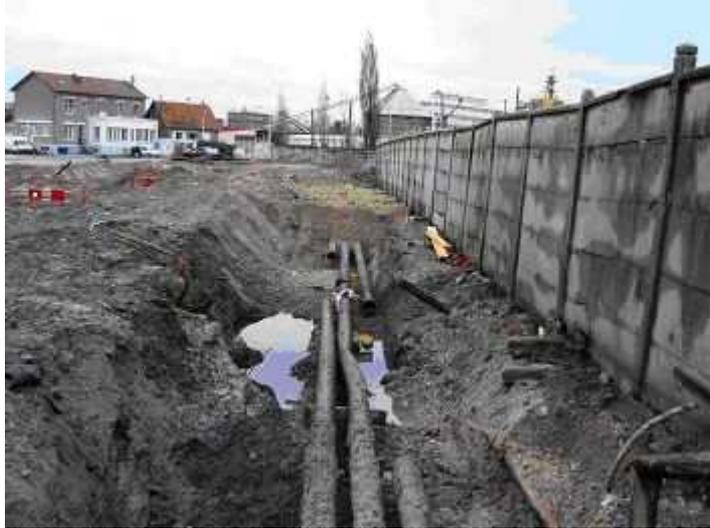
Photo operator

On the morning of December 15 around 11.00 a.m., a gas oil delivery intended for this depot was conveyed through the pipe that had been partially severed 2 days earlier causing an oil spill in the site being dismantled. The construction superintendent of the works company noticed this hydrocarbon spill and promptly informed the oil depot manager. After arriving on site, the oil depot manager ordered an emergency shut down of the transfer. The leak lasted for about 40 minutes.

✓ Nearly 370 m³ of gas oil was spilled on the stretch of land being dismantled. The hydrocarbons seeped into the soil to reach the water table that is 4 meters deep. However, no immediate or medium term pollution was observed in the neighbouring docks of the Seine. Pumping equipment was set up by the various players involved and the operation was coordinated by the fire department right from the afternoon of 15 December on the site being dismantled and in the nearest drainage network. On the evening of 16 December, the pumping equipment helped in recovering 55 m³ of spillage. About three months following the accident 70% of the products had been recovered.
