Major fires

Included in the category of major fires would be all blazes that generate damage beyond the specific unit or machine where the initial ignition occurred. This fact sheet will expose the human potential, social, environmental and economic consequences tied to these events.

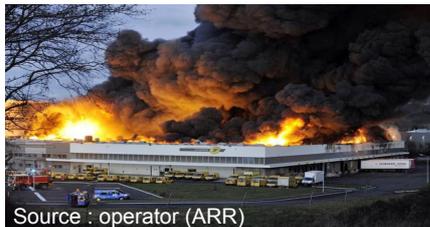
Source : operator (ARR)

Several fires catalogued in the ARIA base involve buildings whose roofs, facades or installed equipments had been designed with combustible materials (e.g. combustible sandwich panels, polyurethane foam, wood structure and facade elements, and glass wool). These materials feed the fire and may complicate fire-fighter response, especially in light of the risks of structural collapse.

In addition to the choice of materials, aggravating design factors include:

- the absence of physical barriers or building compartmentalisation (e.g. fire walls) which would make it possible to contain or even halt entirely the spread of fire;
- the presence of machinery or amenities that promote fire propagation from one building to the next (conveyor system, ventilation ducts, openings in the fire doors).

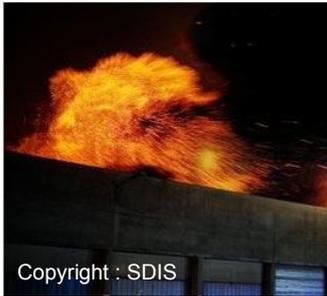
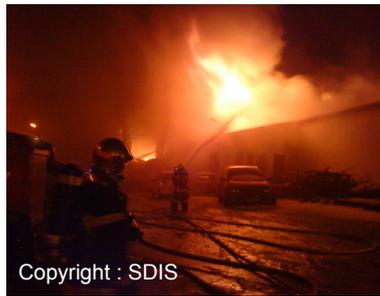
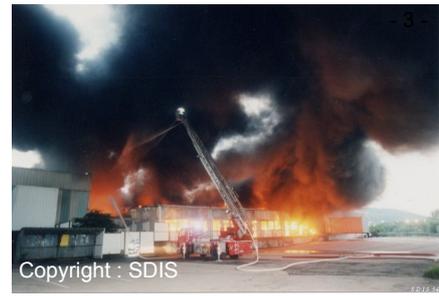
Wind is an aggravating factor regularly encountered in accident records. It stimulates the propagation of fire from one building or one facility to the next and fans flames. Wind also limits the efficiency of smoke exhaust outlets.

ARIA 33271 - 23 July 2007 - 26 - DONZERE

A violent fire broke out around 2:30 pm at a hazardous waste treatment centre. The blaze ignited in an outdoor stockpile of plastic rolls and then spread to the storage of paper-cardboard and adjacent pallets, before reaching the 5,500-m² materials sorting building. **Fanned by strong winds, the fire extended to nearby brush and destroyed 2 ha of vegetation bordering the neighbouring motorway.** On a positive note, a diesel tank in the vicinity was spared. Traffic on the motorway was slowed for a 4-hour period. No victims were reported, but the centre's 20 employees all had to be temporarily laid off. This fire might have been caused by malicious act, but its quick spread had been facilitated by the short distance (less than 10 m) between the various storage sites and the main building.
