Hydrofluoric acid the worst of all acids?

Despite being produced 200 times less than sulphuric acid (1 M vs. 200 M tonnes/year), the ARIA database has recorded nearly 80 accidents involving hydrofluoric acid (HF) (vs. 220 for H_2SO_4). A series of recent accidents serves to recall its hazards, especially the serious consequences in the event of its release..

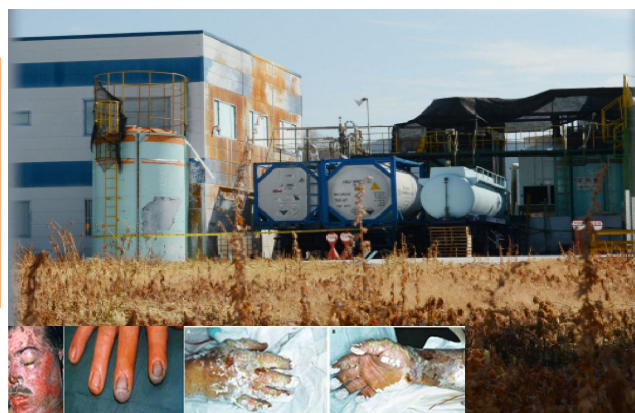
The human and environmental toll of the **Gumi disaster**, which occurred in the heart of South Korea's «Silicon Valley», accounts for one of the most serious accidents involving a massive release of HF
