Handling operations with forklifts: Hazardous situations!

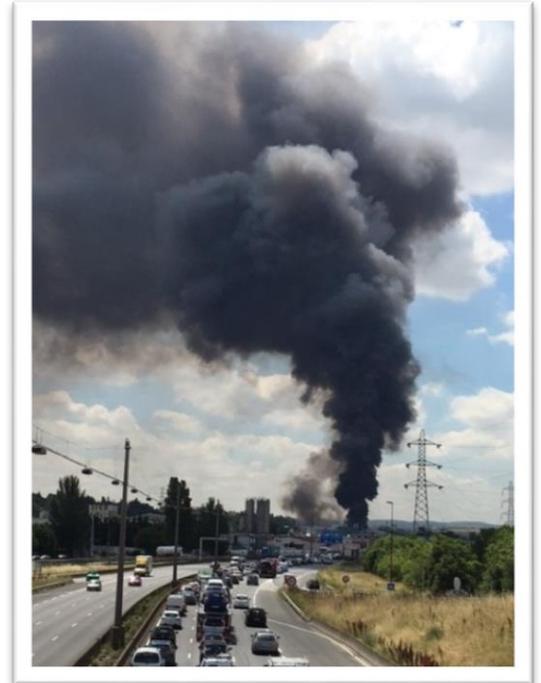
The fire destroyed 600 m² of the warehouse and burned 120 of the 230 t of finished products in storage. The plant was shut down for one week.

Smoke cloud visible from several kilometres away, © SDIS

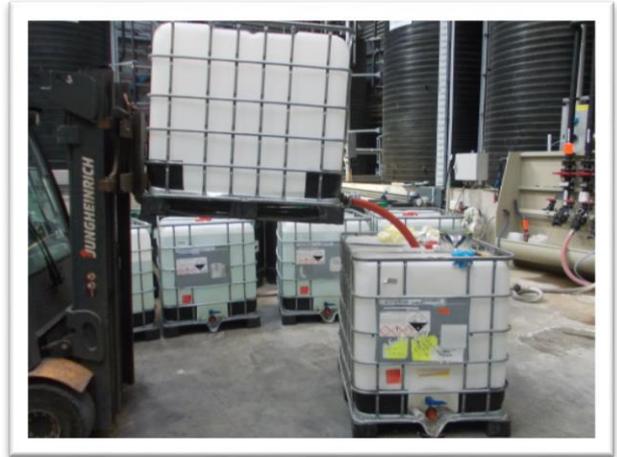
An intermediate bulk container (IBC) containing 32% ammonia, half filled and with the upper cap previously opened, had been placed in a high position by means of a forklift and was connected by a hose to another IBC partially filled with water. The solution then flowed by gravity into the IBC containing water. During the operation, the IBC containing the ammonia solution slid off the forks of the forklift and overturned. As the IBC's upper cap was open, the liquid spilt onto the ground.

The IBC fall occurred during the last operation of this type. The forks had been rendered slippery after being subjected to several washing operations with water. The fall was triggered by the liquid moves inside the IBC.

Position of the IBC at the time of tipping © DREAL

An interim order was issued suspending this type of handling and required the operator to conduct a risk analysis and propose measures to ensure that this type of operation is carried out safely. The facility operator has proposed that transfer operations be conducted from a specific and robust platform capable of supporting the full IBC to be transferred and has revised the associated operating procedure.
