WHEN NATURAL AND TECHNOLOGICAL
HAZARDS COLLIDE

**OVERVIEW OF THE INDUSTRIAL ACCIDENTS
CAUSED BY THE GREAT TOHOKU
EARTHQUAKE AND TSUNAMI**

JAPAN, MARCH 11th, 2011

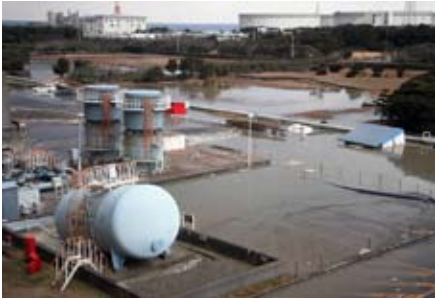
Soil liquefaction outside the Kashima plant
(Source: TEPCO)

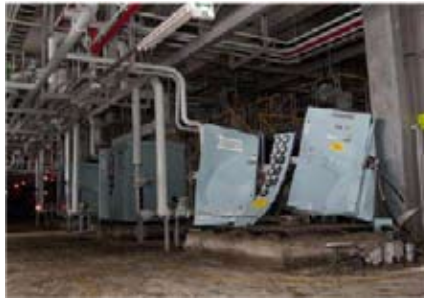
Ground floor of the turbine building after the tsunami, Sendai plant
(Source: Tōhoku Electric Co.)

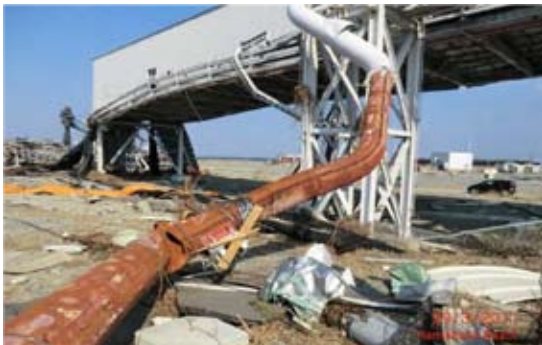
Port coal conveyor damaged by the tsunami at the Sinchi-Soma plant (Source: SPA Risk)

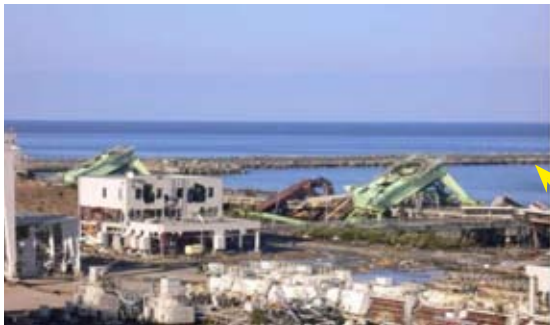
Damaged port facilities, Haramachi plant
(Source: Tōhoku Electric Co.)

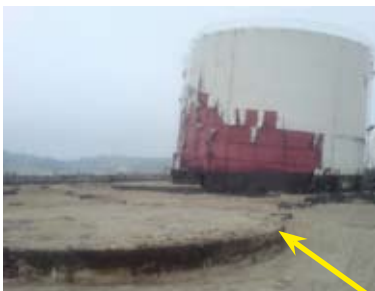
Fuel-oil storage tank pushed off its foundation by the tsunami (amateur photo)

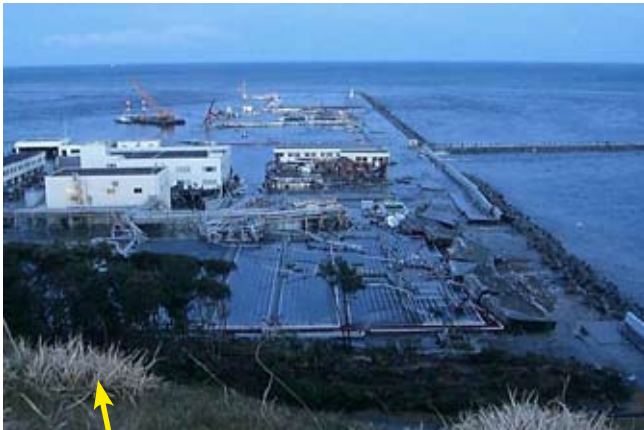
Wastewater treatment plant after the tsunami
(Source : TEPCO)

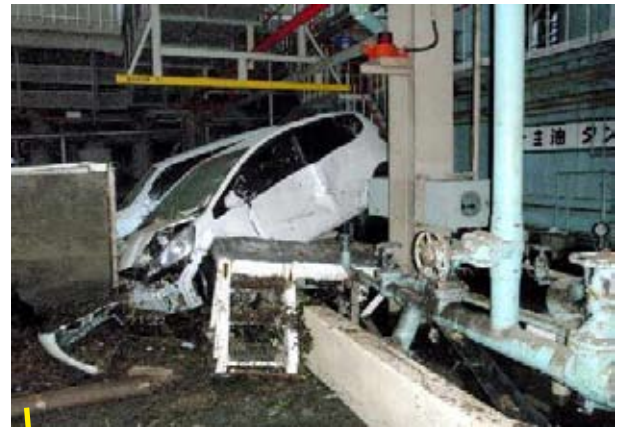
Ground floor of the turbine building after the tsunami
(Source : TEPCO)

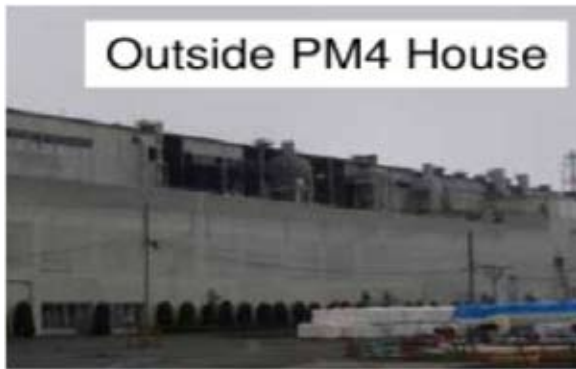
Iwanuma paper mill in Soma: seismic damage sustained by the building housing the paper calenders
(Source: Nippon Paper)

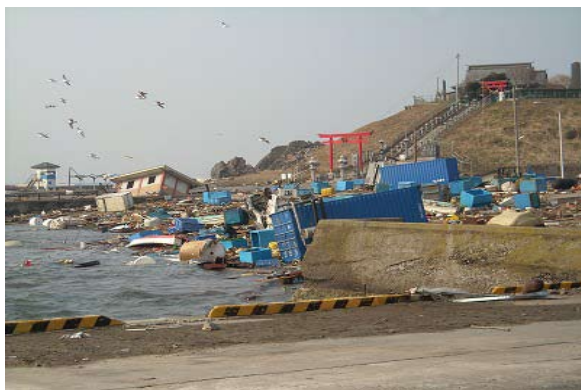
Hachinohe paper mill: supplies deposited outdoors by the tsunami (amateur photo)

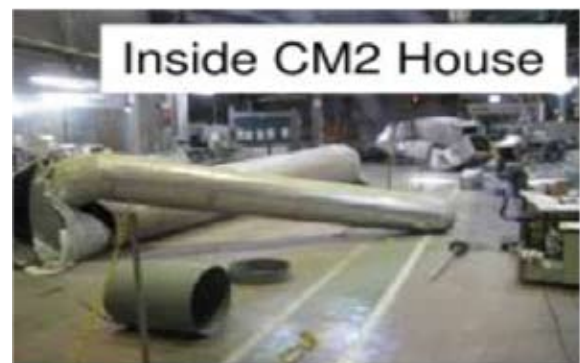
Nakoso paper mill: earthquake damage inside one of the paper coating buildings
(Source : Nippon paper)

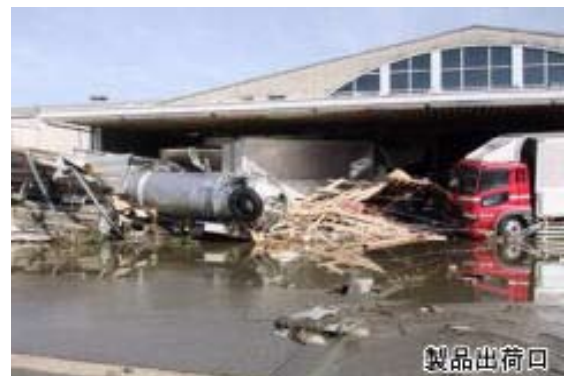
Hachinohe paper mill: equipment and supplies swept away by the tsunami (amateur photo)

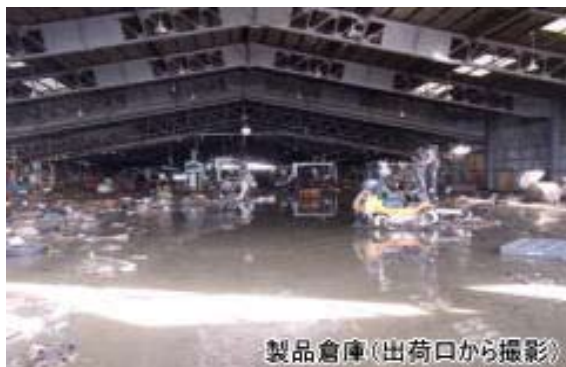
Oji Paper's cardboard packaging plant in the Port of Sendai after the tsunami
(Source : Oji paper)

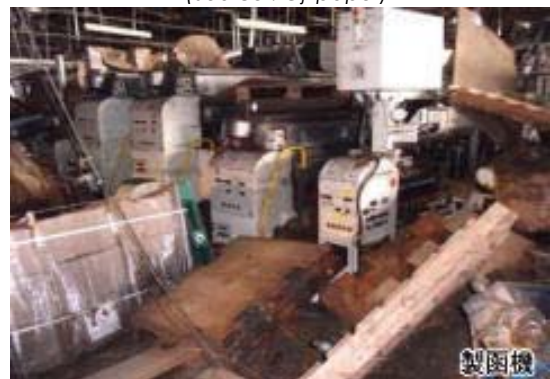
Oji Paper's cardboard packaging plant in the Port of Sendai after the tsunami
(Source : Oji paper)

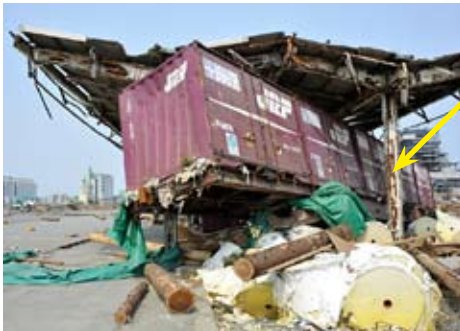
Freight train swept off its tracks

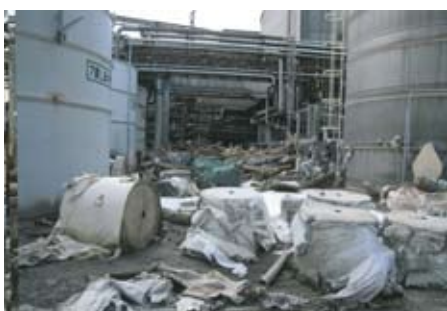
Rolls of paper carried into the plant by the tsunami

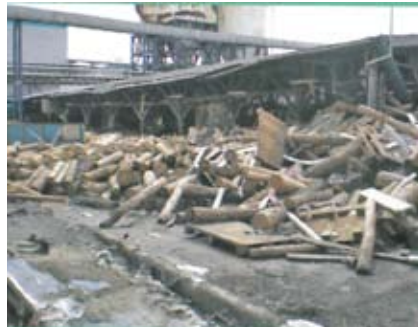
Logs carried into the plant by the tsunami

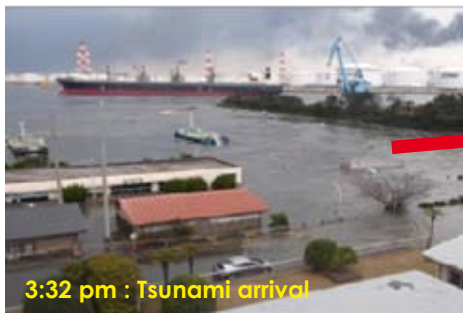
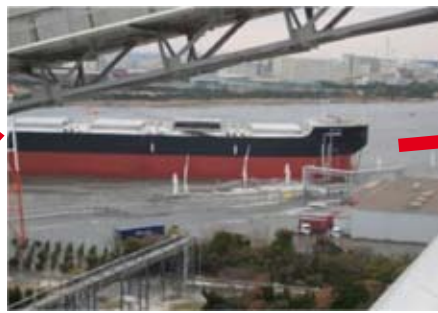
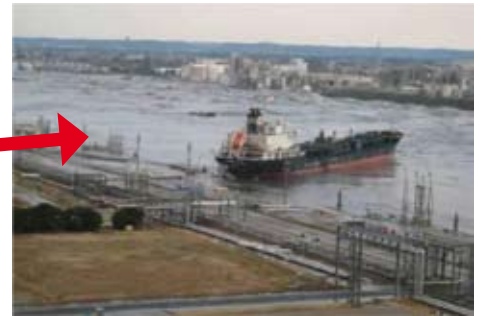
As the tsunami arrived in the southern channel inside the complex, it caused a chemical tanker to lose its moorings and crash into the nearby facilities and loading docks

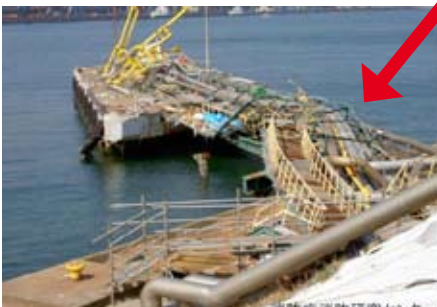
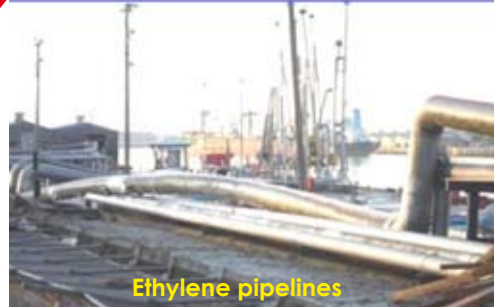
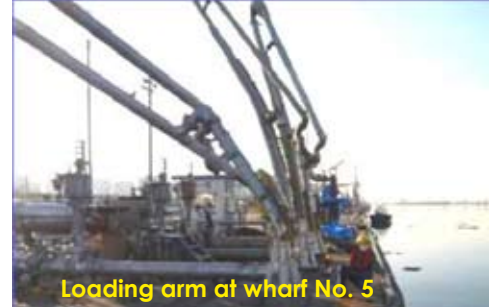
Pipes and facilities at the port damaged by the tanker (left, source: NRFID) and by the tsunami (right and below, source: METI)

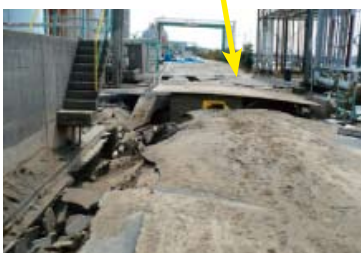
Road liquefaction between two production units
(Source : Asahi glass)

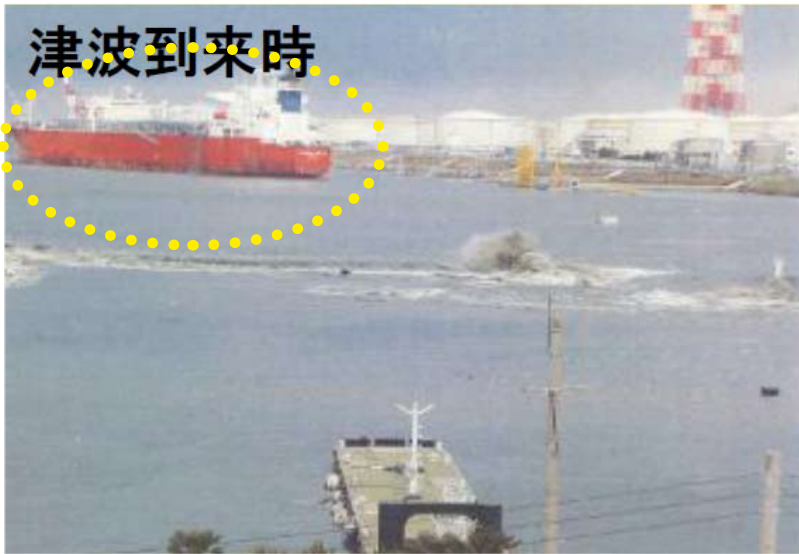
Casualties	None (one or more BLEVEs in the port are reported to have had devastating consequences)
Damage caused by the tsunami	<ul style="list-style-type: none"> The gash in the hull allowed water to enter the engine room, endangering the compressors used to maintain the propane in a liquid state Damaged rudder system Several impact points on the hull (a collision with a large vessel could have ripped open the hull and resulted in a large propane spill)
Resumption of operations	The vessel remained at anchor in shallow water facing the port for two weeks before it was able to unload its propane cargo. During these two weeks, food onboard had to be rationed and the crew was in danger of being contaminated by radiation. The vessel was subsequently moved to a repair yard in Tokyo Bay

The Flanders Tenacity adrift in the Port of Kashima after being wrenched from its moorings by the tsunami on the afternoon of March 11th, 2011
(Source : METI)

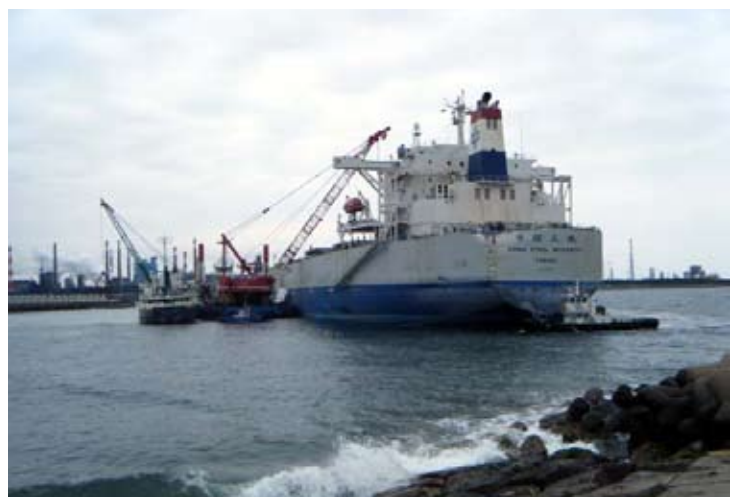
The China Steel Integrity was being loaded with iron ore on the Sumitomo site in the Port of Kashima when it was dragged away by the tsunami. After colliding with the Flanders Tenacity, it ran aground at the entrance to the Port of Kashima's main channel
(amateur photo)

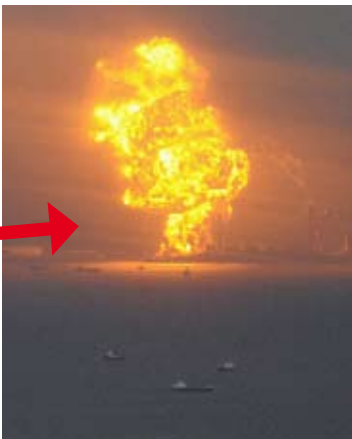
View of a BLEVE from the opposite side of Tokyo Bay (estimated diameter of the largest BLEVE: 600 m). Below: piece of a sphere. (Source : NRFID)

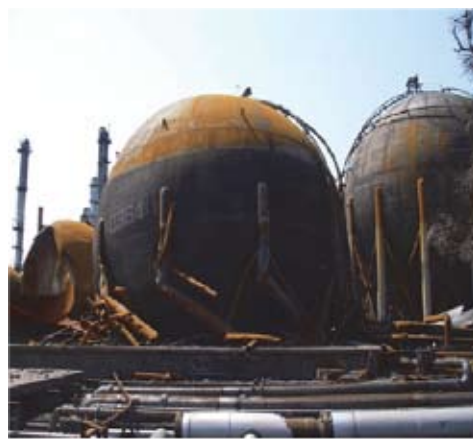
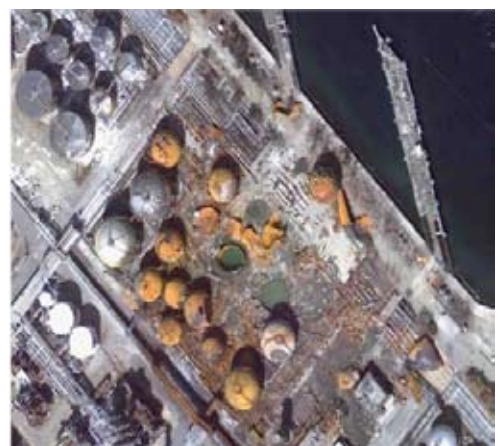
Views of the spheres and the surrounding area after the blaze (Source : Google Maps / NRFID)

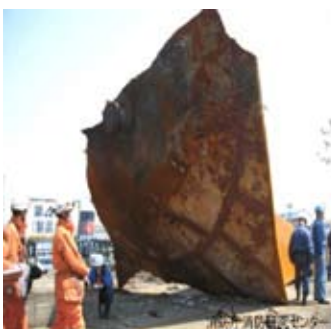
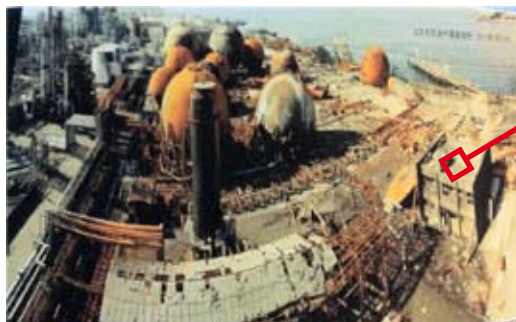
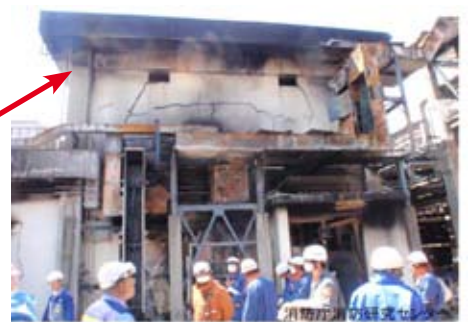
The number of BLEVEs was limited by the spray rings on the spheres (flow rate of 5 l/m²/min) (Source : NRFID)

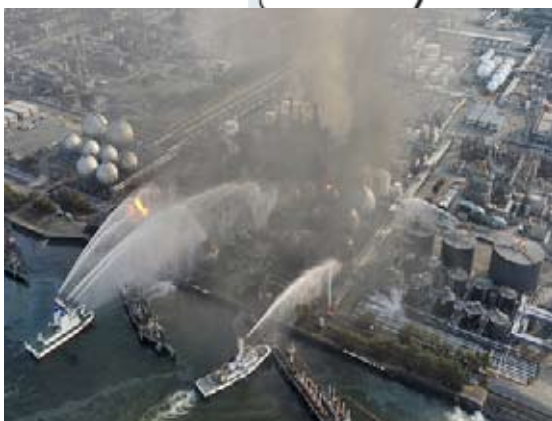
Fireboats extinguishing the LPG tank farm blaze. The wind coming from the sea made extinguishing the fire from land impossible (amateur photo)

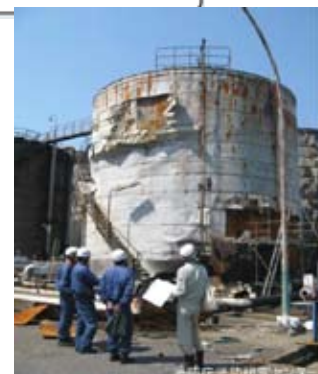
The nearby bitumen storage tanks after the fire (Source : NRFID)

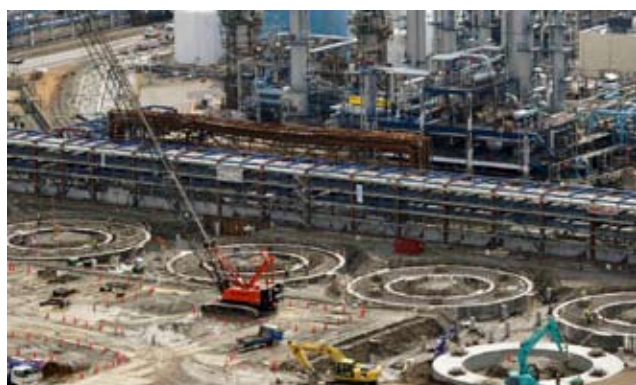
Locations of the breaking points on the tank s' legs (Source : Cosmo oil)

The LPG tank yard being rebuilt to new standards in September 2011 (Source : Cosmo oil)

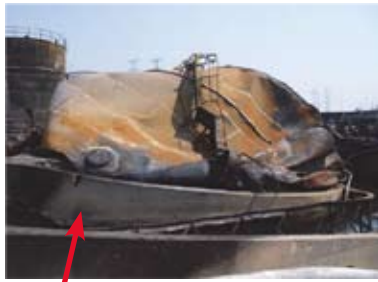
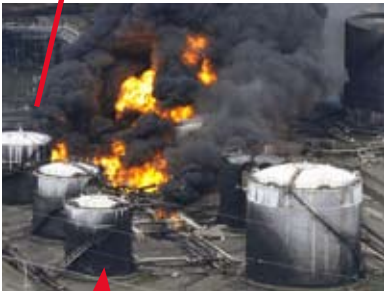
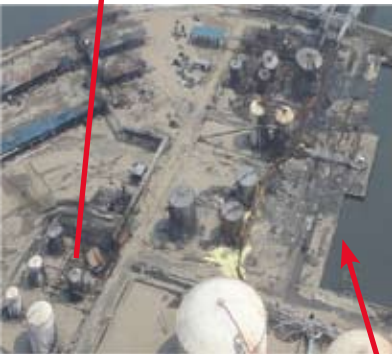
The fire spread to the petrol, liquid sulphur and bitumen storage tanks. A tank tilted to one side by the tsunami collapsed while burning (Source : NRFID)

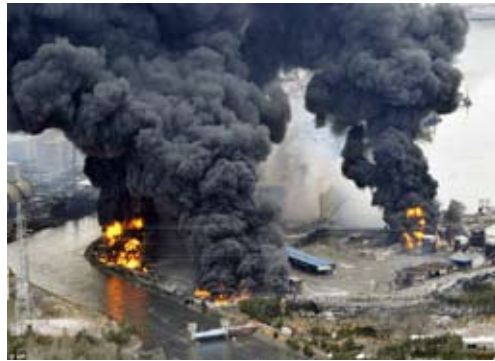
View of the road/rail loading station during the fire (amateur photos). A leak on a petrol pipe is the likely cause of the hydrocarbon vapour cloud, which ignited

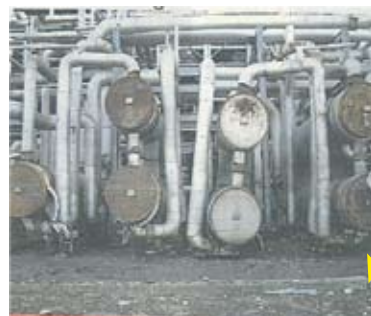
Collapsed foundations of the heat exchangers (Source : JX)

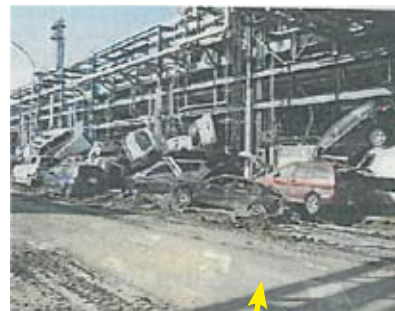
Below: The foundations of the FCC reactor collapsed in two stages. First, from debris carried by the tsunami, then from the aftershocks of 7 April 2011 (Source : JX)

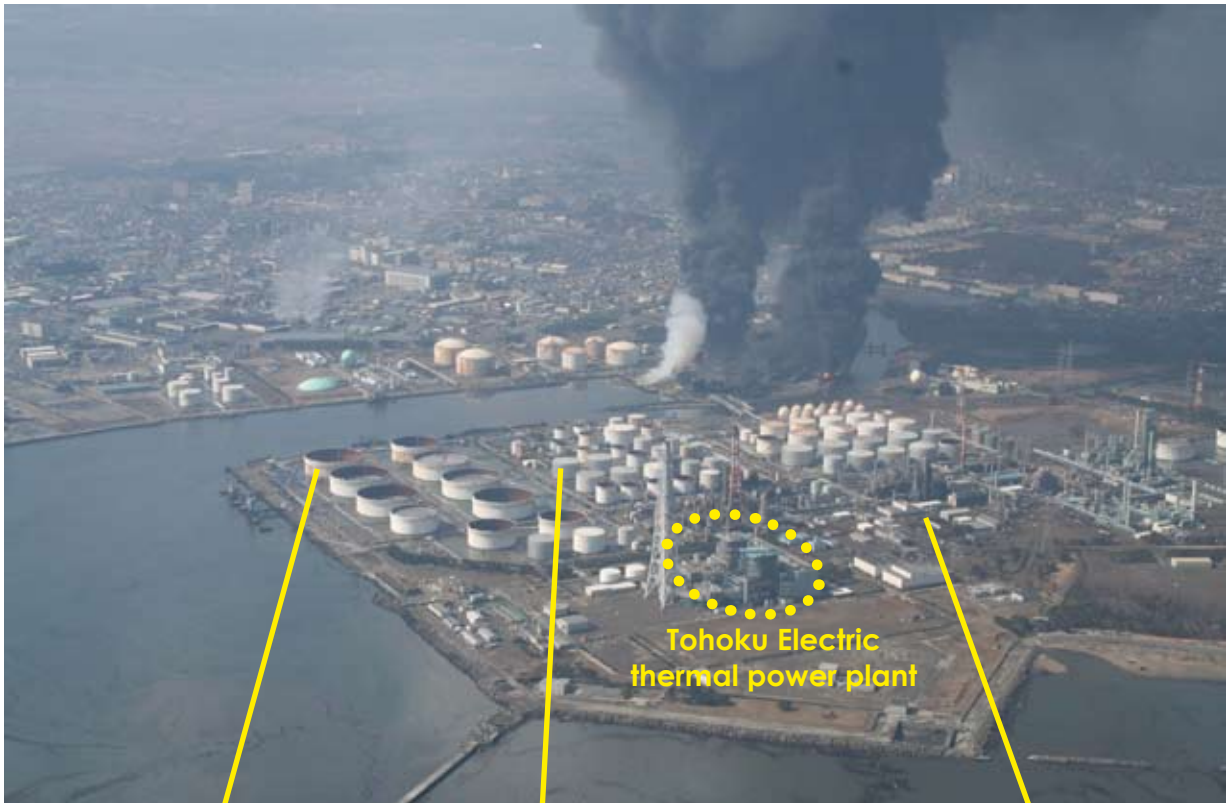
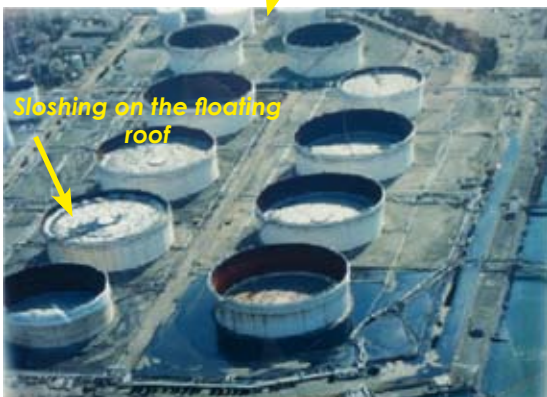
Sloshing on the floating roof

Although they were empty, the crude-oil storage tanks (2 million m³) stayed in place during the 3.5 m tsunami. The pipes, however, gave way after being pushed up by the incoming water.
(Source : NRFID)

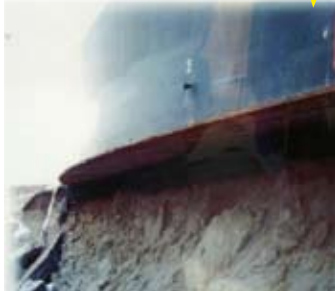
Soil erosion, as much as 3 m deep in places, caused by the tsunami around the large storage tanks (Source : JX)

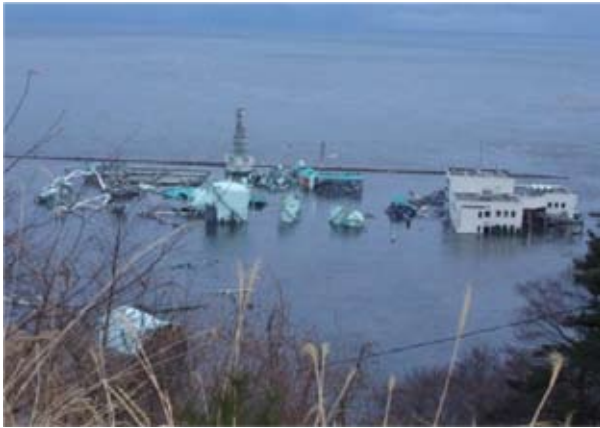
Photo of the outdoor facilities of the Kuji national reserve on March 11th after the tsunami struck
(Source : JOGMEC)

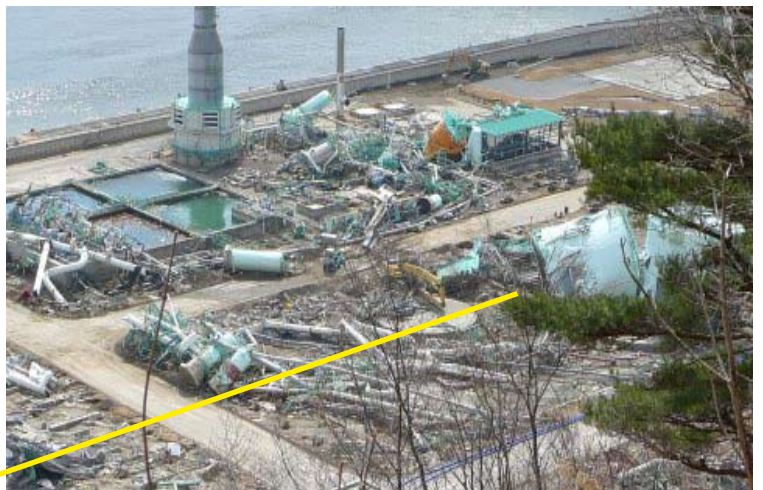
Above: Outdoor water and fuel-oil storage tanks swept away by the tsunami. Left: Surface facilities of the Kuji strategic national reserve. The underground fuel storage tanks were unscathed but seawater had to be pumped out.
(amateur photo)

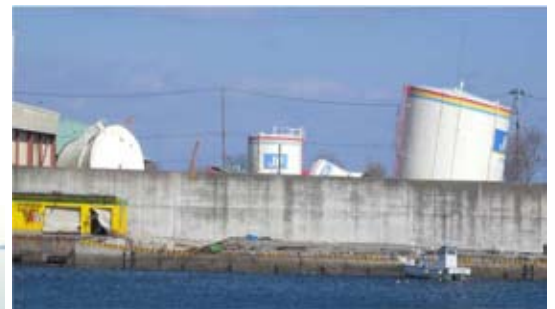
Storage tanks displaced after being submerged (4.3 m) in the Kuji oil terminal
(amateur photo)

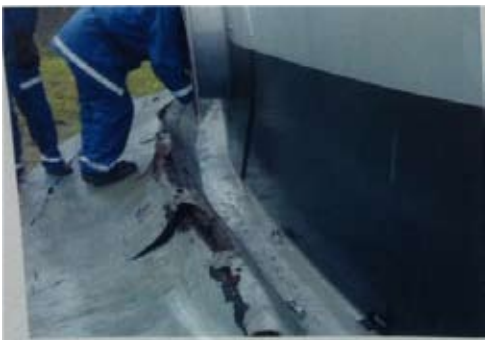
Storage tank foundation buckled by liquefaction in the Niigata oil terminal
(Source : NRFID)

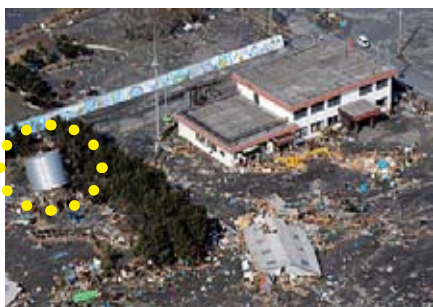
Storage tank carried inland from the Misawa oil terminal
(amateur photo)

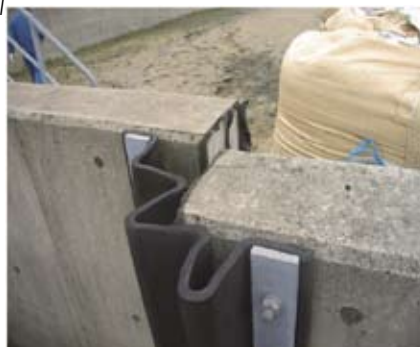
Bund walls buckled by liquefaction in the Kashima oil terminal
(Source : NRFID)

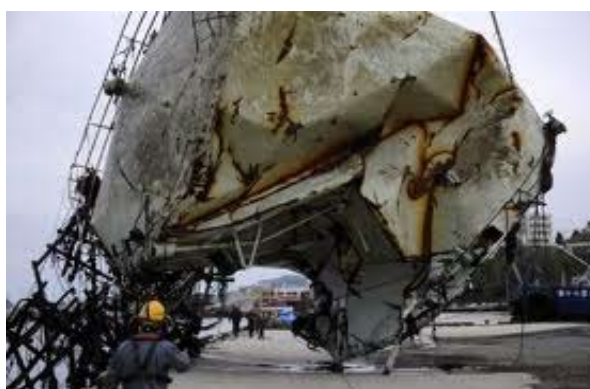
Removing damaged storage tanks in May 2011
(amateur photo)

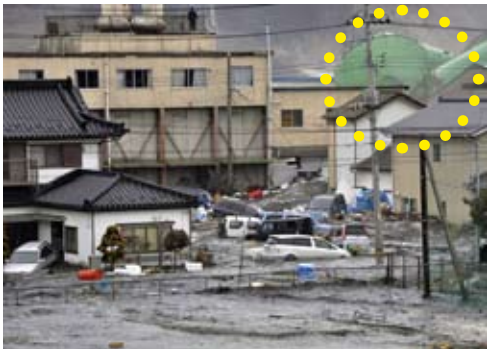
Storage tank being swept away as the tsunami hits the estuary (amateur photo)

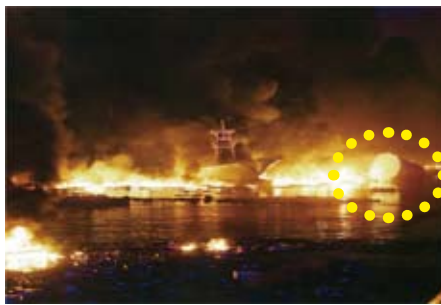
The fire spread through the bay and the village during the night but did not reach the terminal (amateur photo)

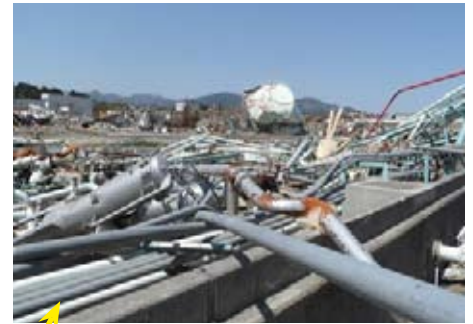
The foundations of the storage tanks were left intact (Source : NRFID)

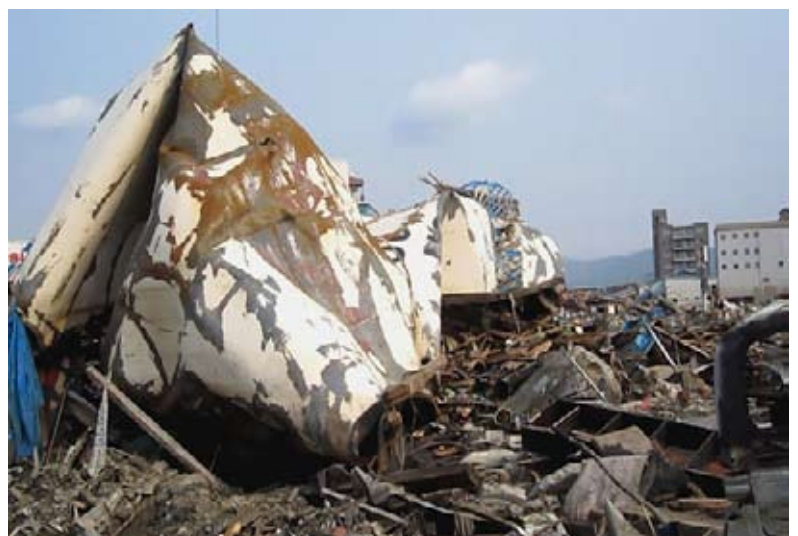
Above: Photo of storage tanks swept into the bay (amateur photo)

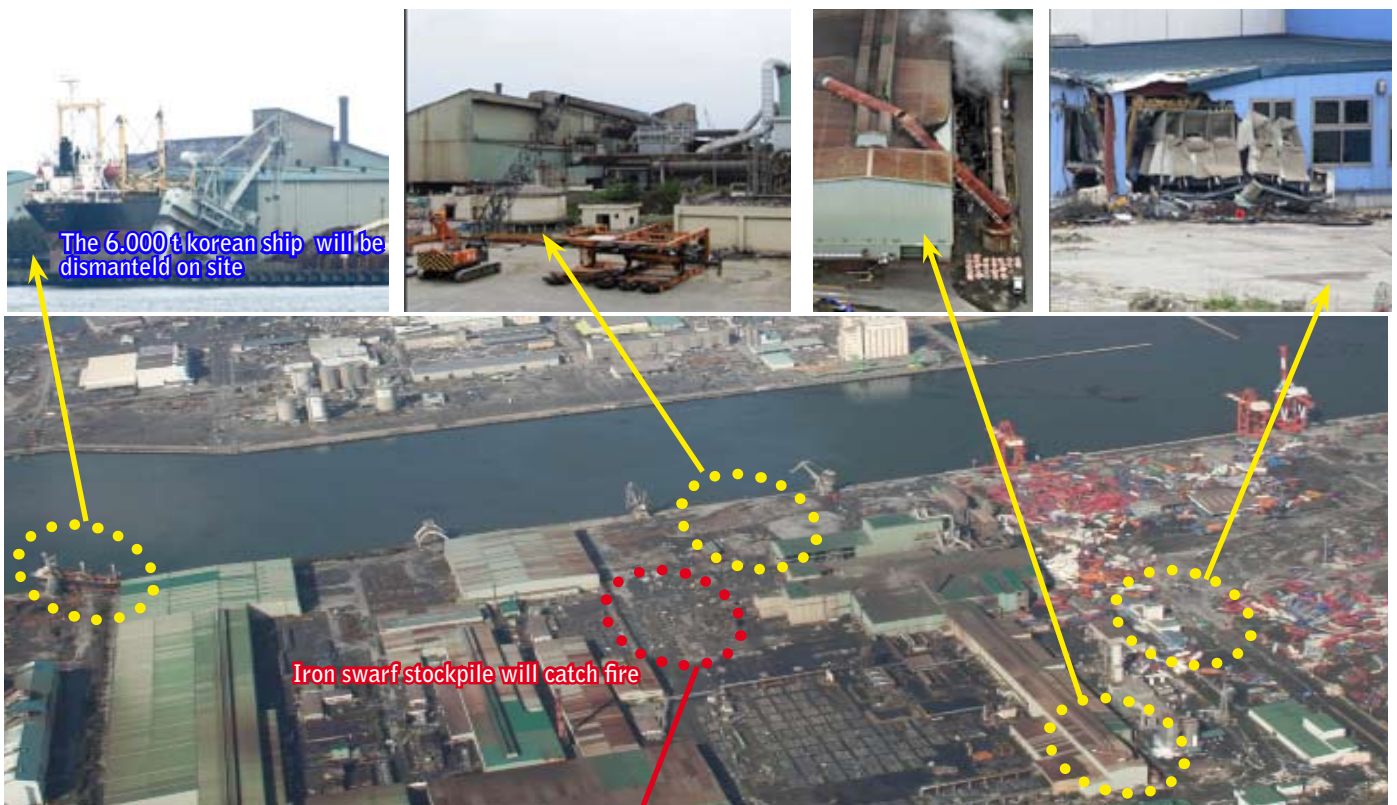
Aerial view of the JFE Bars site a few hours after the tsunami hit the Port of Sendai
(Source : Aero Asahi Corp.)

On March 12th a heap of iron scrap oxidised by seawater caught fire, releasing heavy smoke. It was put out with fire monitors after the heap was broken up by heavy machinery

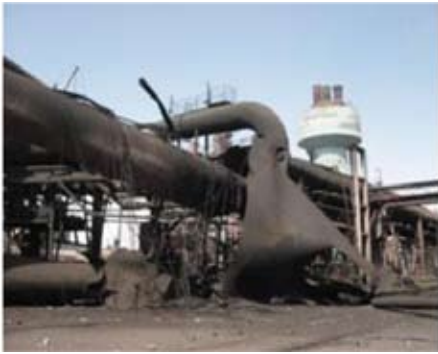
Damage to a coke oven gas pipe
(Source : Sumitomo)

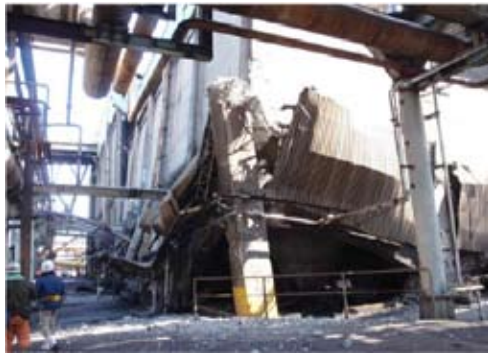
Damage to the base of the coke oven
(Source : Sumitomo)

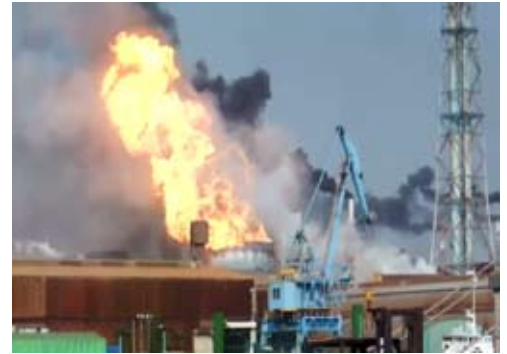
Gas holder fire, March 11th, 2011
(amateur photo)

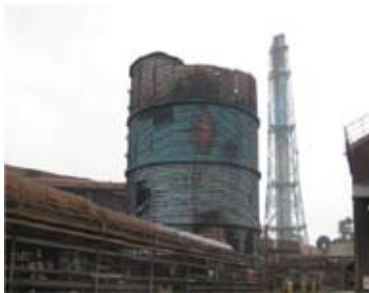
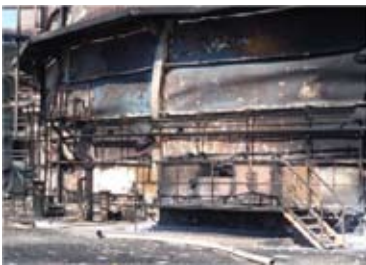
Top and base of the gas holder
after the fire (above) and after
being repaired in April 2011
(below)

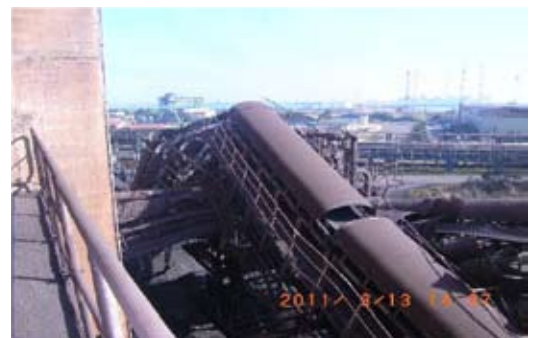
Damage to the sinter conveyor
(Source : Sumitomo)

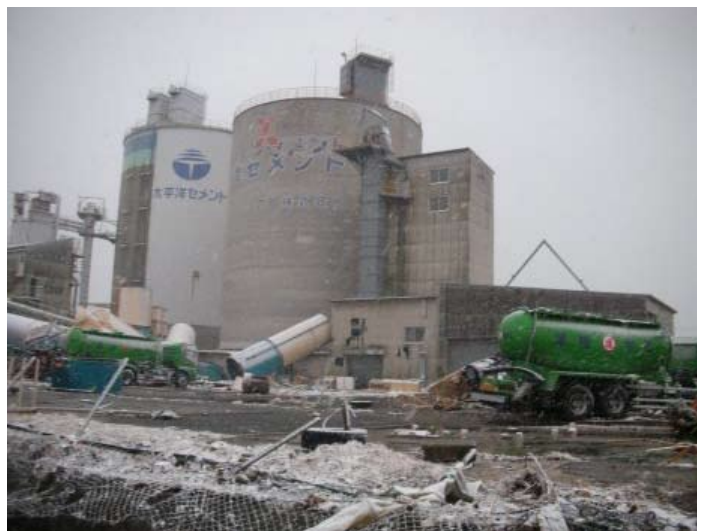
Concrete plant after the tsunami struck the Port of Sendai in March 2011 (amateur photo)

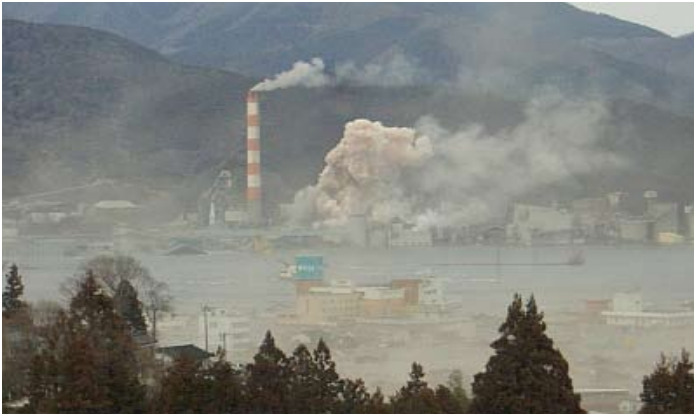
Storage silo collapsing during the tsunami of March 11th (amateur photo)

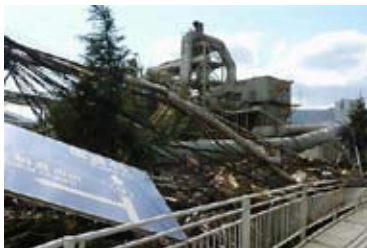
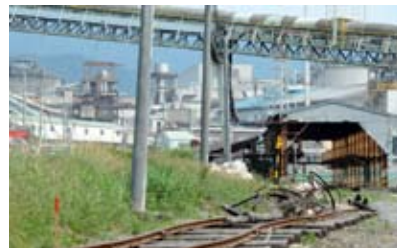
Portion of the cement plant that was submerged by the tsunami, including the port facilities, rail facilities and storage silos (left : amateur photo)

The tanks used to store fuel oil (supplying the rotary kilns) and bulk raw materials storage areas (clay, silica, etc.) were swept away by the tsunami

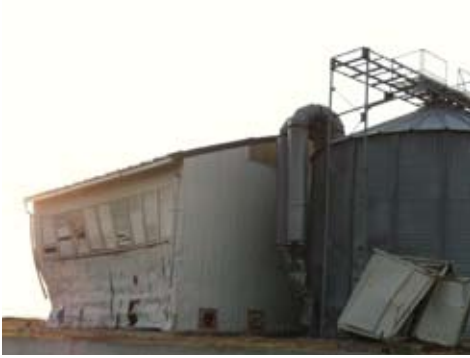
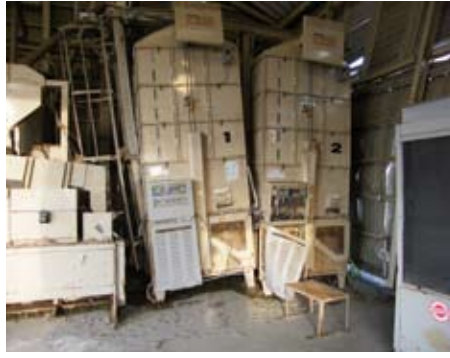
Above: exterior and interior photos of a grain silo damaged by the tsunami and its debris near Natori (Source : DGPR), Right: liquefaction of the dock of a grain silo in the Port of Kashima (source: METI)

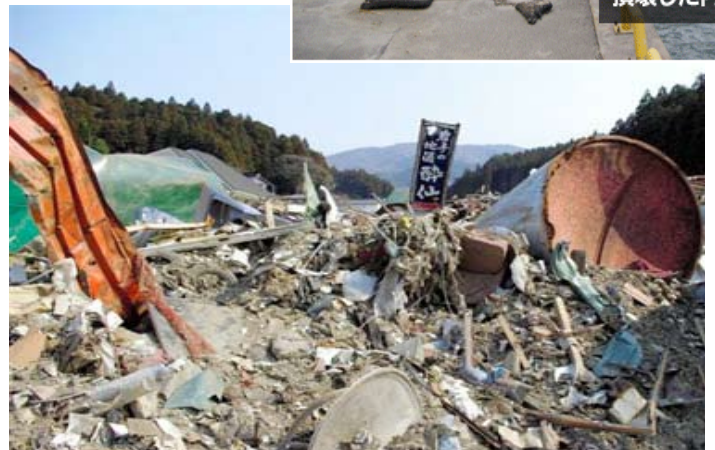
The 2011 Tōhoku tsunami levelled the Suisen Shuzo saké brewery in Rikuzentakata, killing 7 of the brewery's 57 employees (Source : Sake World)

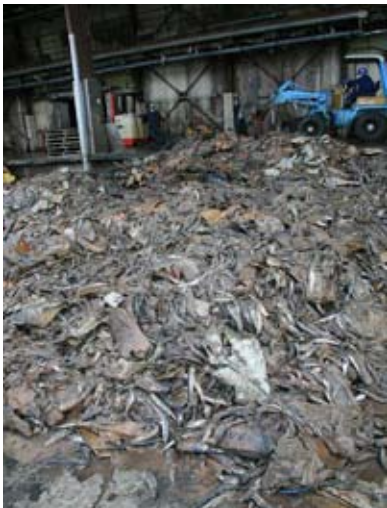
Decomposing fish being cleared away by an excavator in the Port of Kesenuma. More than 200,000 tonnes of rotting fish had to be collected in the Tōhoku region's ports. 50,000 tonnes were disposed of in the sea (amateur photo)

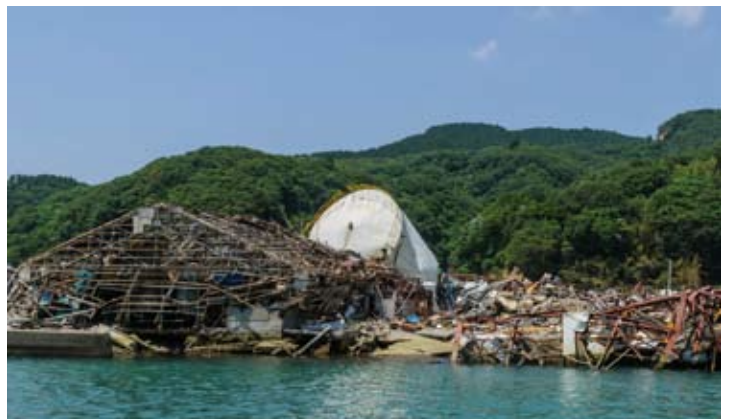
Nippon Suisan fish freezing plant levelled by the tsunami in the Port of Onagawa (amateur photo)

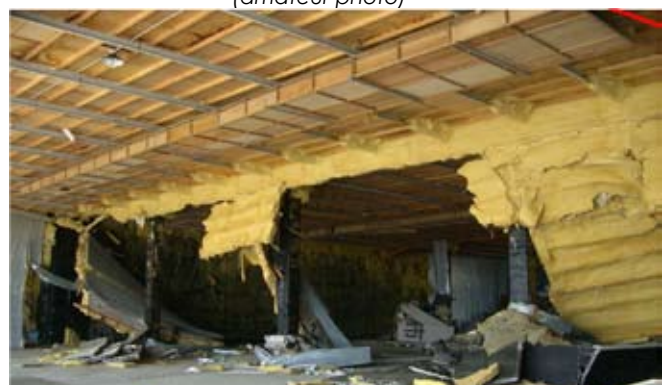
Interior of a refrigerated warehouse in the Port of Ishinomaki (amateur photo)

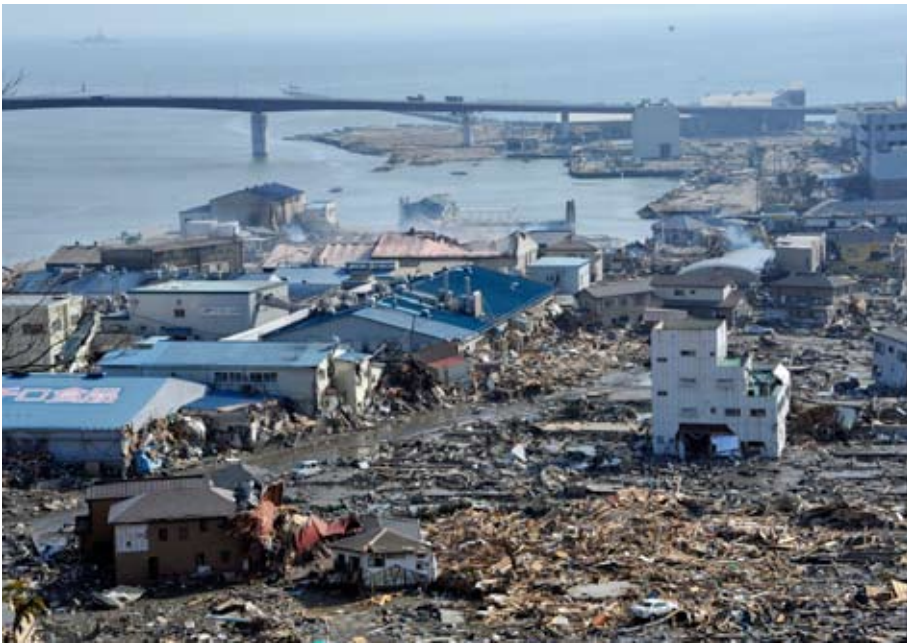
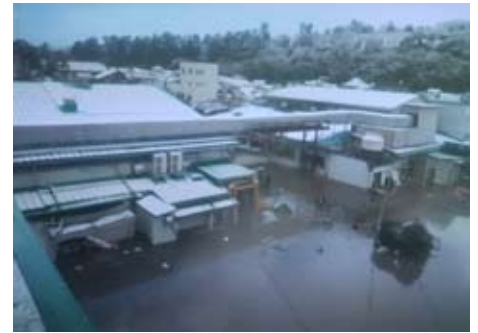
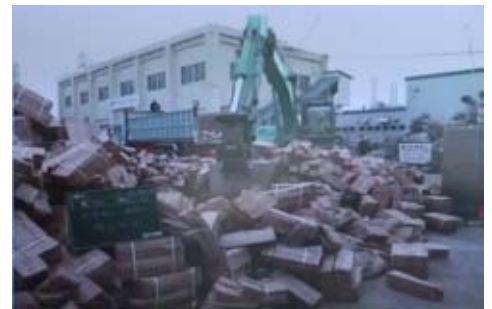
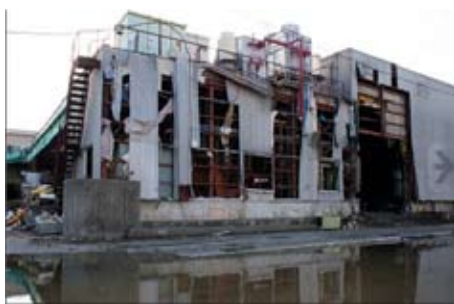
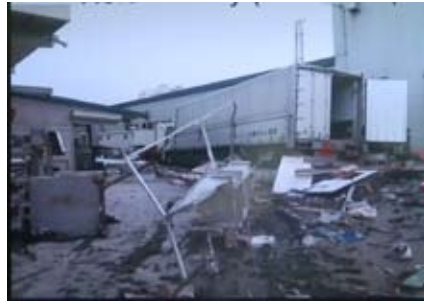
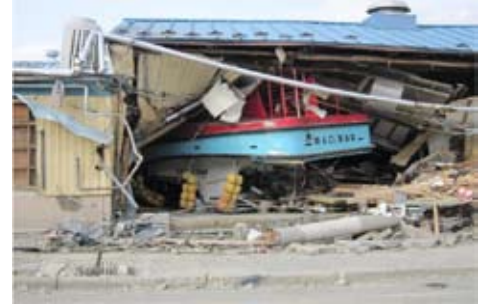
MARUHA NICHIRO SEAFOOD PROCESSING - PORT OF ISHINOMAKI

Damage caused by the tsunami	<ul style="list-style-type: none"> 86% of buildings damaged, primarily their interiors (structures left intact). Extensive damage from external debris (one fishing boat, cars, one truck, debris from homes). Inventory of frozen foods swept away by the tsunami. No ground pollution found
Damage in €	<ul style="list-style-type: none"> 65% of employees laid off; 70% drop in production capacities on Nov. 30 th, 2011 €25 million in damage and operating losses
Chronology of resumption of operations	<p>14 March: Search conducted to find missing employees</p> <p>1st April: Start of cleaning operations, demolition of damaged buildings and rebuilding of the packing lines</p> <p>6 July: The first fish-processing line is brought back into operation</p> <p>8 August: The second fish-processing line is brought back into operation</p>
Technical lessons	<ul style="list-style-type: none"> Emergency electricity supply for the audible warning system (down on 11 March due to lack of power) and emergency exit lighting Stock of provisions, blanks, emergency tools and communication devices stored in the hilltop shelter

Left: buildings pummelled by the 7-metre-high wave (amateur photo)
Right: Debris carried in and around the site by the tsunami (Source : Maruha Nichiro)

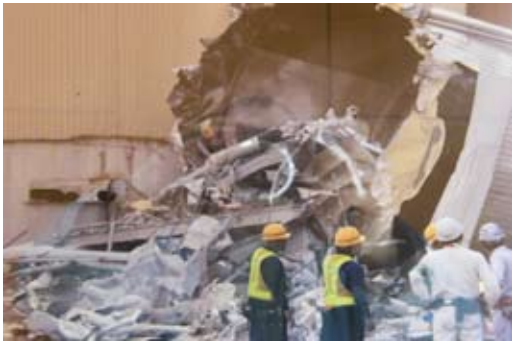
Casualties	None
Damage caused by the earthquake	Four of the 15 beer storage silos collapse (individual capacity: 400 m ³)
Damage caused by the tsunami	<ul style="list-style-type: none"> Finished products warehouse, packing unit and wastewater treatment plant submerged. Undamaged equipment such as the fermentation tanks had to be cleaned and overhauled. Damaged equipment (packing unit) was cleaned of rust and defective parts were replaced. Control systems and their networks had to be replaced. The stocks of canned and bottled beer and fruit juice, in cases or kegs, were swept out of the warehouse and scattered throughout the industrial section of the Port of Sendai. The FIBCs of malt and hops were also swept away
Damage in €	€51 million
Chronology of resumption of operations	<p>April–May 2011: Site cleaned. Glass bottles scattered inside the buildings are picked up by the employees by hand</p> <p>26 September 2011: Can and keg filling lines and two production lines are started back up</p> <p>26 September 2011: Can and bottle filling lines and two production lines are started back up</p> <p>June 2012: Production and bottling line operating at full capacity</p>

Damage sustained by one of the silos
(Source : Kirin)

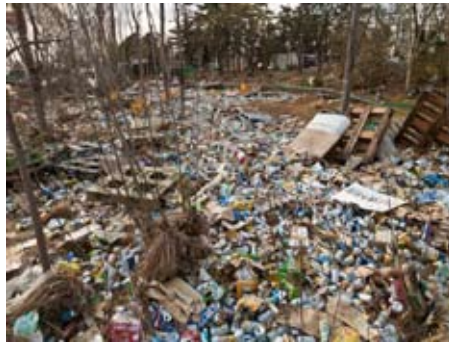
Goods were scattered for several kilometres around
the site by the tsunami (amateur photo)

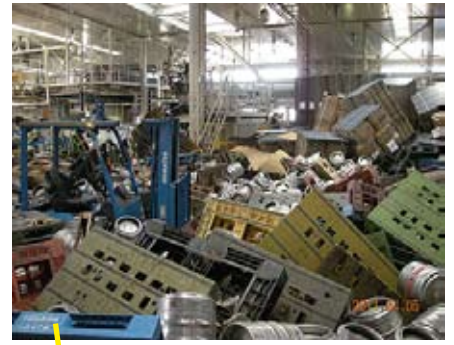
Inside the bottling building
(amateur photo)

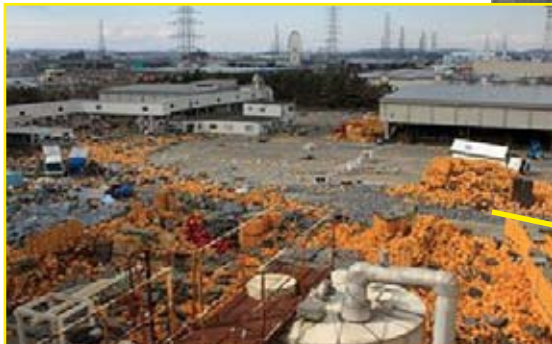
View of the site after the tsunami
(amateur photo)

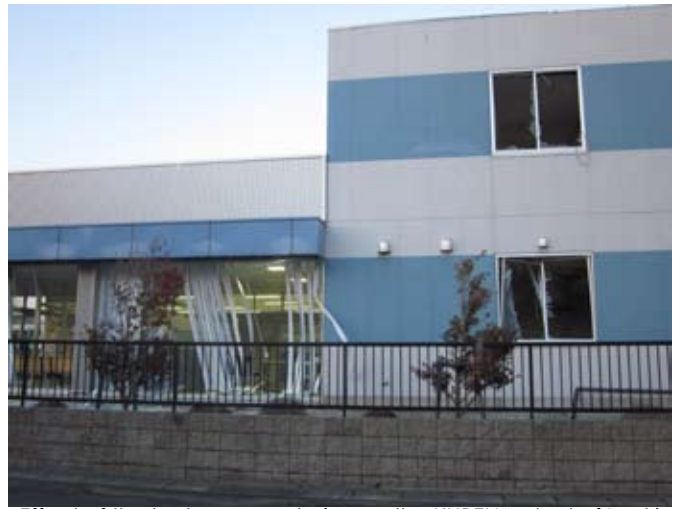
Effect of the hydrogen explosion on the KUREHA plant of Iwaki (amateur photo)

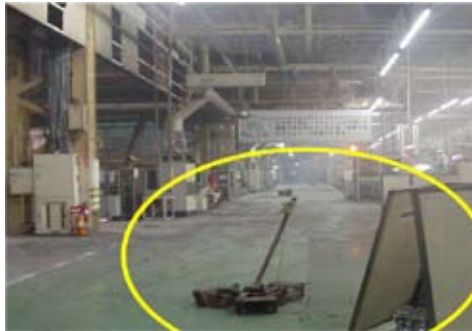
Drop of broadcast system (Source : Nissan)

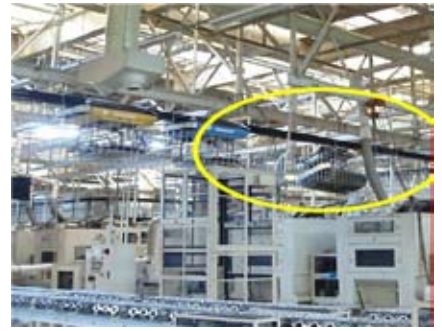
Drop of overhead carrier
(Source : Nissan)

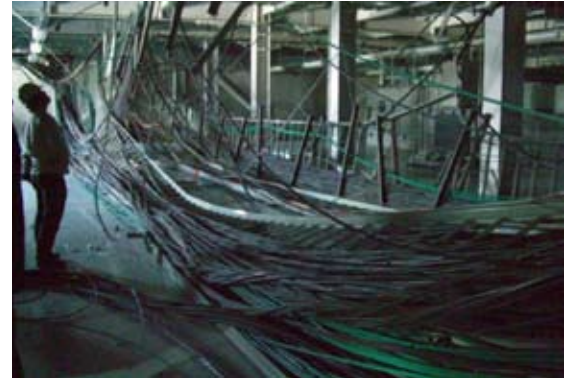
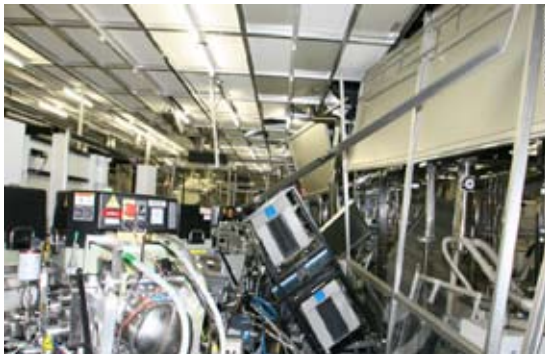
*The clean room after the earthquake
(Source : Renesas)*

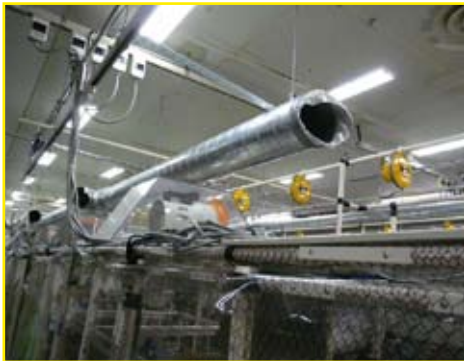
Failure of the duct used to supply the server ageing test equipment (Source : Fujitsu)

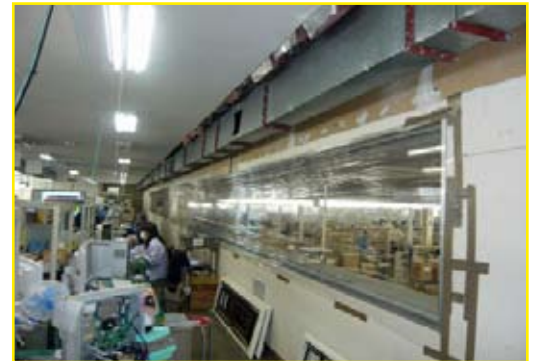
Plastic film on the window looking out onto the PC assembly room (Source : Fujitsu)

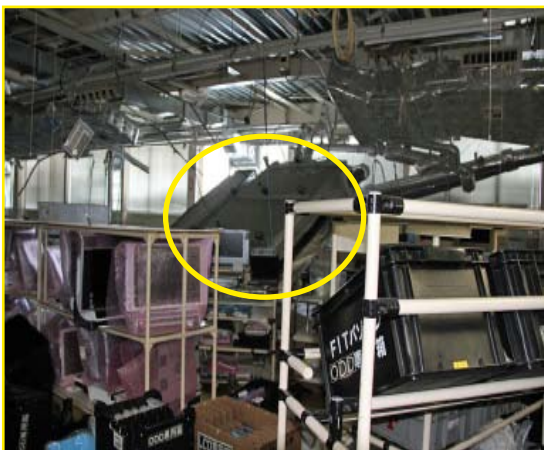
This air conditioner collapsed onto the spare parts racks on the second floor (Source : Fujitsu)

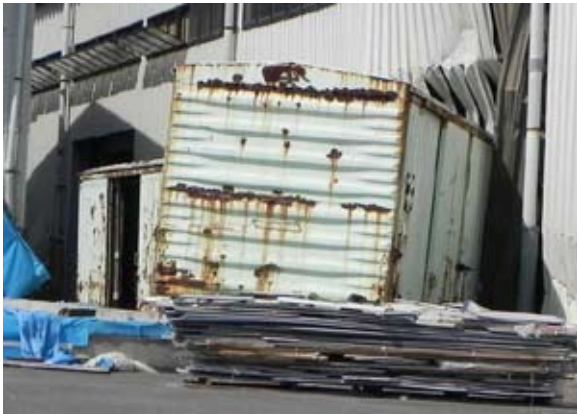
Warehouses damaged by the tsunami and large debris in the Port of Sendai (amateur photo)

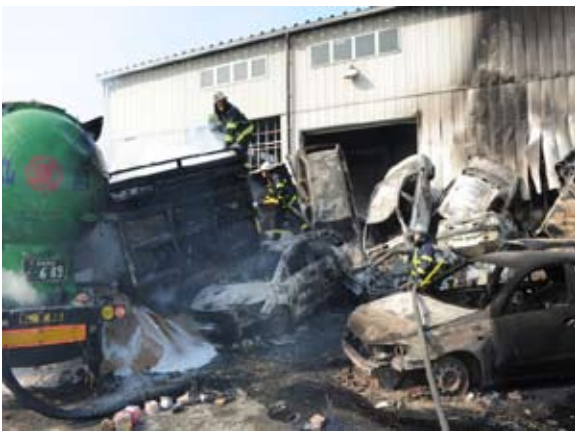
Warehouses in the Port of Sendai set on fire by cars (amateur photo)

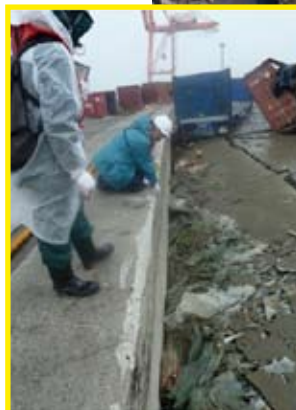
Earthquake damage to the platforms of the logistics terminal (amateur photo)

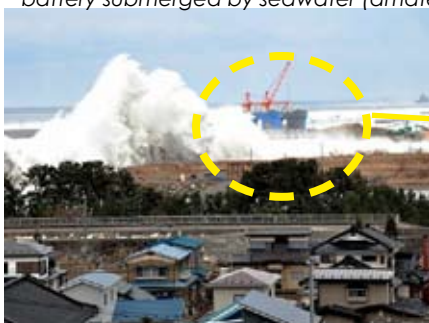
View of the container terminal in the Port of Sendai. Of the four giant cranes at the terminal, the two without seismic protection systems were damaged (amateur photo)

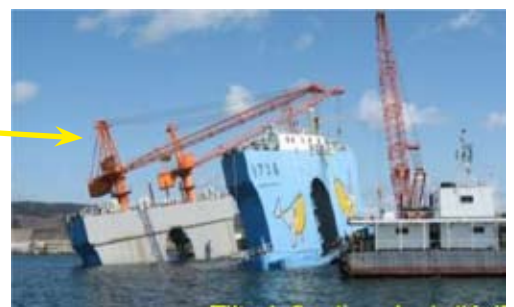
The tsunami arriving in the Port of Kuji on March 11th. Half-sunken floating dock (amateur photo)

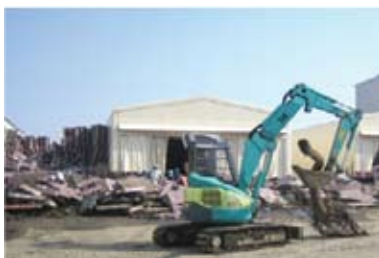
Clearing away debris and sedimentation (Source : JPR)

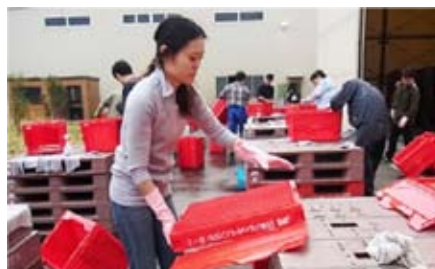
Cleaning and reconditioning of salvaged pallets (Source : JPR)
